# Tsunami Impacts to Lifelines:

*Review of Current Knowledge and Post-Event Survey of the 16 September 2015*

*M8.3 Illapel, Chile Tsunami*

Nick Horspool, Stuart Fraser (GNS Science)  
Richard Mowll (Wellington Lifelines Group)

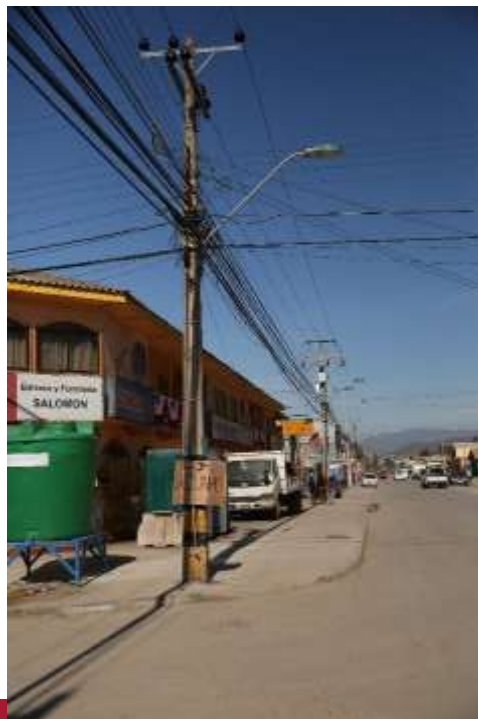
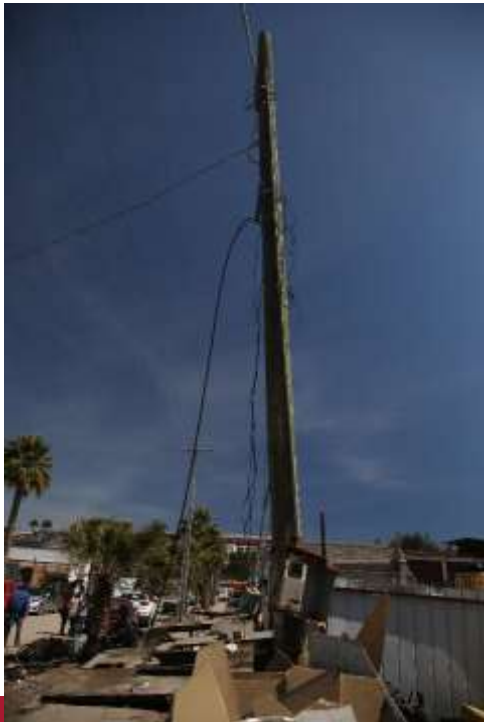
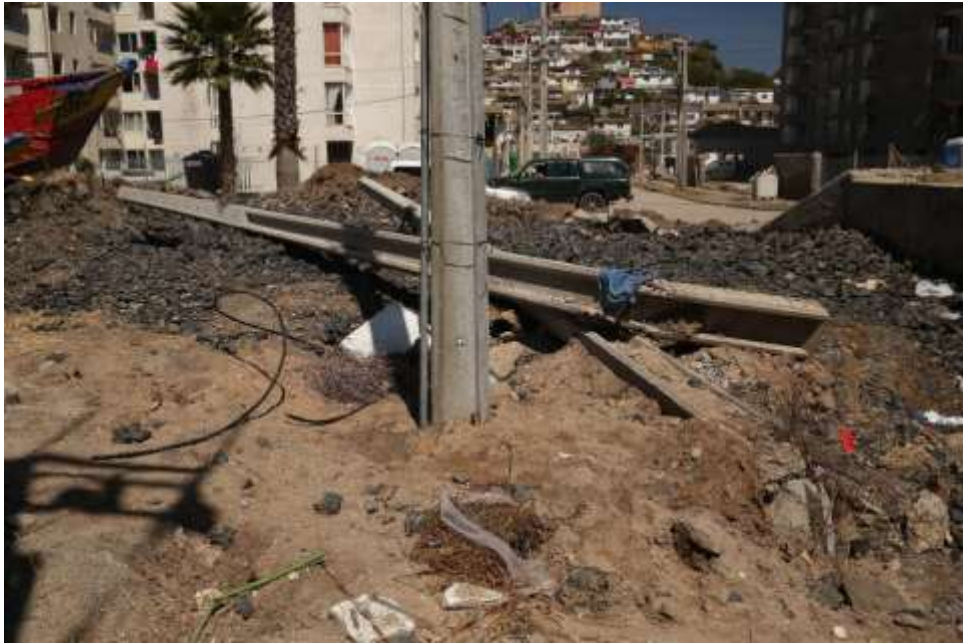
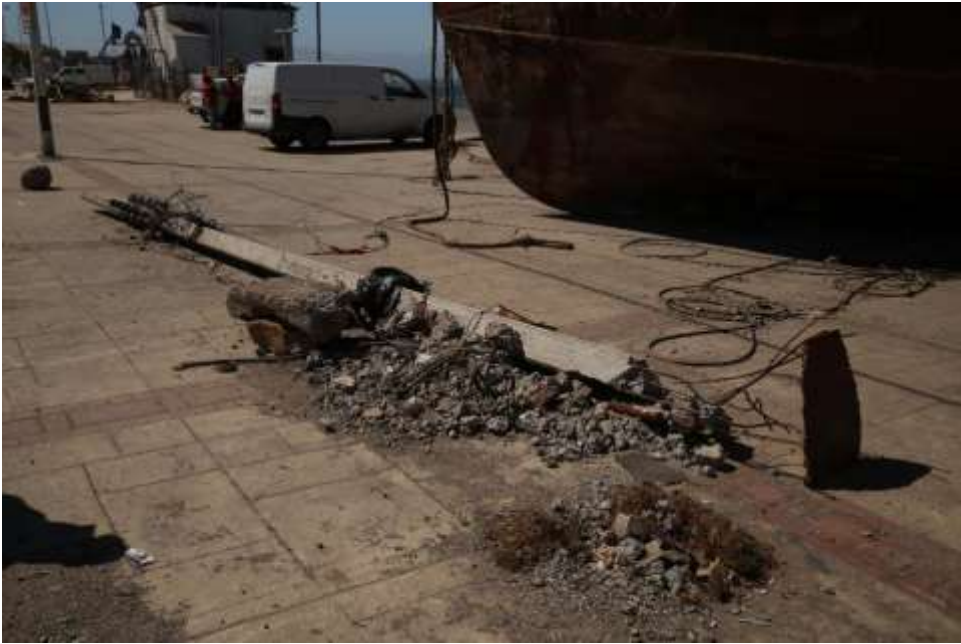
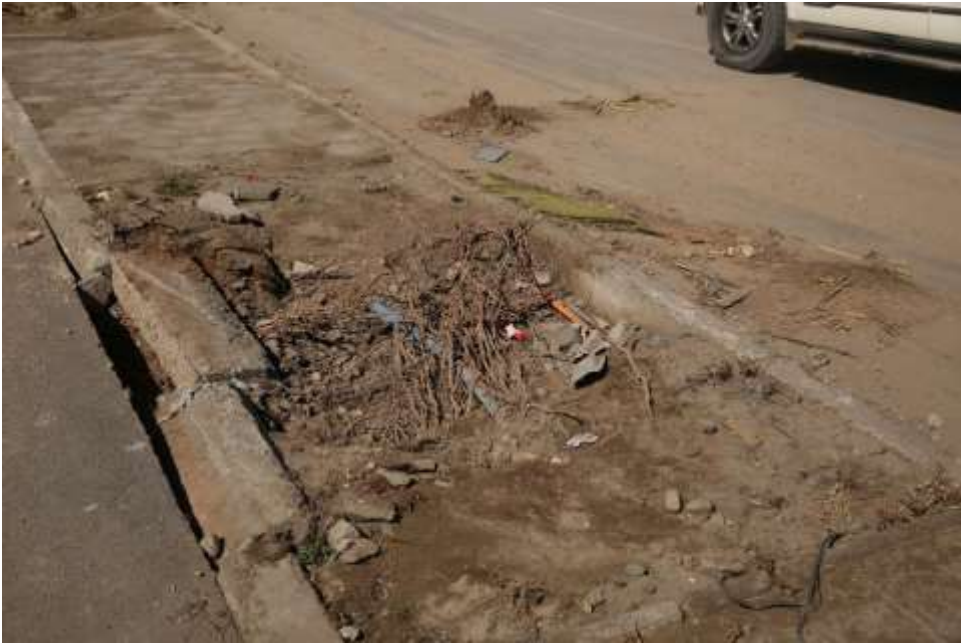
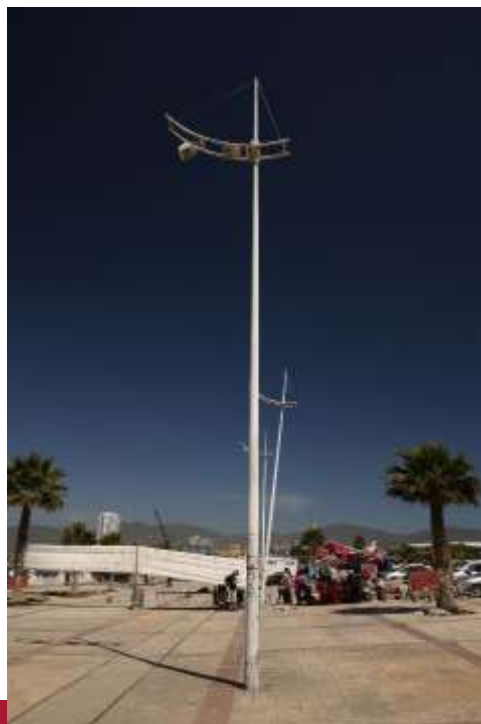
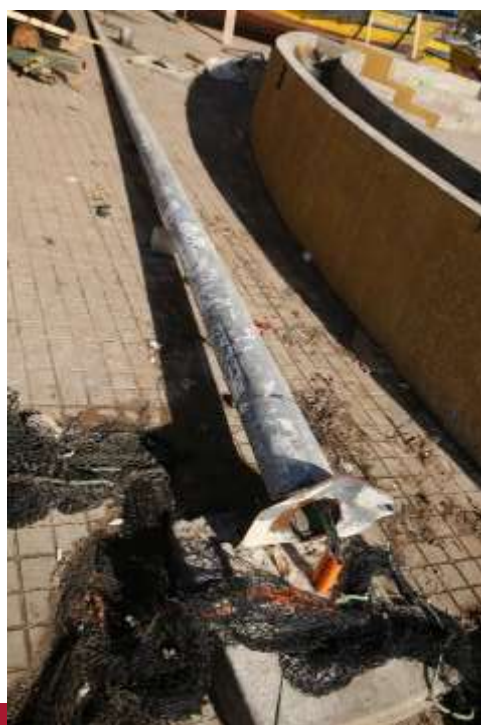
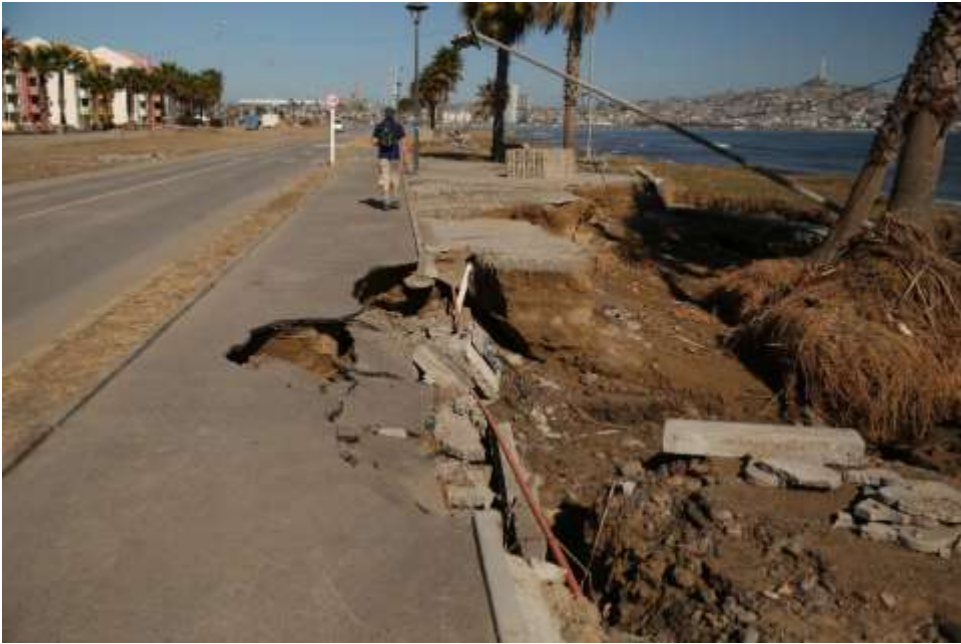
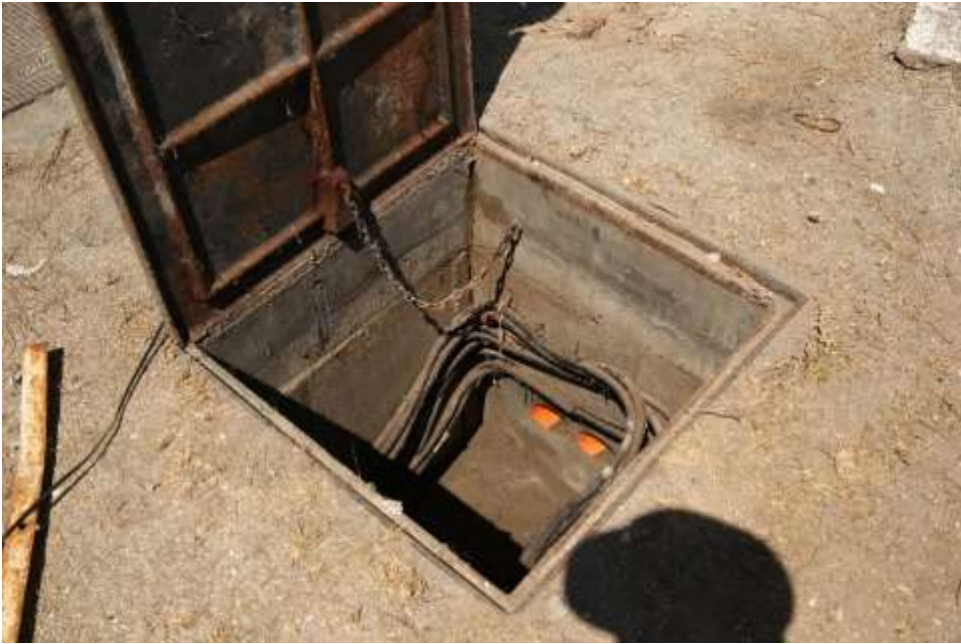
- There were no transmission assets in the tsunami zone
- There were minimal buried cables in the tsunami zone
- The distribution network was largely overhead
- Data was captured for:
  - Power poles
  - Street lights
  - Substation(?)
- Information gathered from Conafe (local lines company)
- Overhead lines/pole mounted transformers were washed away if tsunami reached them
- Pole failure from shearing at base, debris strike, scouring at foundations

- Buried lines are less vulnerable than overhead lines unless cable housing damaged by earthquake
- Locate substations outside of tsunami inundation zones
- Outside substations are more vulnerable than internal ones, particularly for washout
- Stockpile spares (electrical components, poles etc) for rapid repairs
- Have a plan for response – larger than BAU

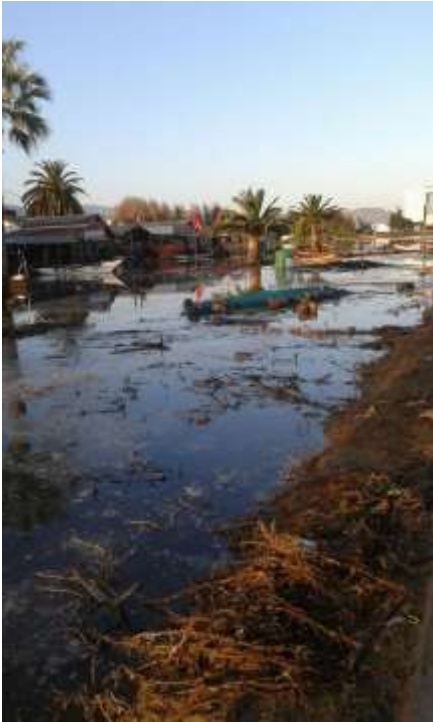
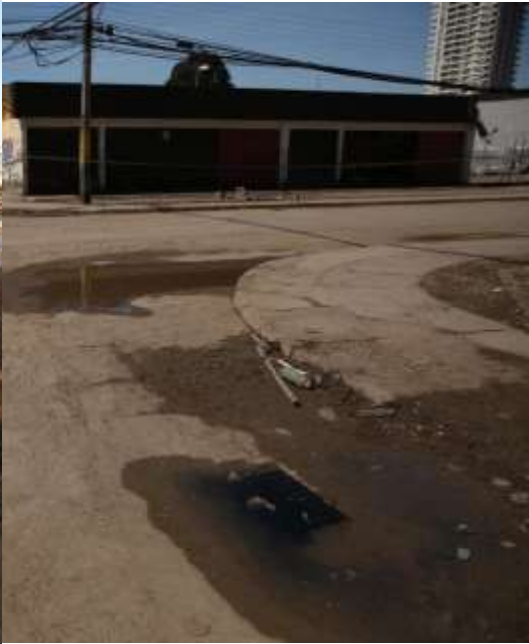
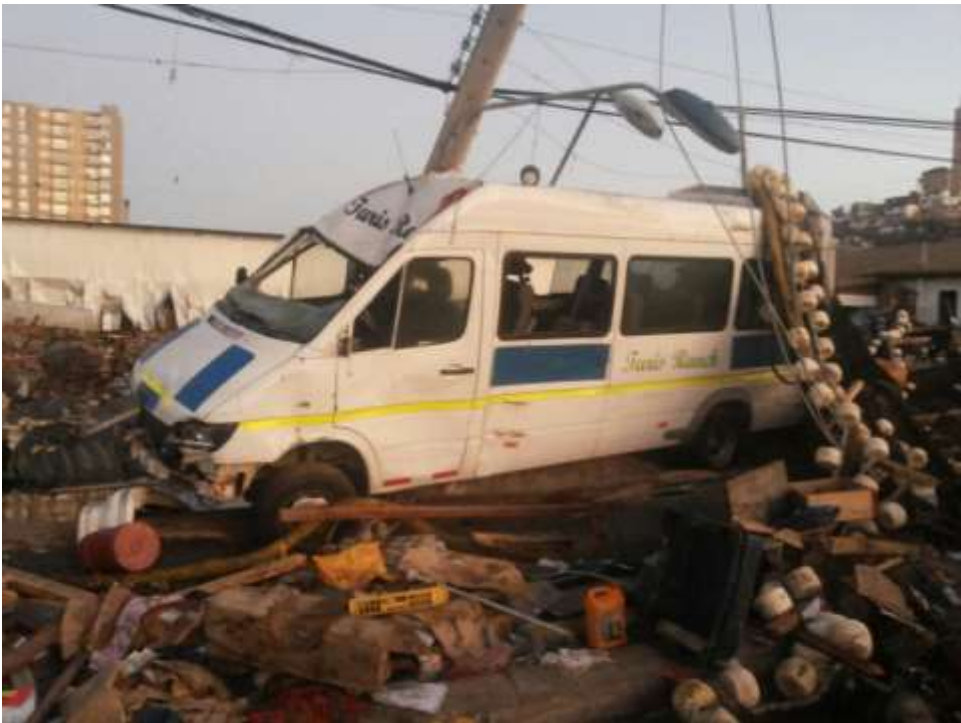
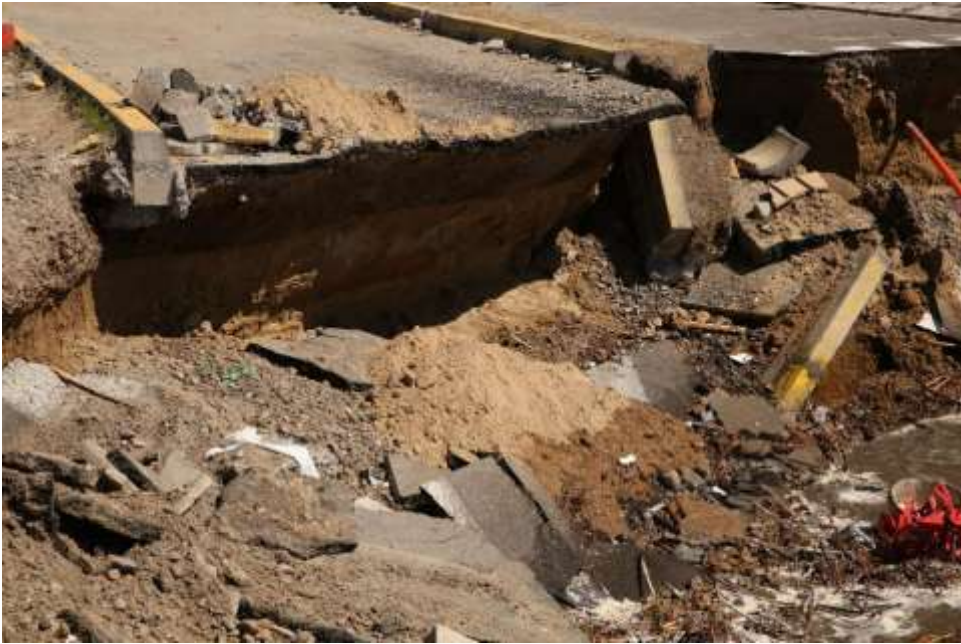
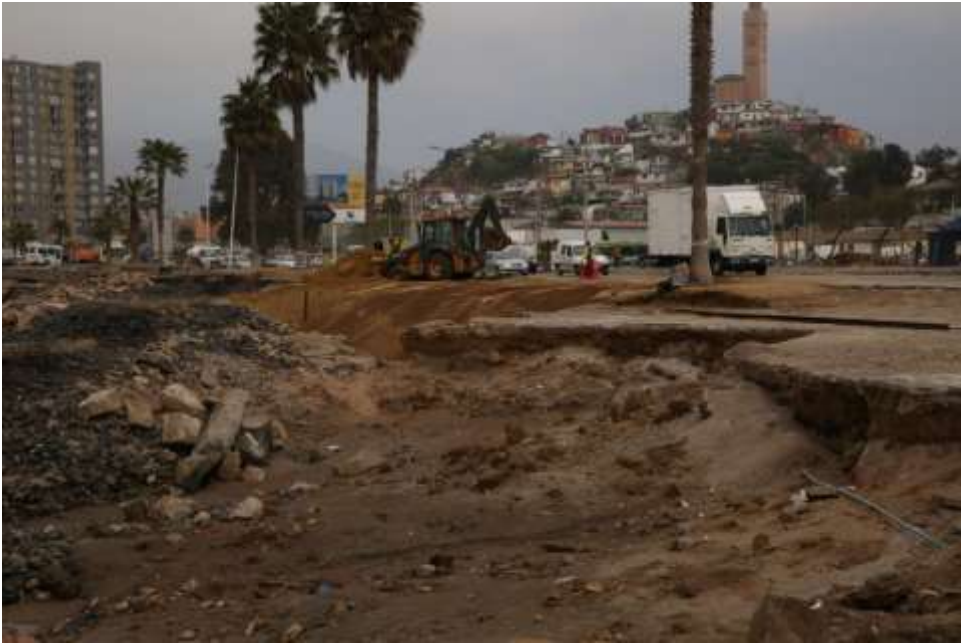
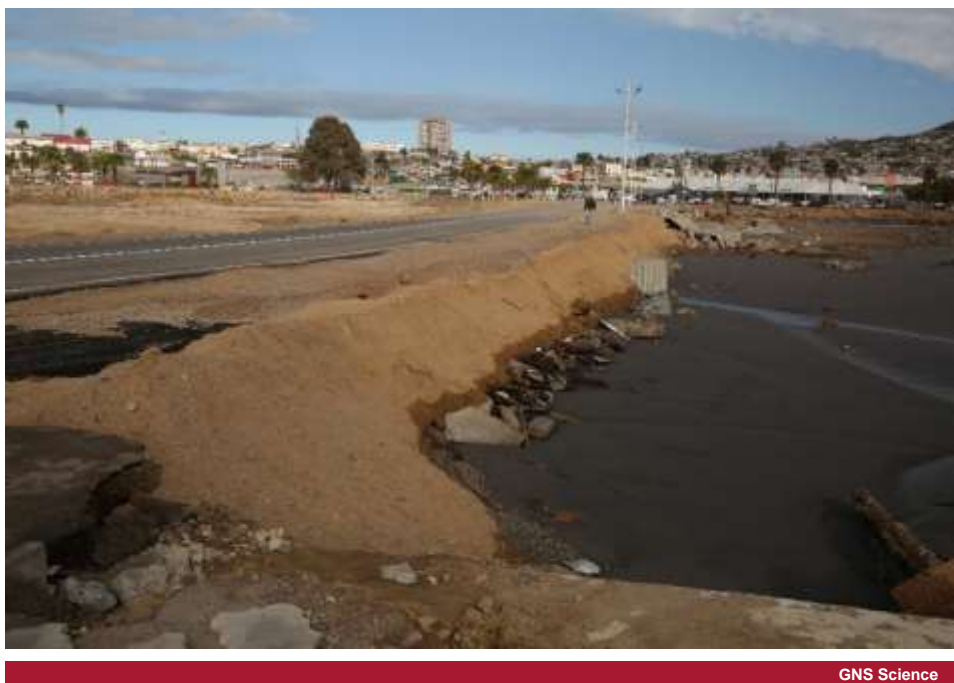
- Most observations (below) from a 0-5m flow depth
- Debris and flooding present after tsunami
- Most roads in the inundation zone were founded on sandy material, with a granular base and a thin asphalt surface
- There were very few ‘both-lane’ wash-outs (by the sea)
- There were many minor / single lane wash-outs (by the sea)
- All wash outs were where culverts ran under road to sea
- Most roads away from the sea/drainage features were relatively unaffected

- Introduce redundancy in network
- Strengthen and protect coastal roads at sites of culverts or outflows with rip rap
- Develop arrangements with contractors to clear debris repair scoured sections
- Use well engineered road bases

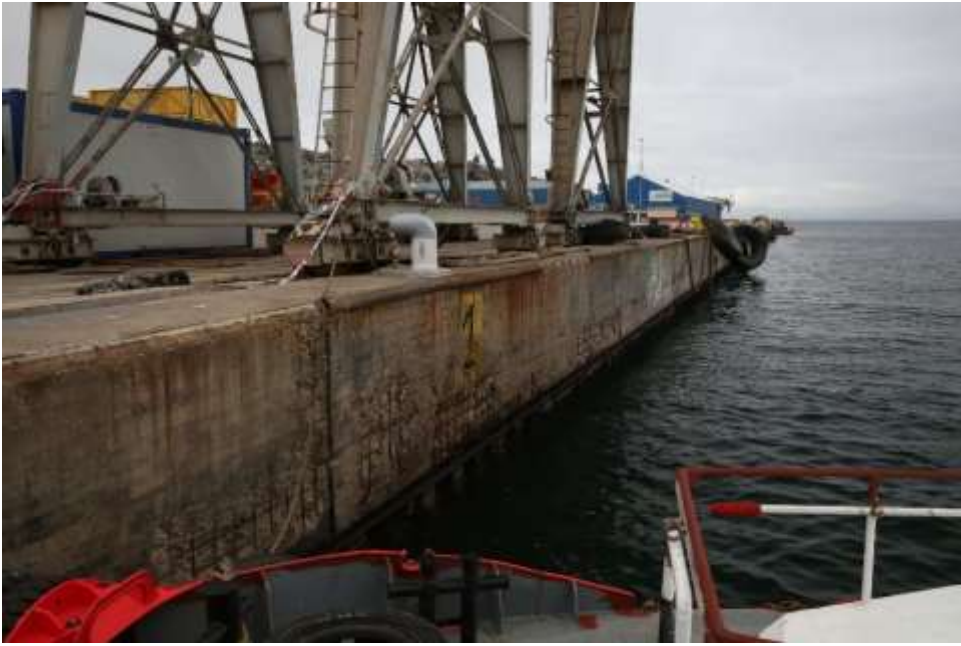
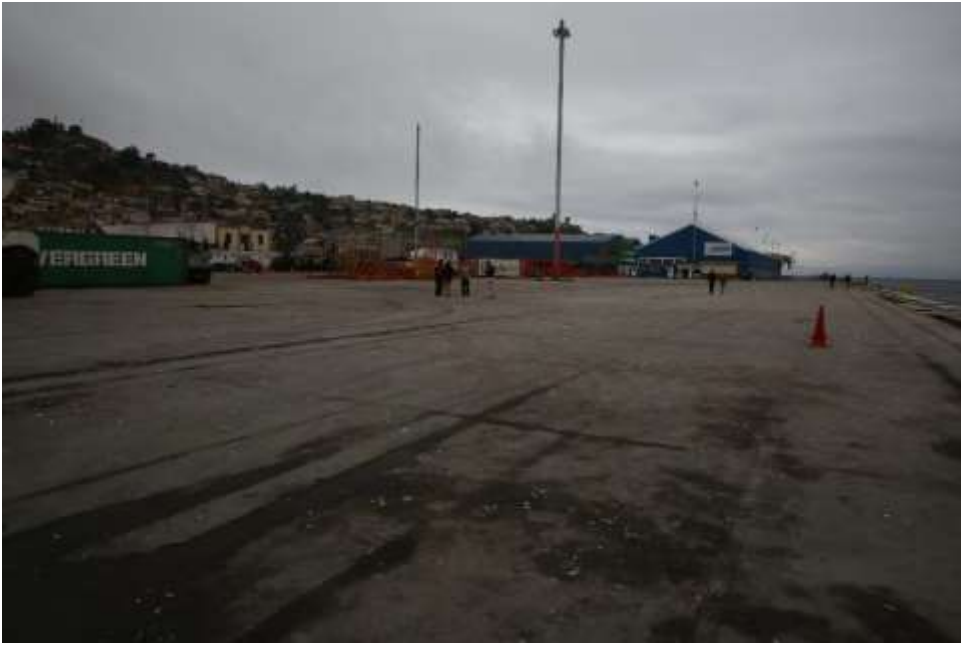
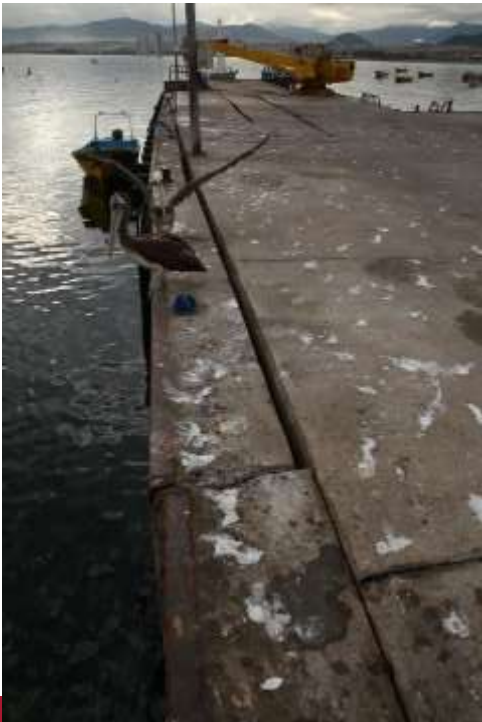
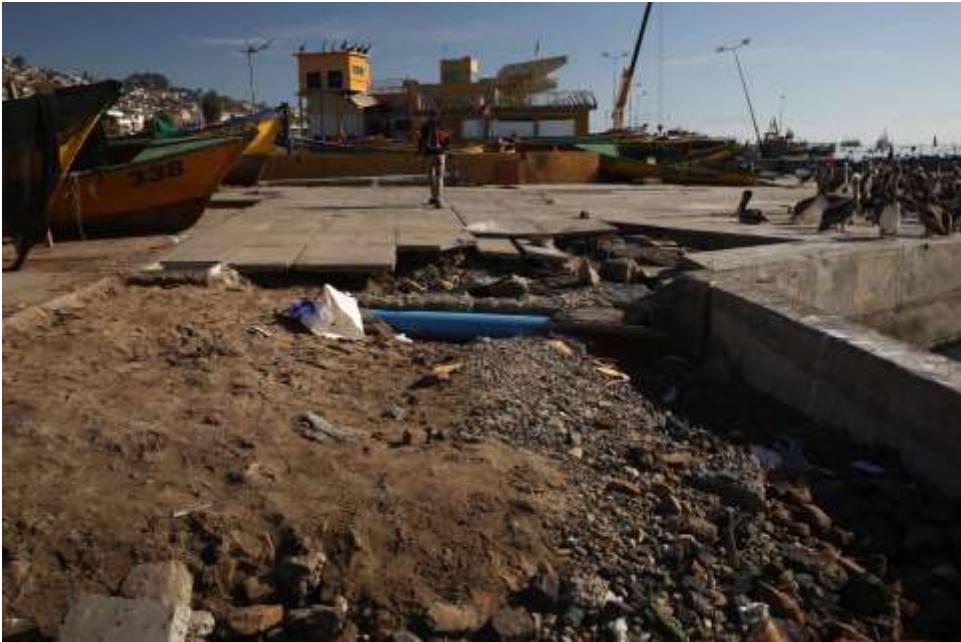
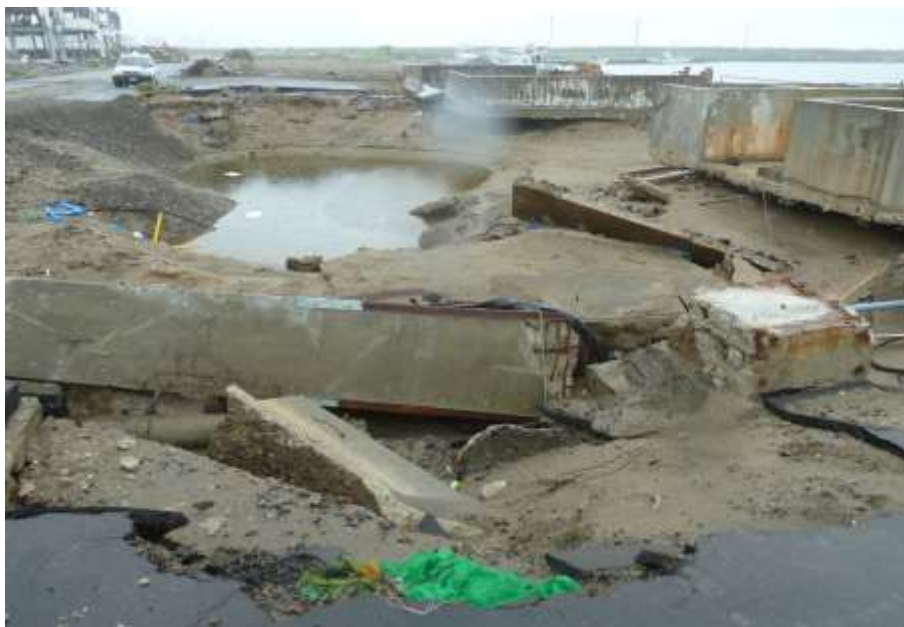
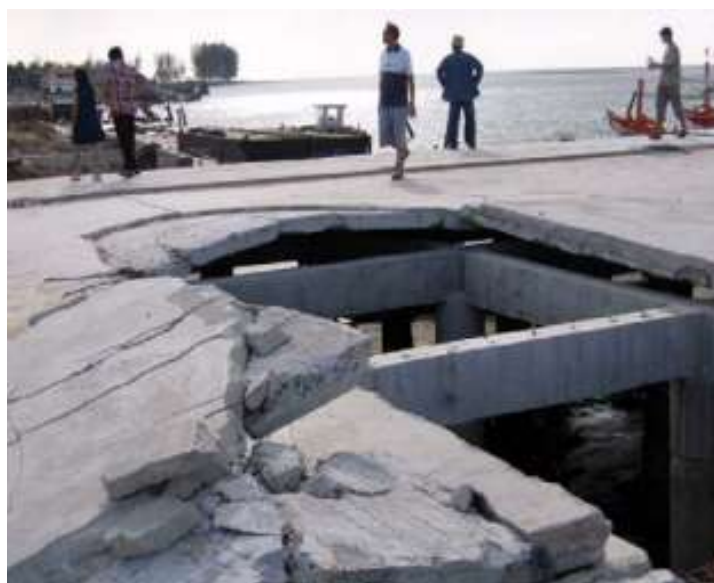
- Wharves relatively unaffected by tsunami (higher levels of earthquake damage likely)
- Operations heavily affected by floating debris

- Strengthen ties between piers and decks to resist buoyancy forces
- Develop response plan for large vessels to exit to deep water (~150m depth)
- Some evidence 'bumpers' can reduce impact forces from debris/vessel strikes
- Evacuation plan for port/wharf personnel

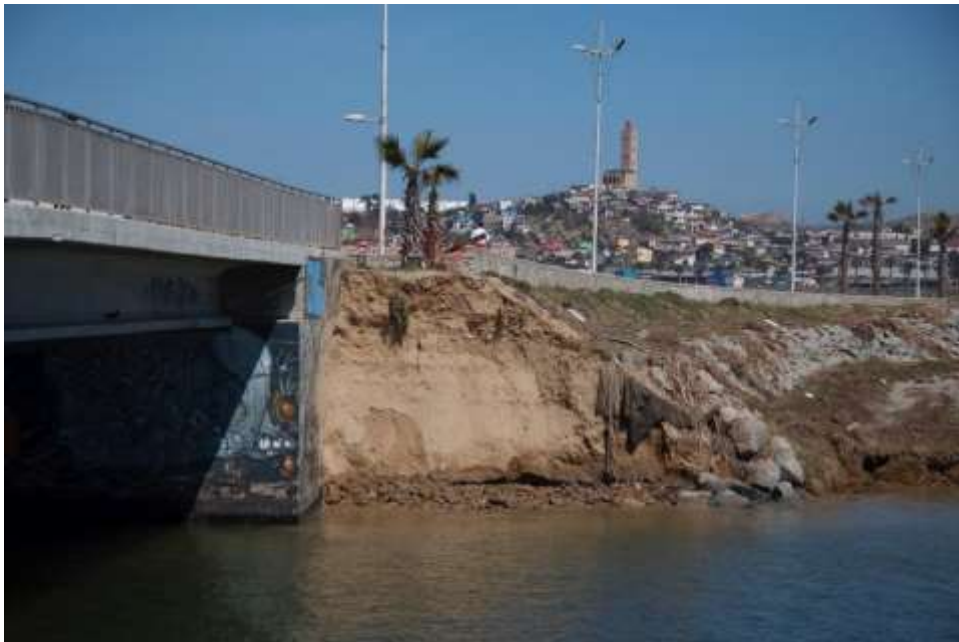
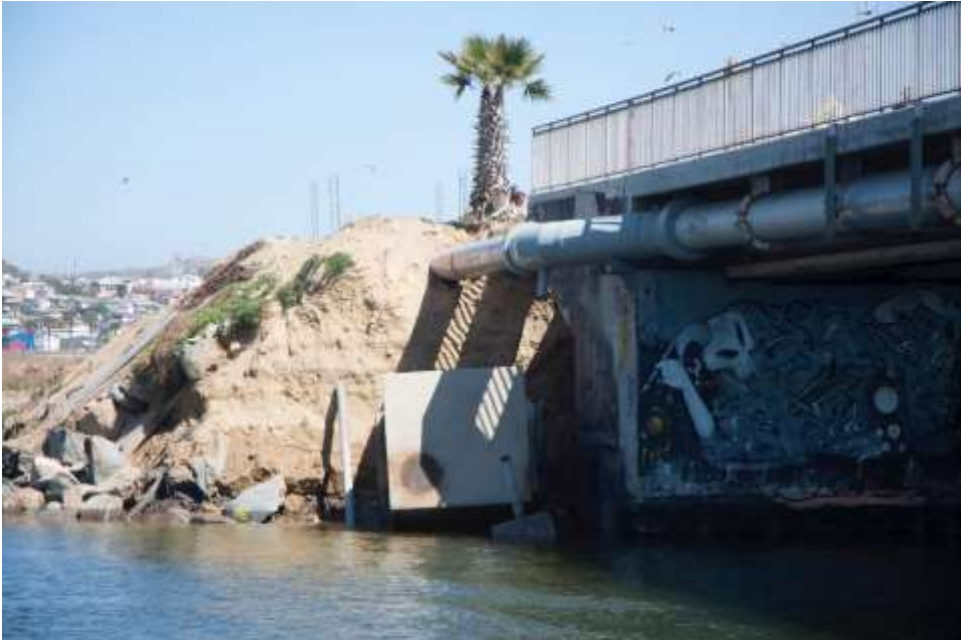
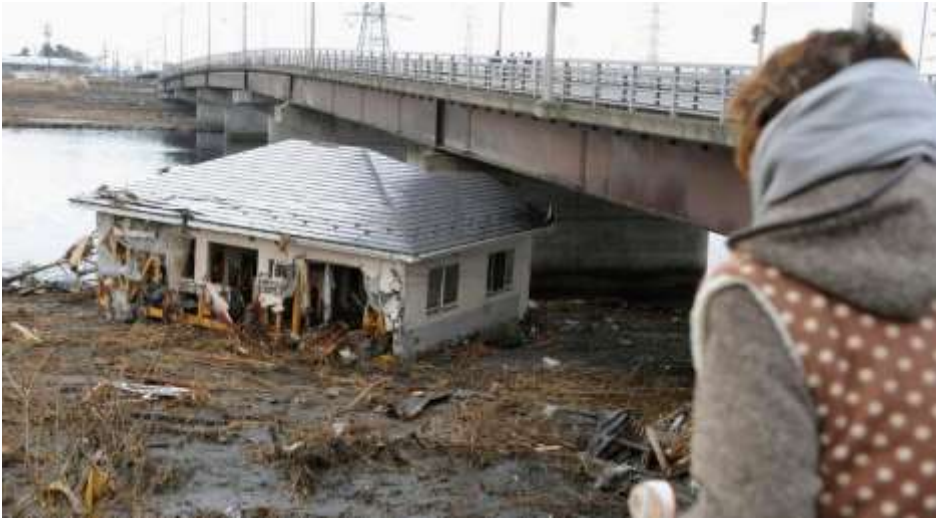
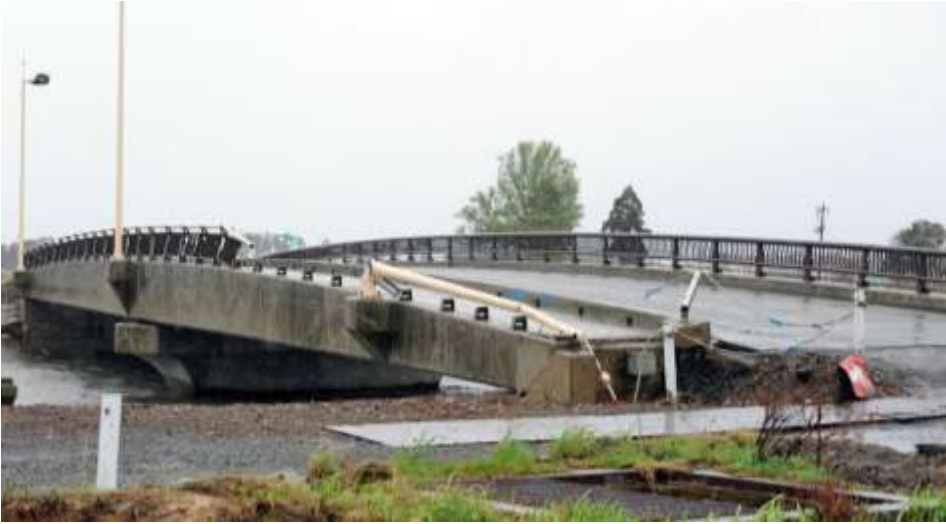
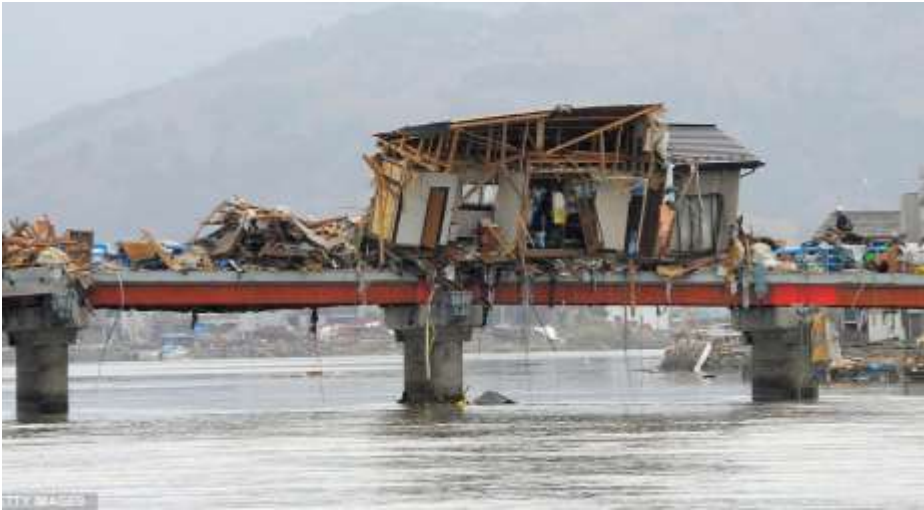
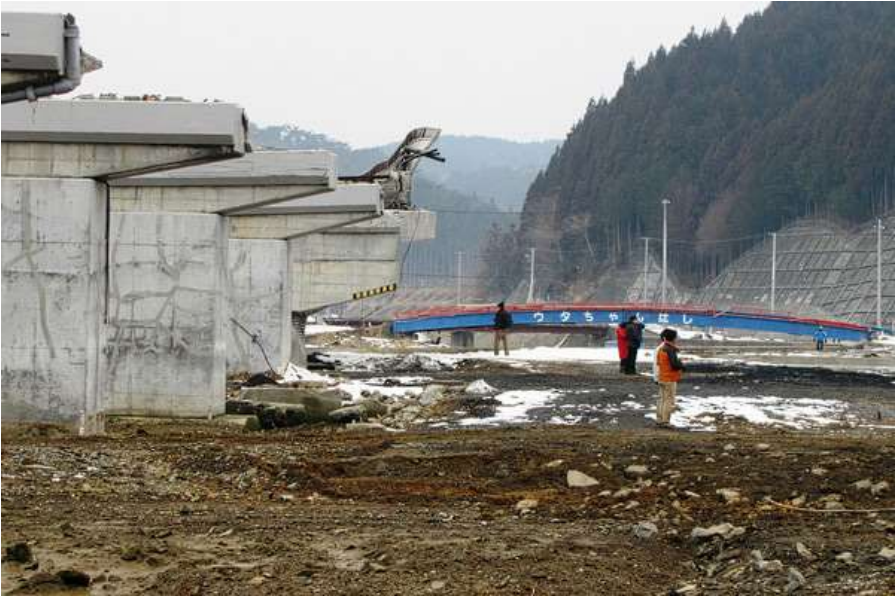
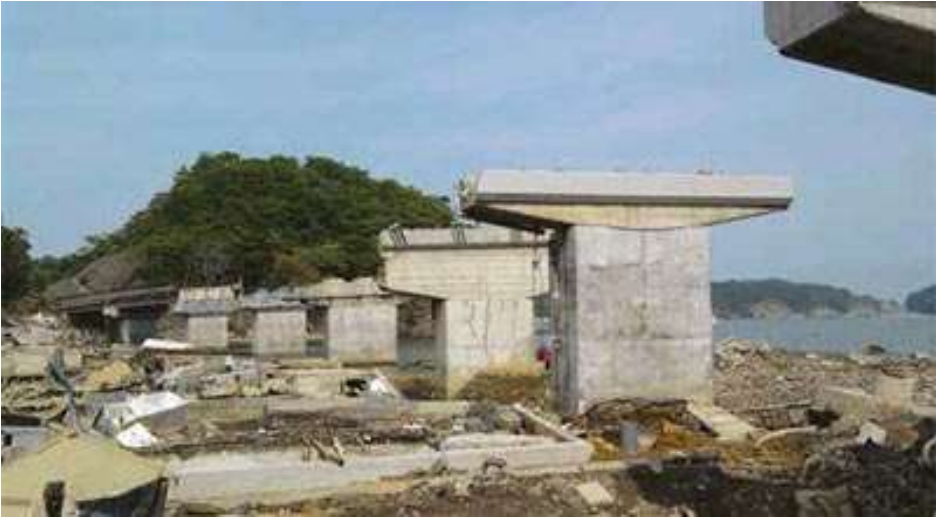
- RC four-lane multi-span bridge
- Bridge was overtopped by 1m flow depths
- Superstructure undamaged
- Minor-moderate scour of unprotected wing-walls on all four sides. More severe on landward side.
- Failure of services on landward side of bridge from scour

- Design longer wingwalls to reduce scour
- Use deeper pier foundations to reduce effect of scour
- Design with lower profile to reduce hydrodynamic drag and chance of debris strike
- Strengthen connections between piers and superstructure to resist buoyancy forces
- RC/PC perform better than steel or steel truss
- Bury services instead of attaching to bridge

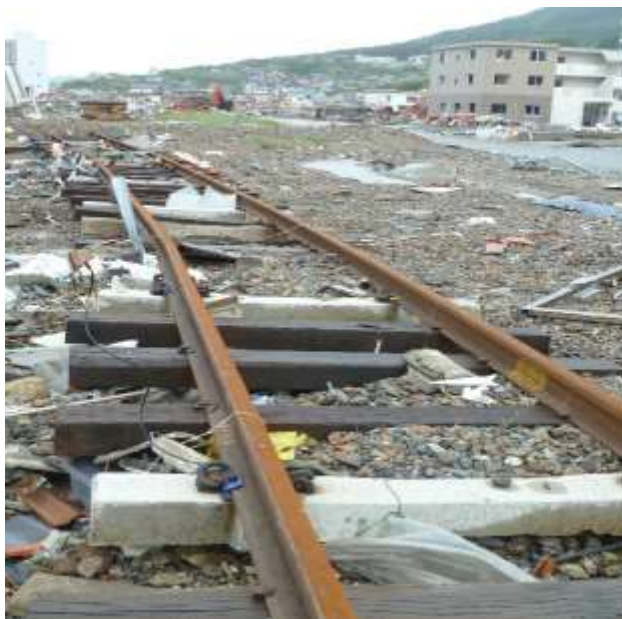
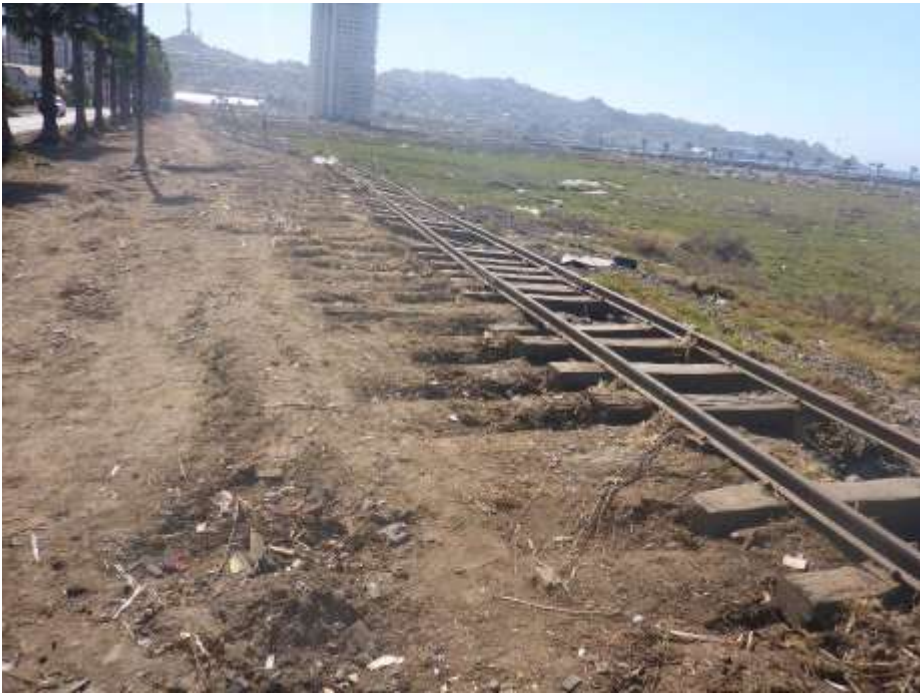
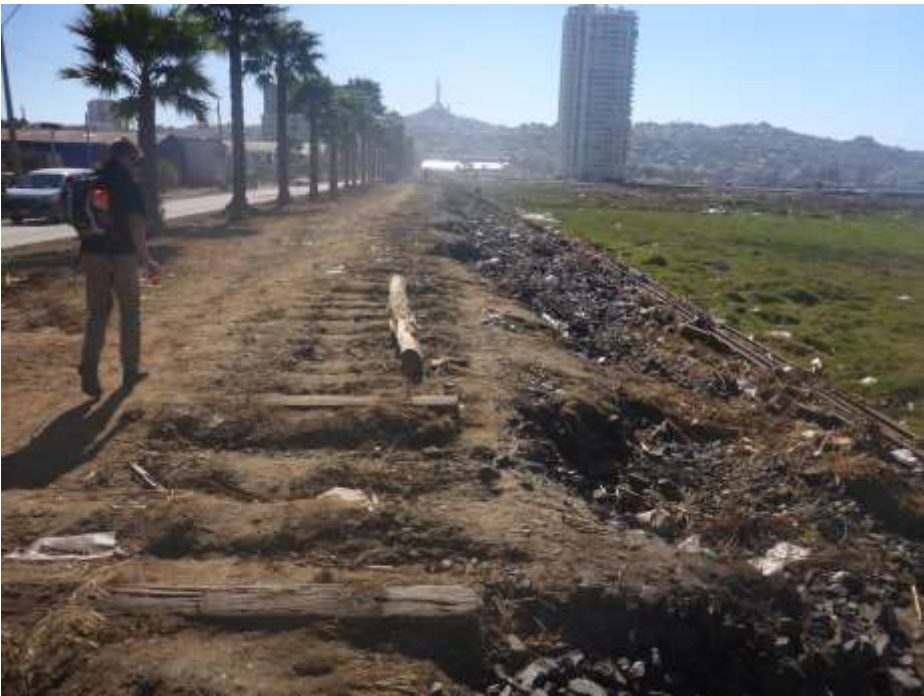
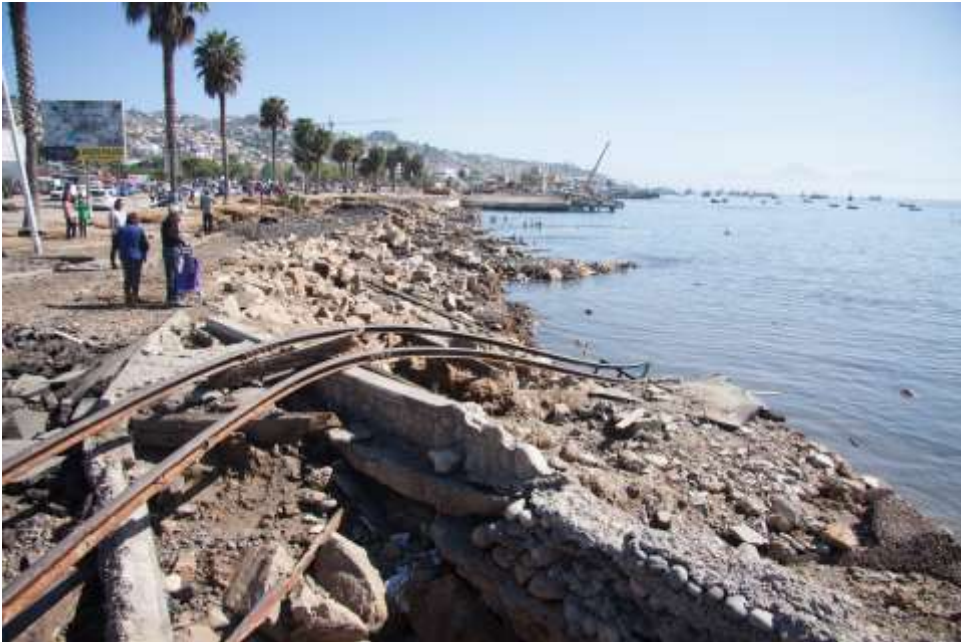
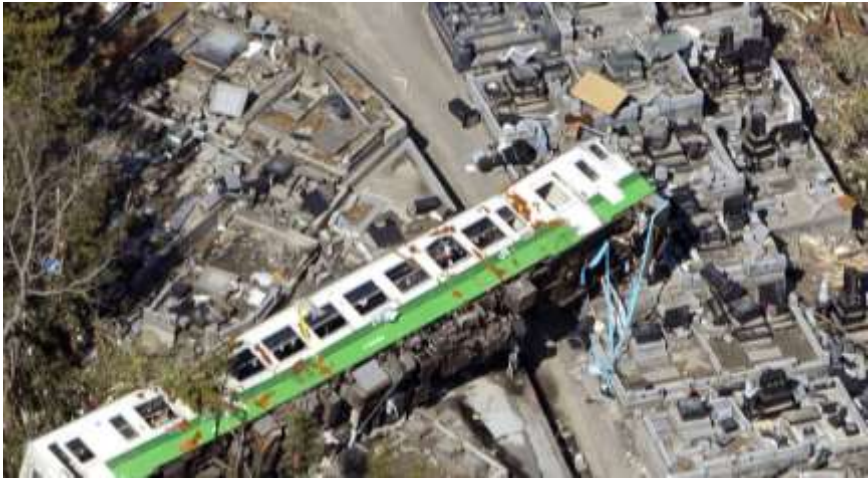
- Single track in inundation area
- On wooden sleepers
- Shifted laterally in <1 m flow depths
  - 200 m length
- Washed away in > 2 m flow depths
  - 800 m length
- Minor scouring of ballast

- Develop contingency plan to clear debris from line, repair overhead lines, repair scour or washouts
- Stock pile of spares of electrical equipment
- Develop tsunami evacuation response plan for passengers on coastal lines
- Strengthen steel rail bridges in tsunami inundation zones

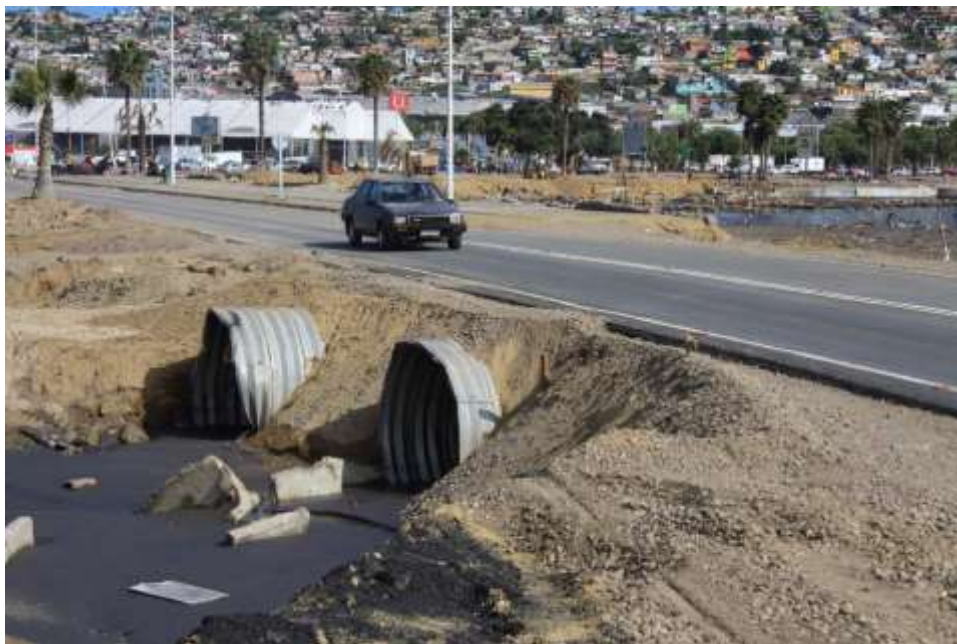
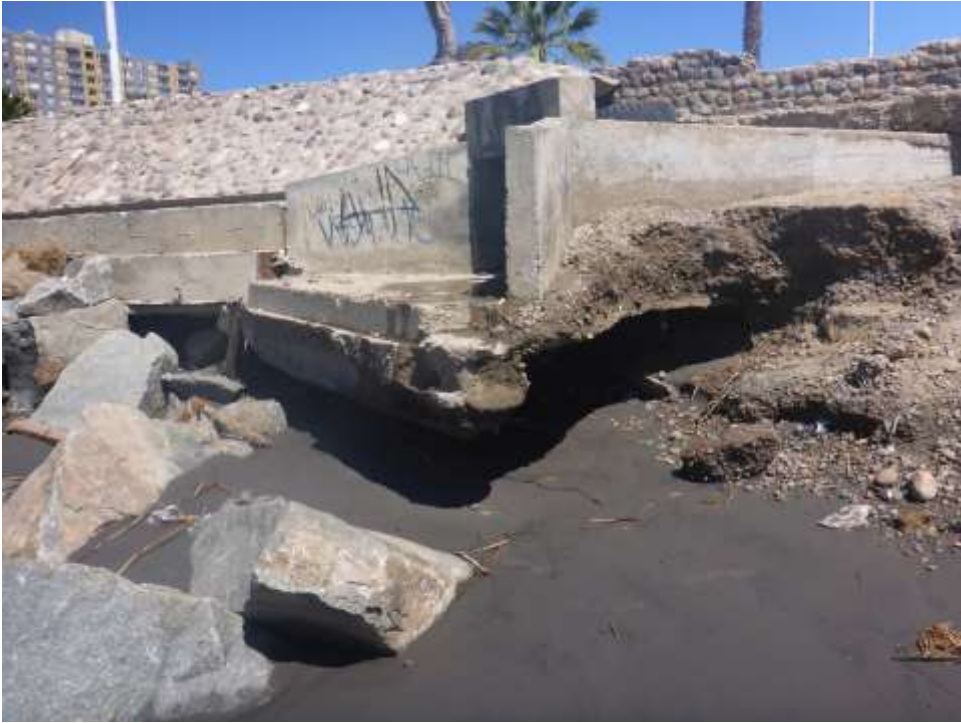
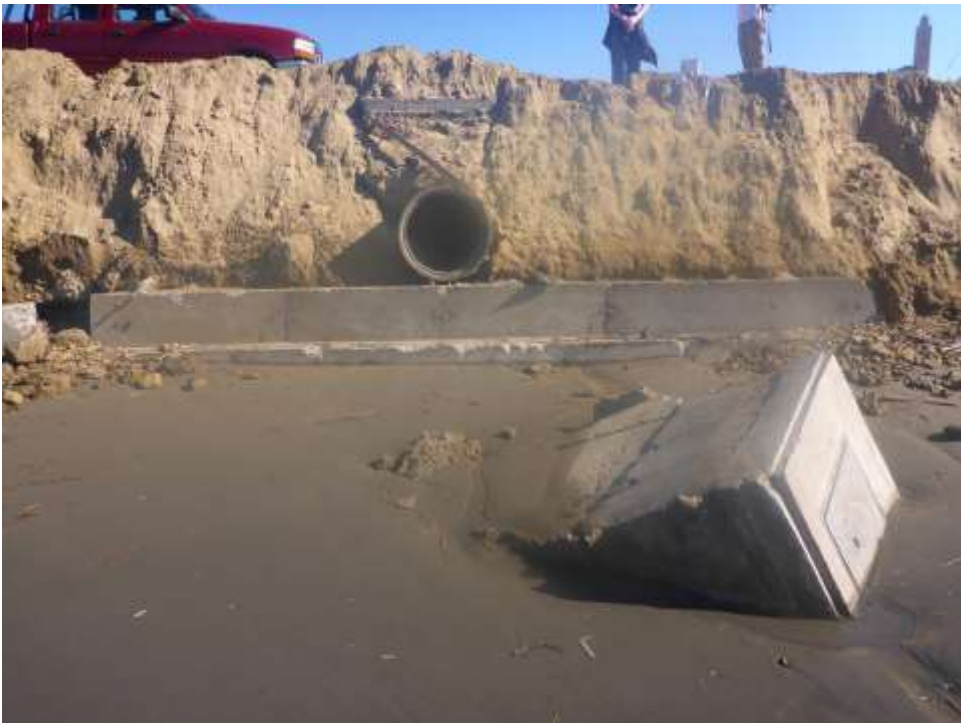
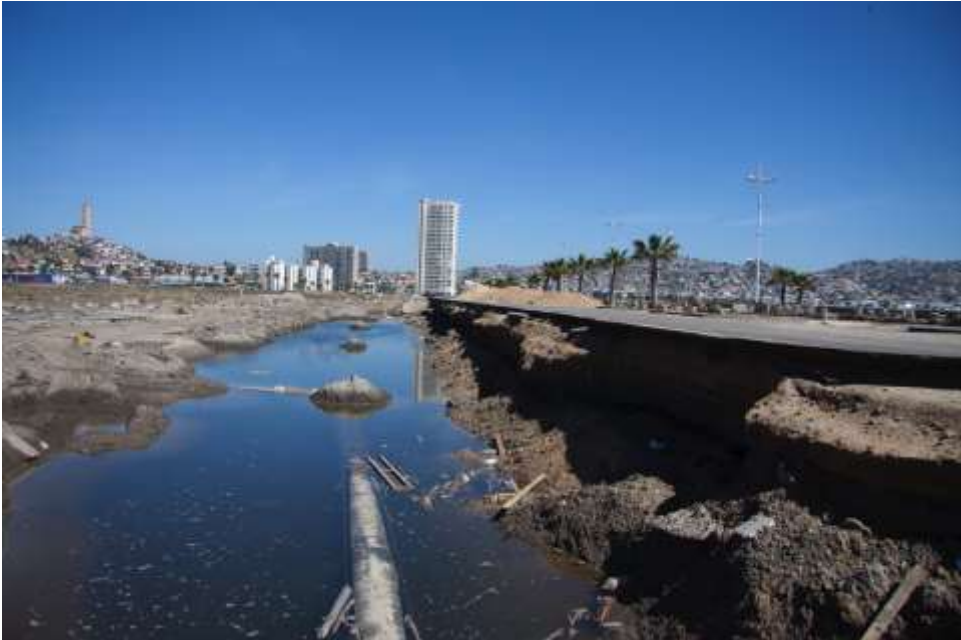
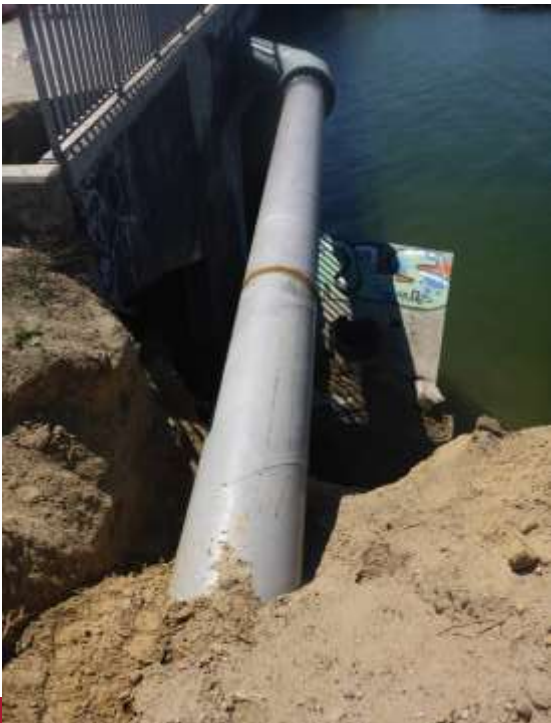
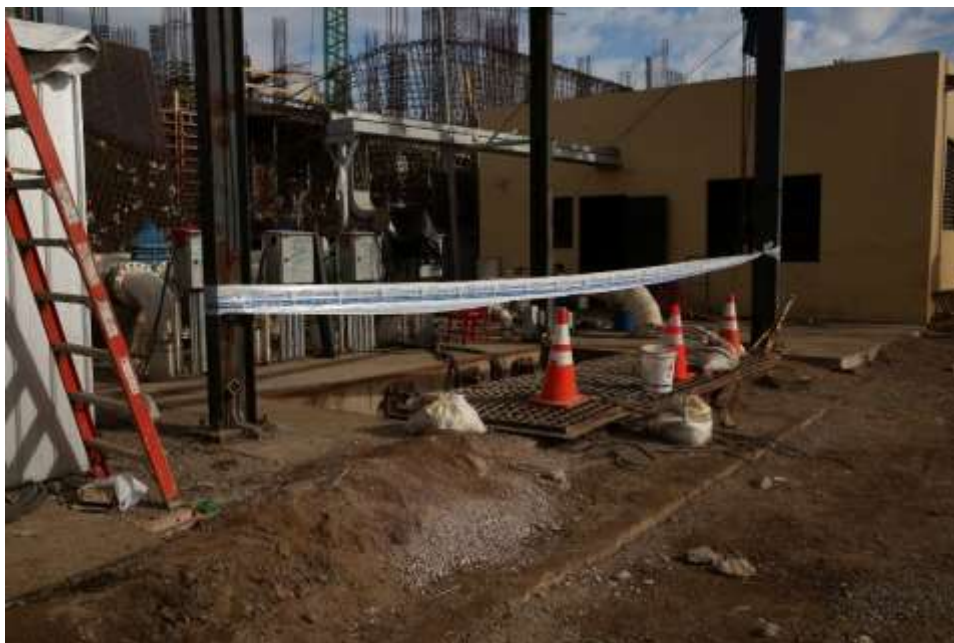
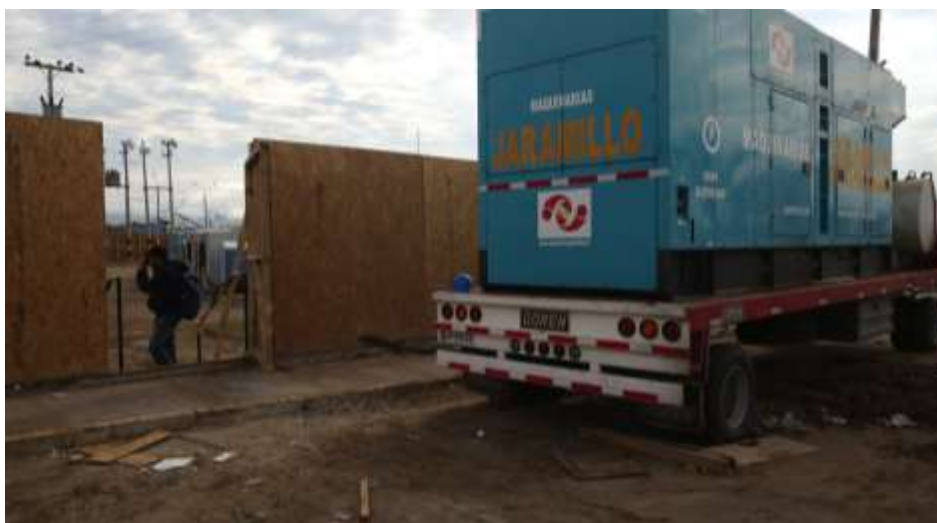
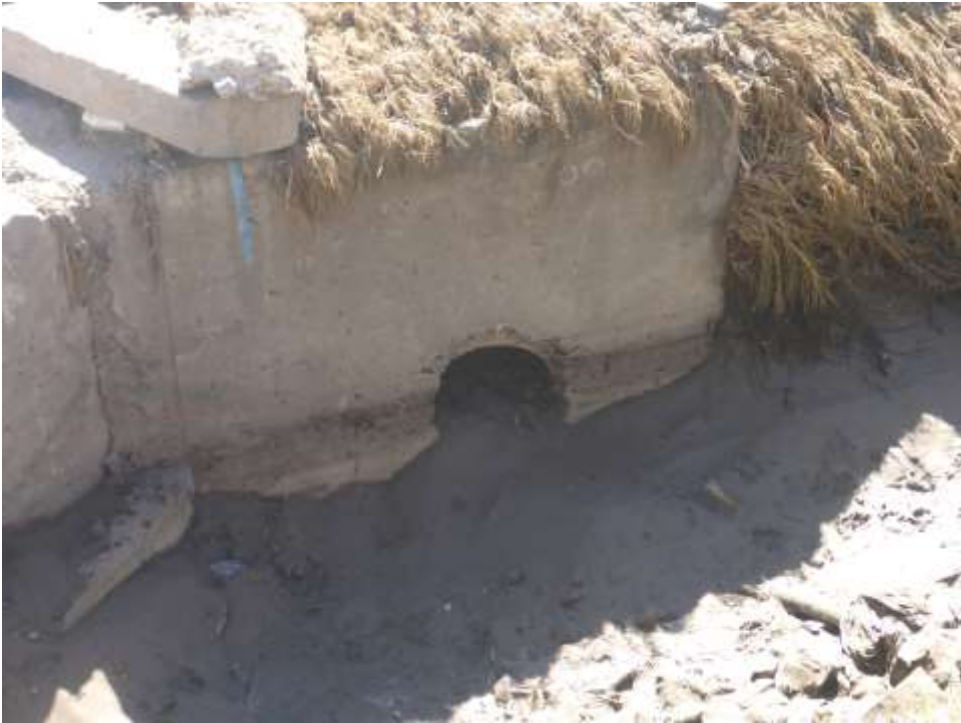
- Surveyed:
  - Manholes
  - Drains
  - Pump station (1)
  - Pipes (where visible)
- Potable water pipe broken at bridge from embankment scour. Rest of pipe scoured but not damaged.
- Main sewerage pump stations severely damaged. Back to 70% load in 2 weeks.
- Most drains blocked, but cleaned out 10 days later
- Culverts were points of weakness and most heavily damaged from scouring

- Locate water supply and treatment facilities outside of tsunami inundation zones;
- Construct facility buildings using reinforced concrete and ensure areas containing power systems are watertight, or locate electrical equipment at height to minimise damage to key electrical components;
- Install sealed lids on pumps and tanks to stop contamination by saltwater, sediment, and debris;
- Bury pipes across water crossings or attach to earthquake strengthened reinforced concrete bridges, preferably with protection buffers to reduce damage from debris impacts;
- Use watertight caps on wells
