# Tsunami Impacts to Lifelines:

*Review of Current Knowledge and Post-Event Survey of the 16 September 2015*

*M8.3 Illapel, Chile Tsunami*

Nick Horspool, Stuart Fraser (GNS Science)  
Richard Mowll (Wellington Lifelines Group)

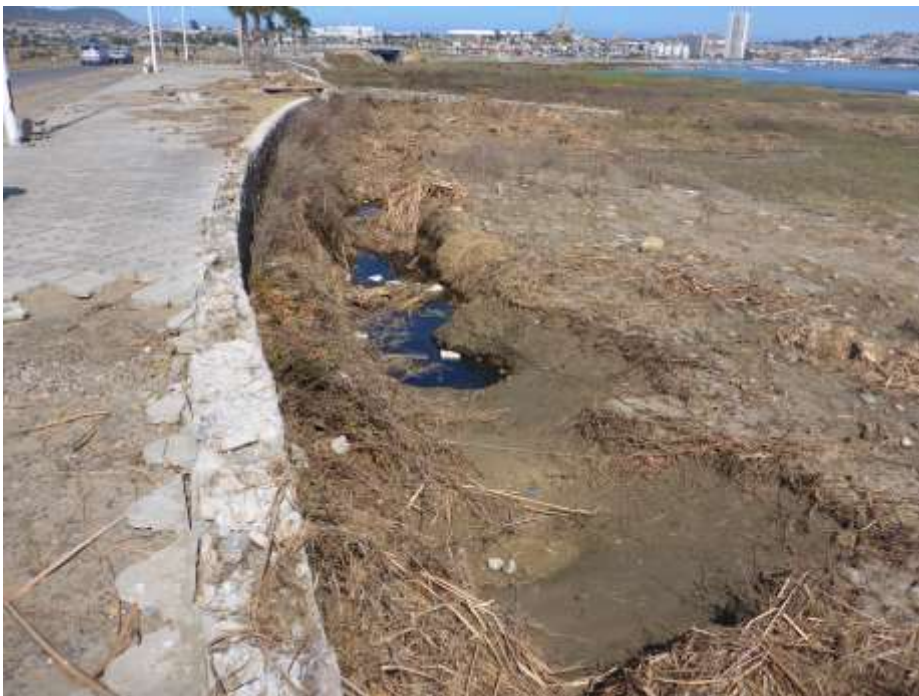
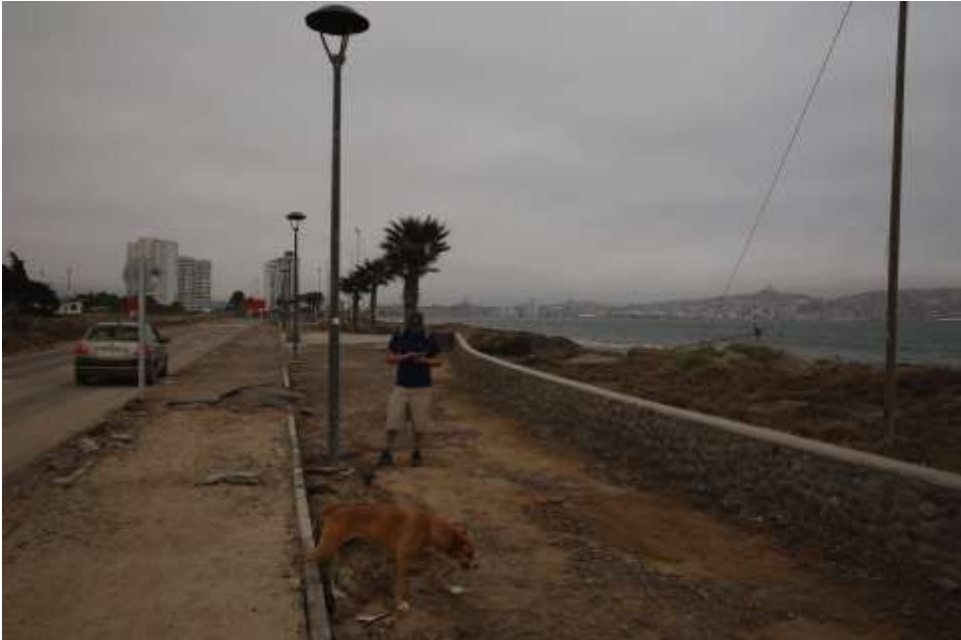
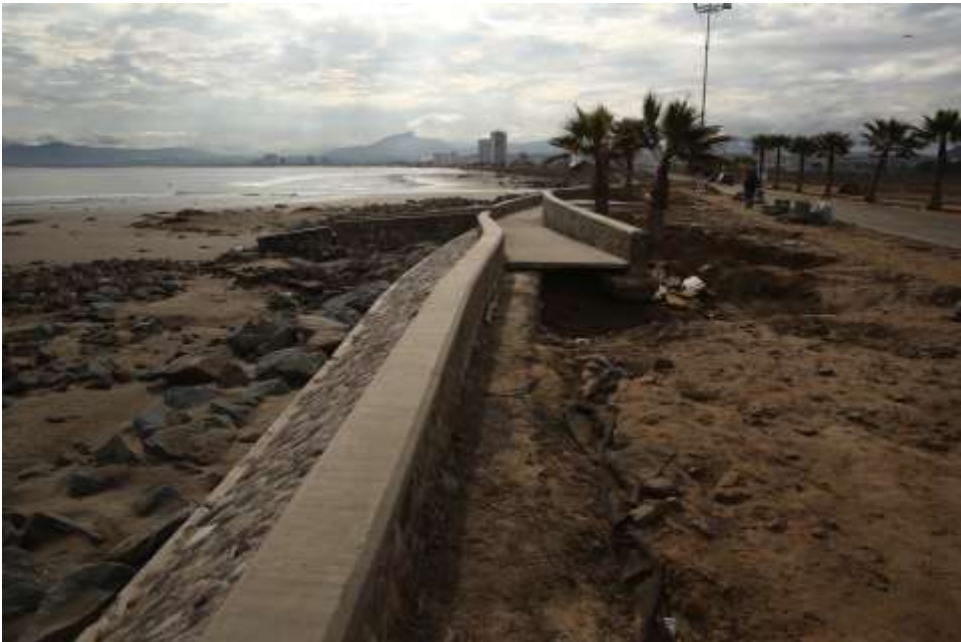
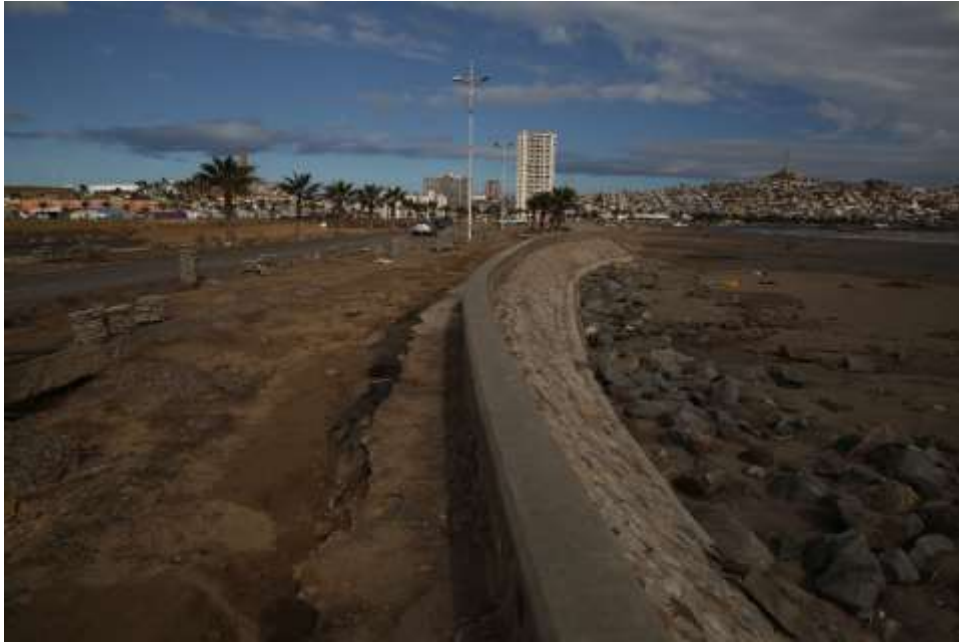
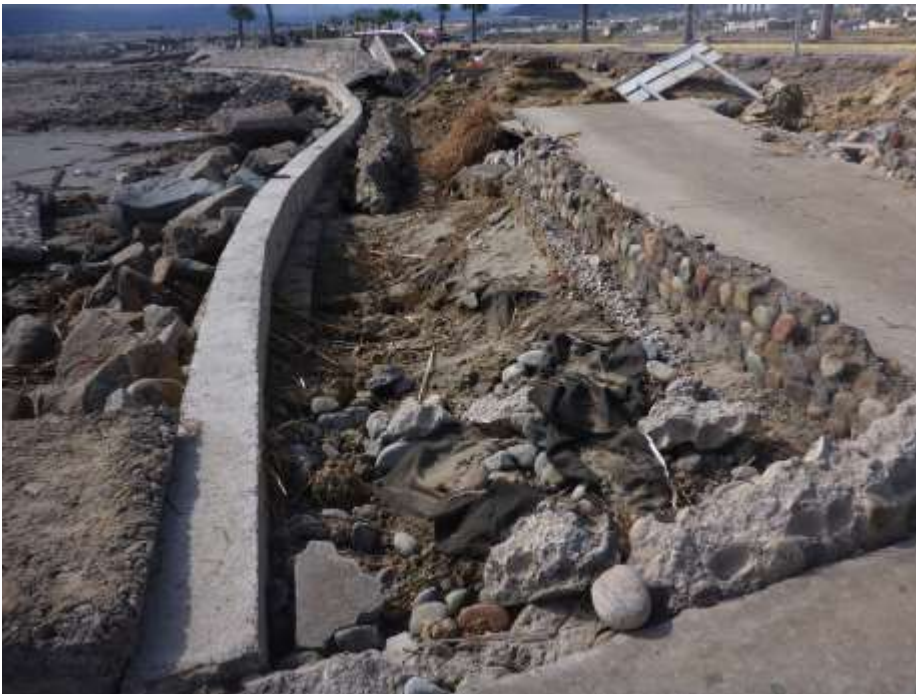
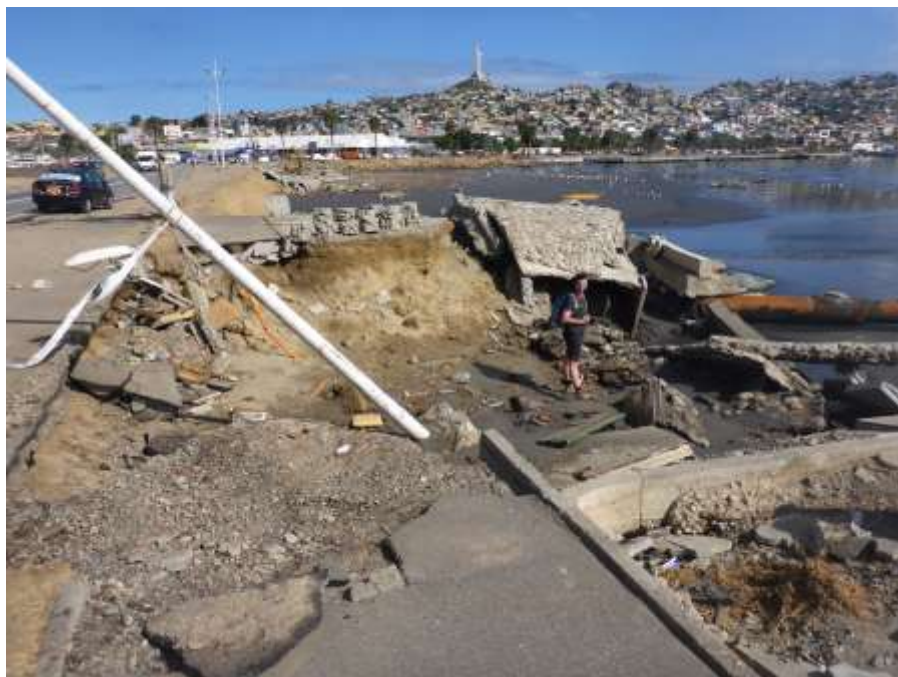
- Significant sea wall washout can occur in flow depths  $>2$  m
  - $\sim 1$  km in length
- Seawalls suffered minor damage in flow depths  $< 1$  m
  - $> 3$  km in length
- No damage  $< 0.5$  m flow depth
- Sea wall failure often exposed road/footpath behind seawall for scour
- Significant scour of seawall occurred at sites of storm water outflows or culverts
