Managing Seismic Risk

2008 National Lifelines Forum

Review Programme

Example of photos taken for each site

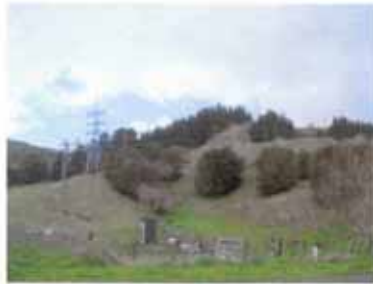
Transmission line feeding Gisborne

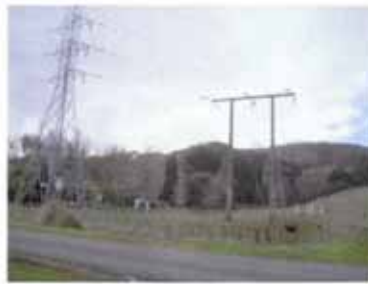
Termination tower and H poles

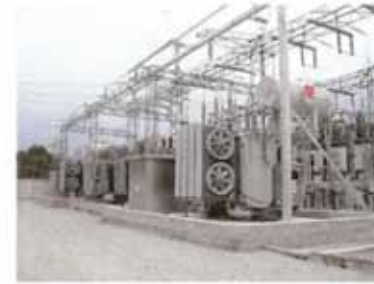
Older lattice and newer pipe gantries

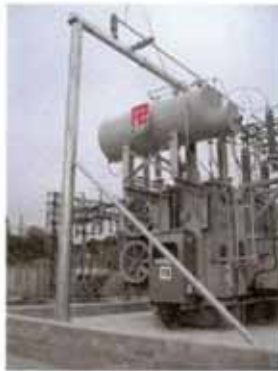
Newer type RHS and pipe gantry

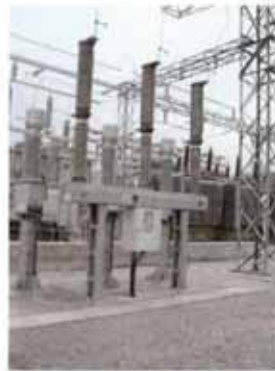
GEG CB's on sturdy steel stands

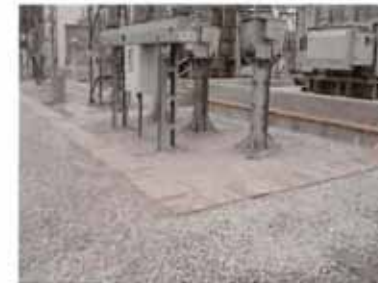
Note CB's and CT's etc on well grouted base plates

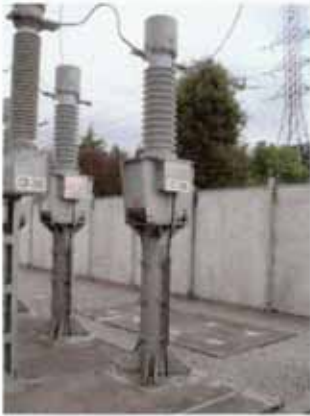
CT's on sturdy pipe stands

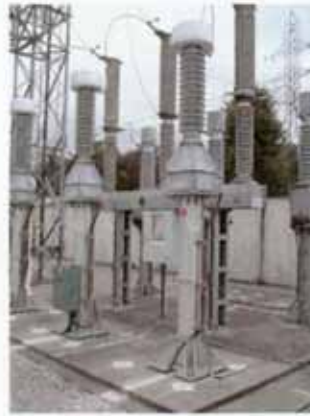
VT's on sturdy pipe stands

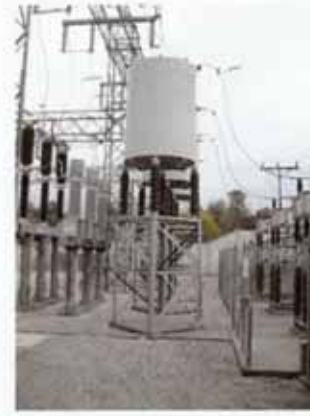
Reactors on lattice stands

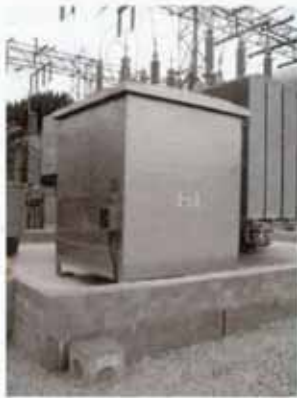
Neutral Earthing Resistor bolted down to transformer pad

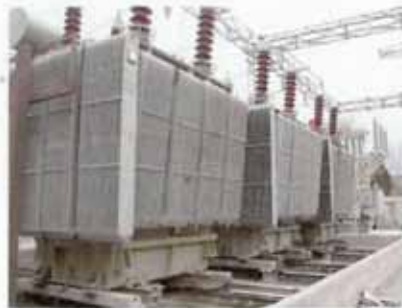
Older single phase transformers well restrained

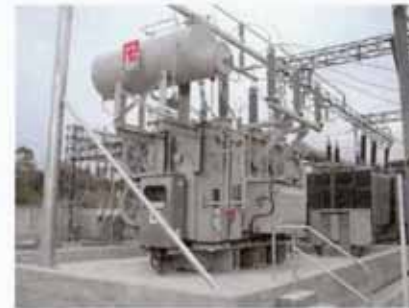
Newer three phase transformer well bolted down

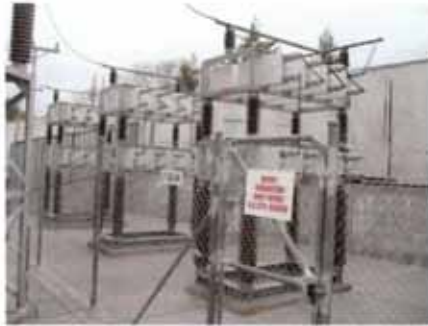
Capacitor banks on post insulators

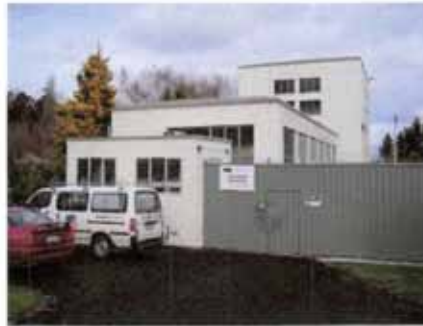
Traditional cast insitu reinforced concrete control building and crane room

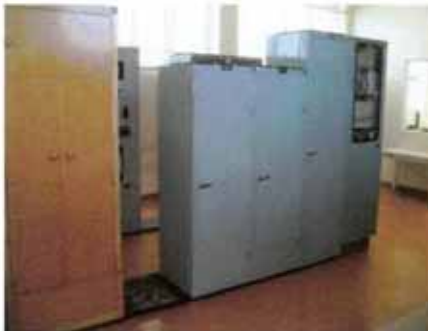
Cabinets in the relay room

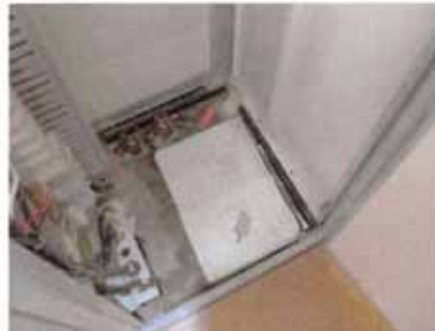
Typical cabinet hold down. Note manuals and paper should not generally be left in cabinets due to potential fire hazard

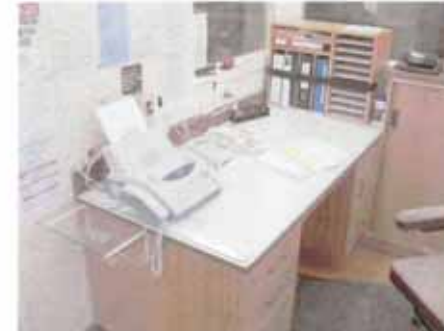
Restrained desk, book shelving and fax, excellent practice

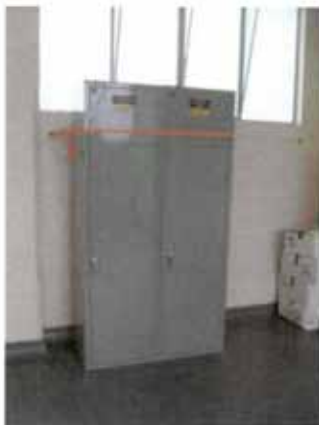
Restrained cabinet good practice

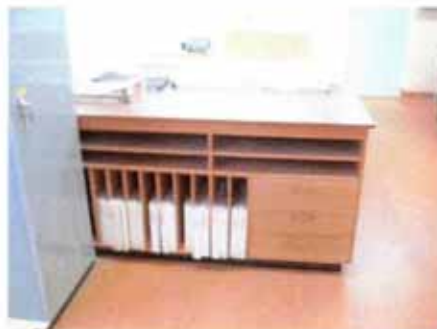
Restrain cabinet and manuals

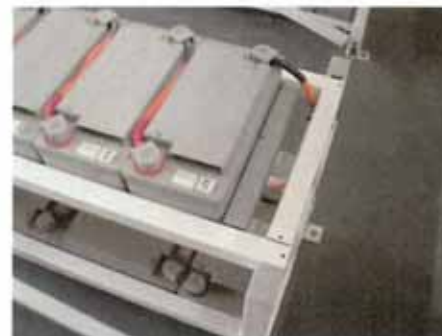
Batteries properly packed out at end.

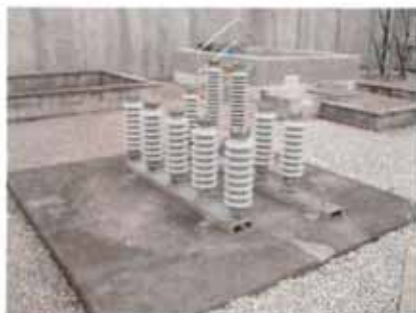
Spares restrained on spares pad

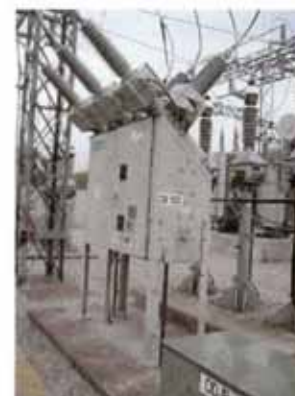
Three phase CB inside cabinet on cantilevered legs

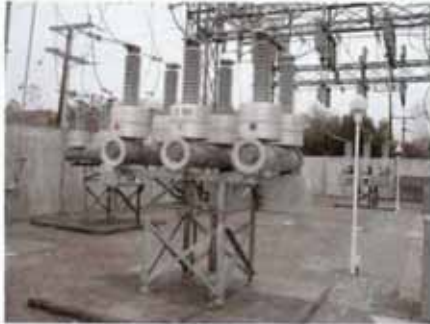
CB's on sturdy lattice stand

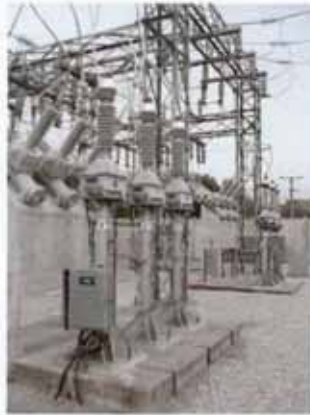
VT's on sturdy pipe stands

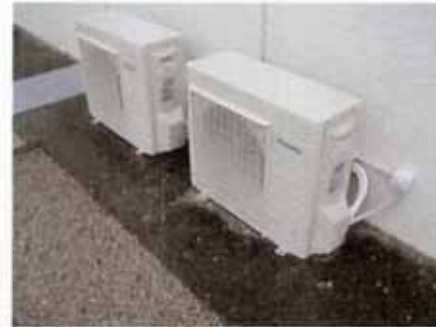
Airconditioning units restrained

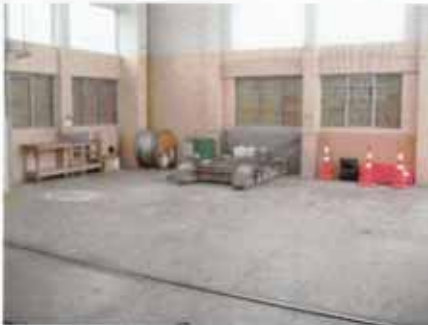
Storage in crane room

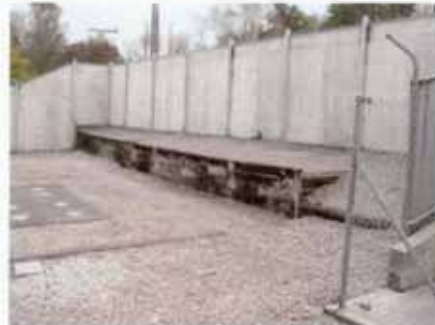
Retaining wall has moved in the past and should be monitored

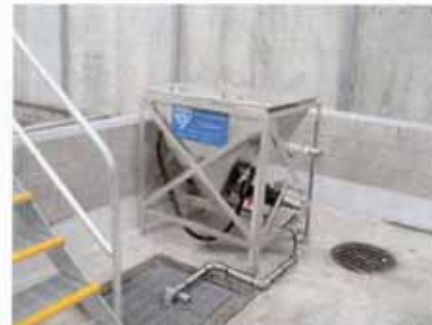
Oil Separator unit well restrained

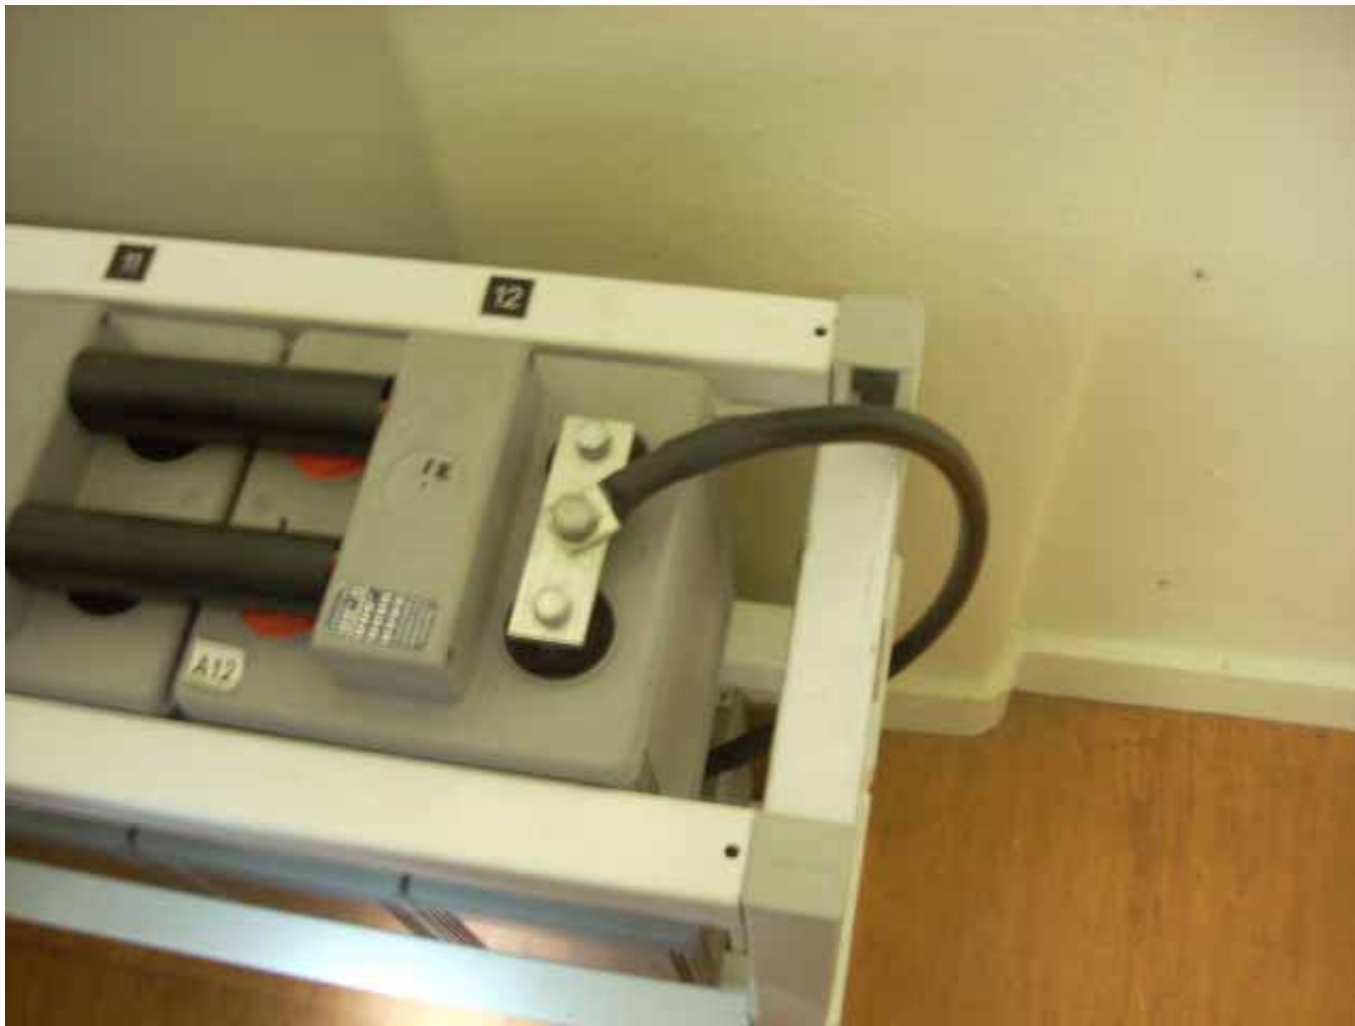
Back up batteries not as secure as they could be

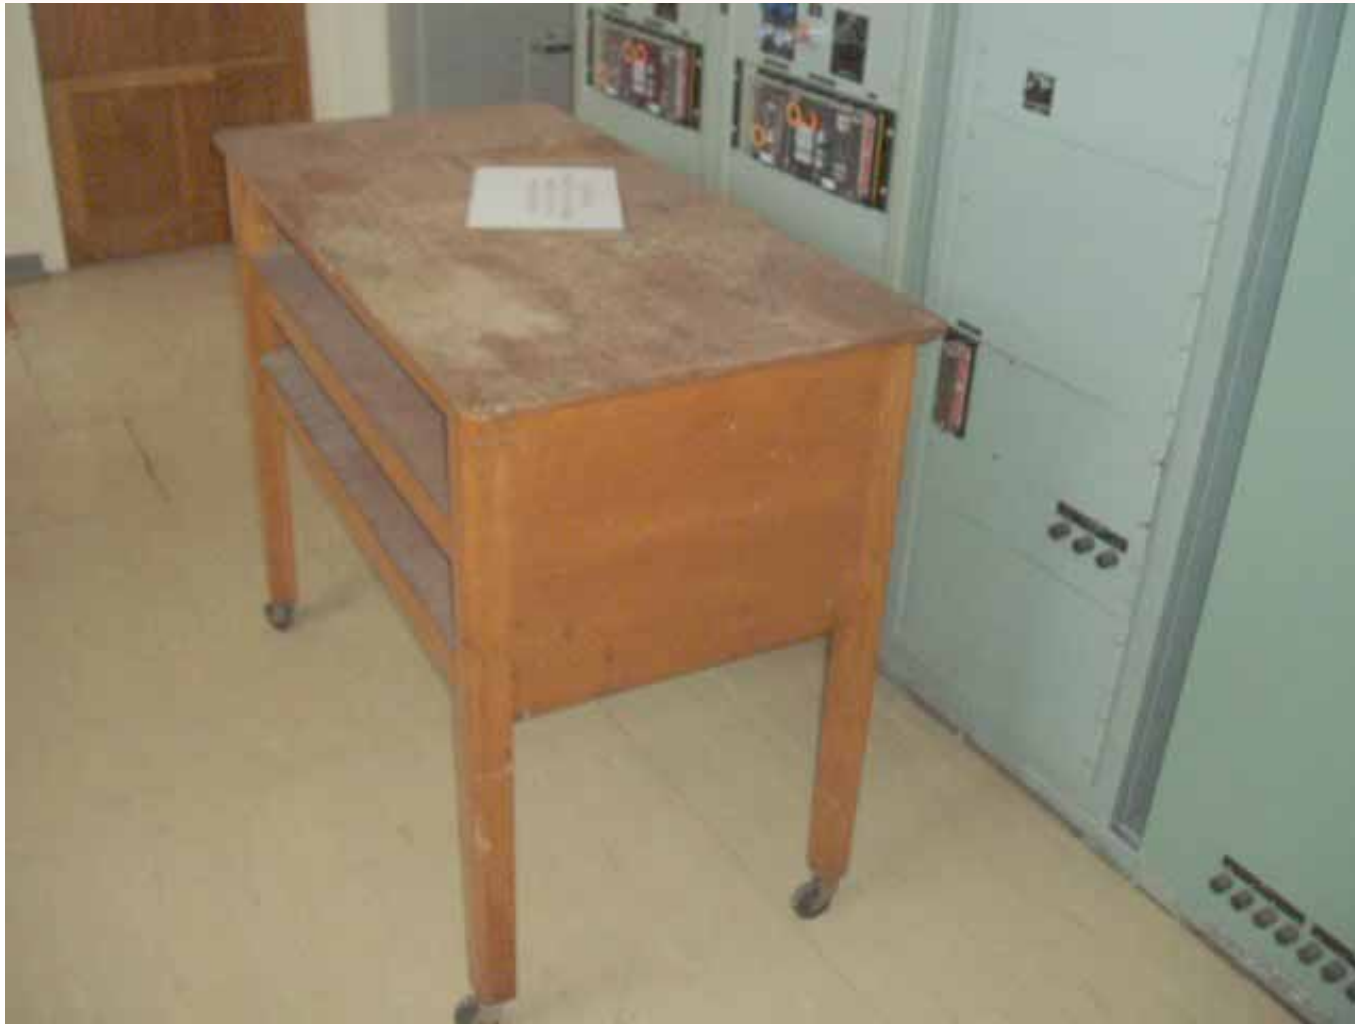
Unsecured wheeled furniture in relay room

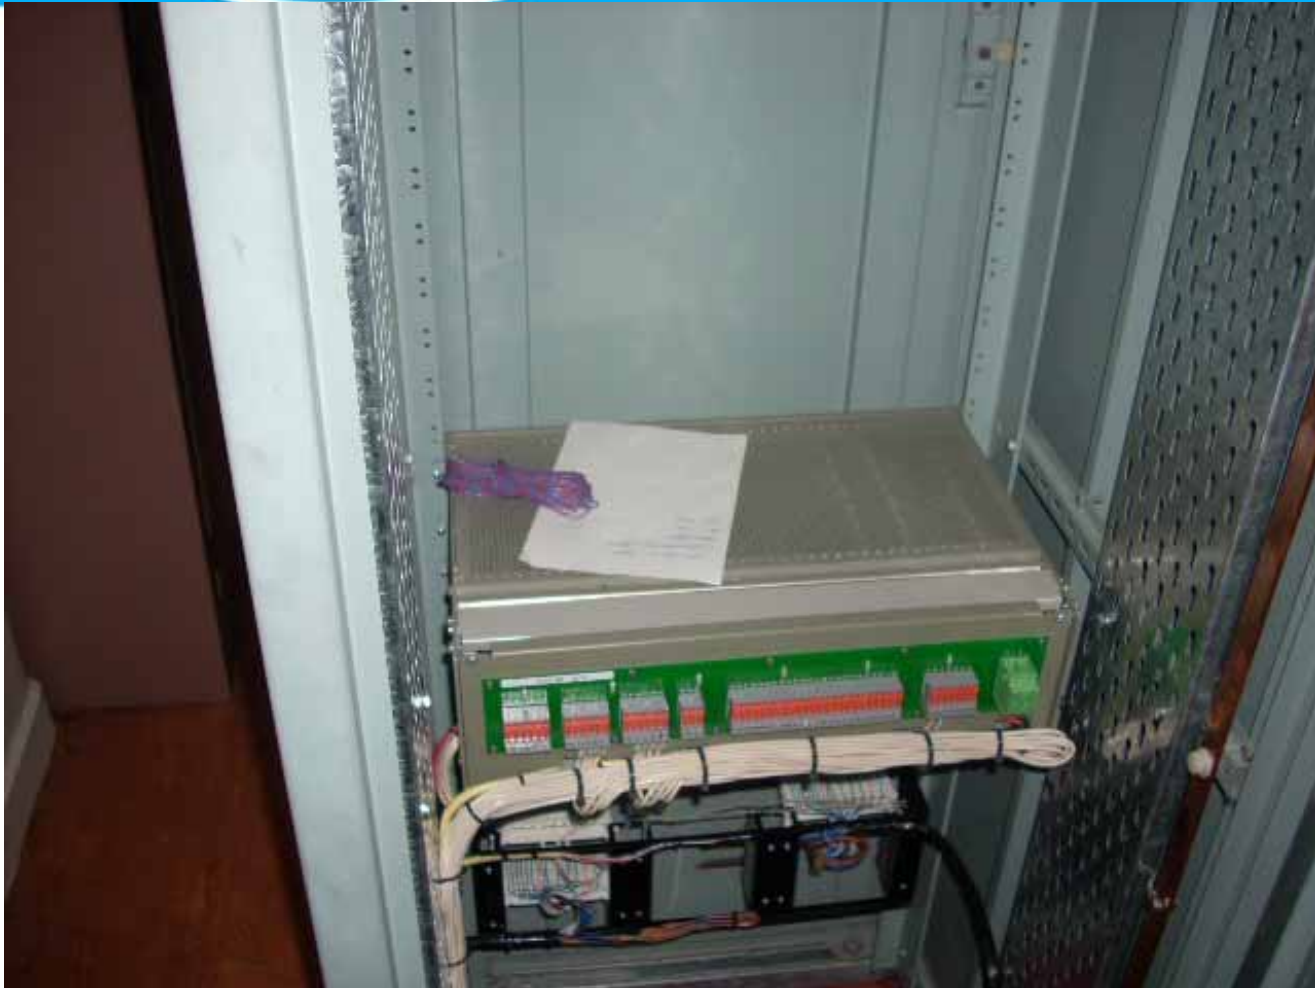
Paper on equipment potential fire hazard

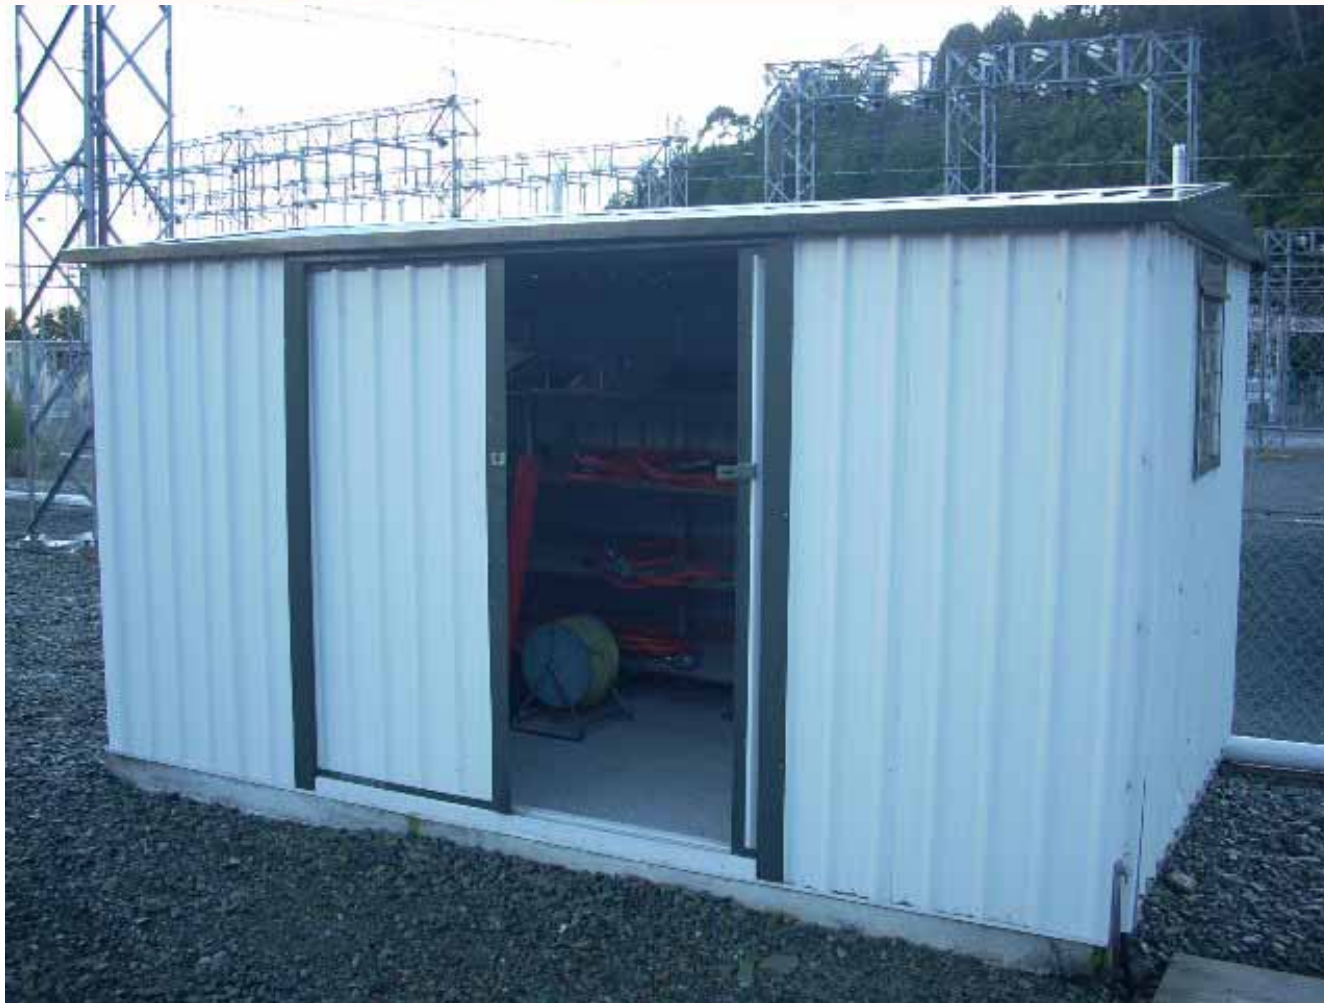
Light unframed garden sheds in switchyard

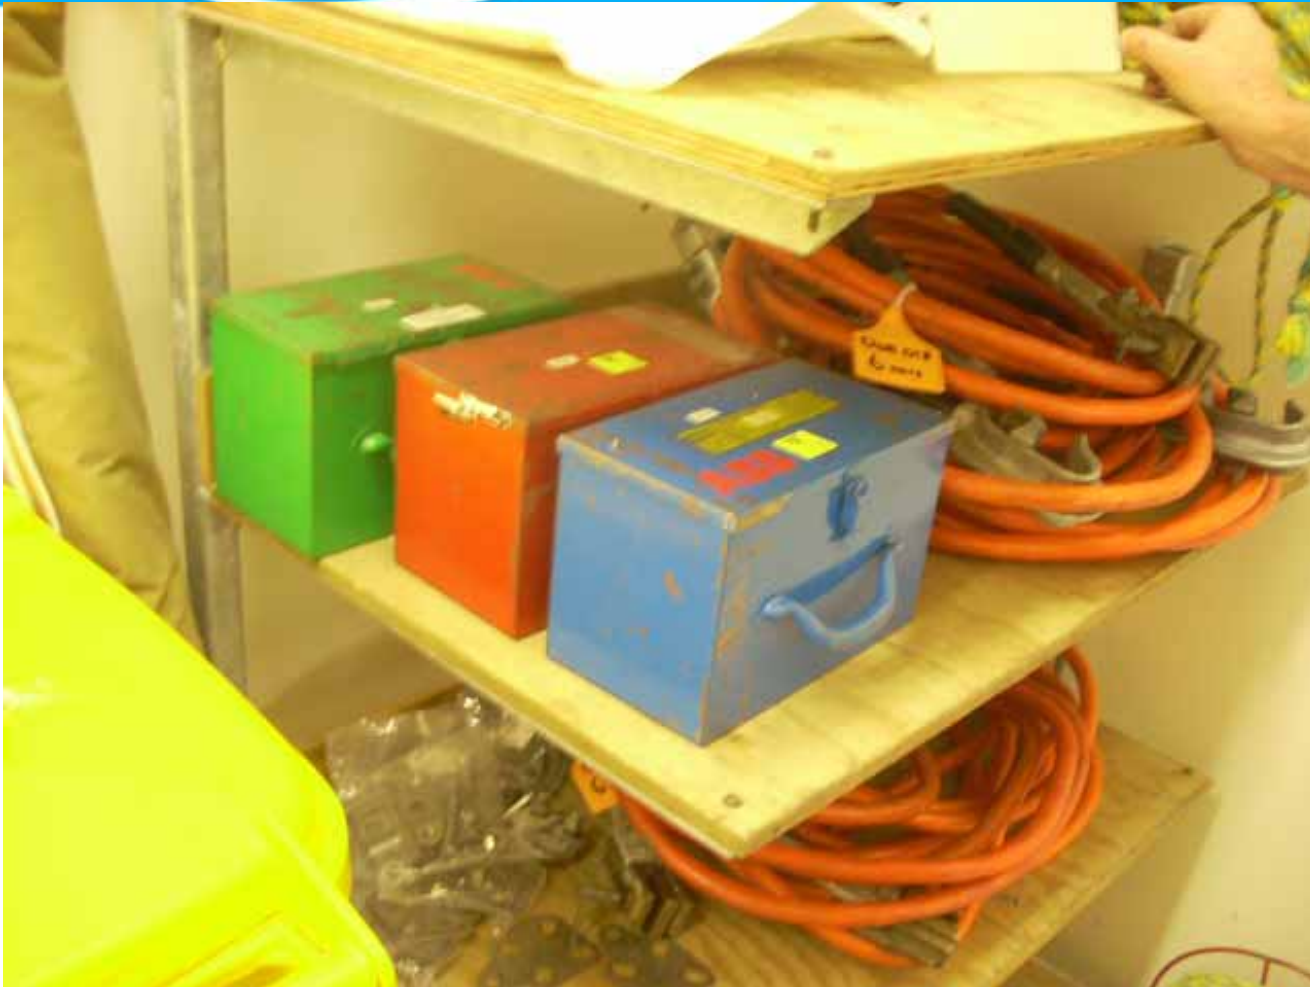
Equipment vulnerable on shelving

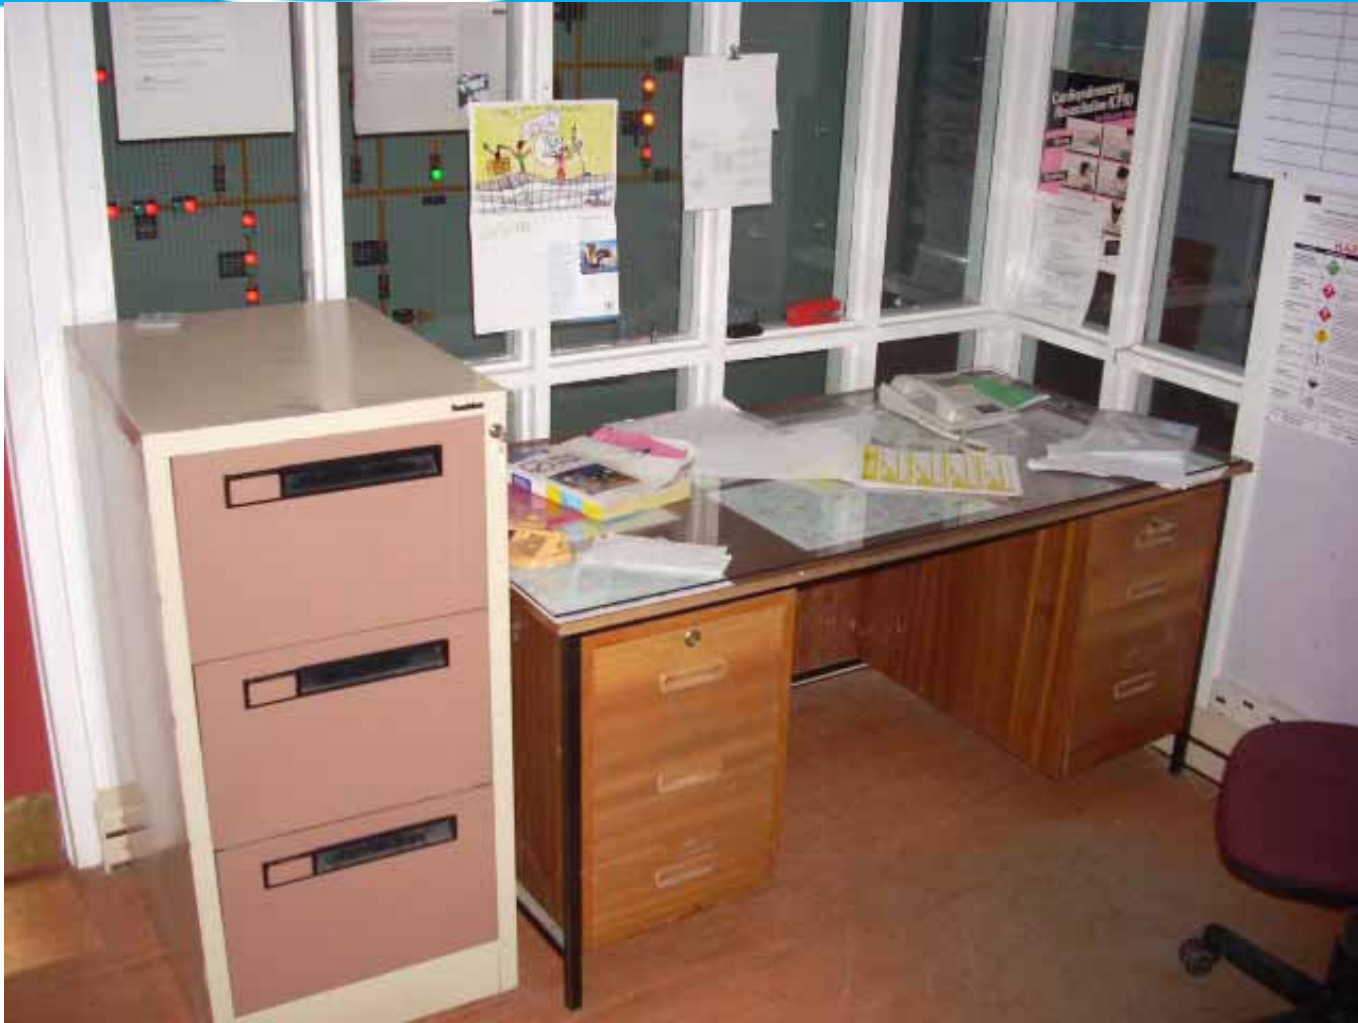
Unsecured furniture including fax's etc

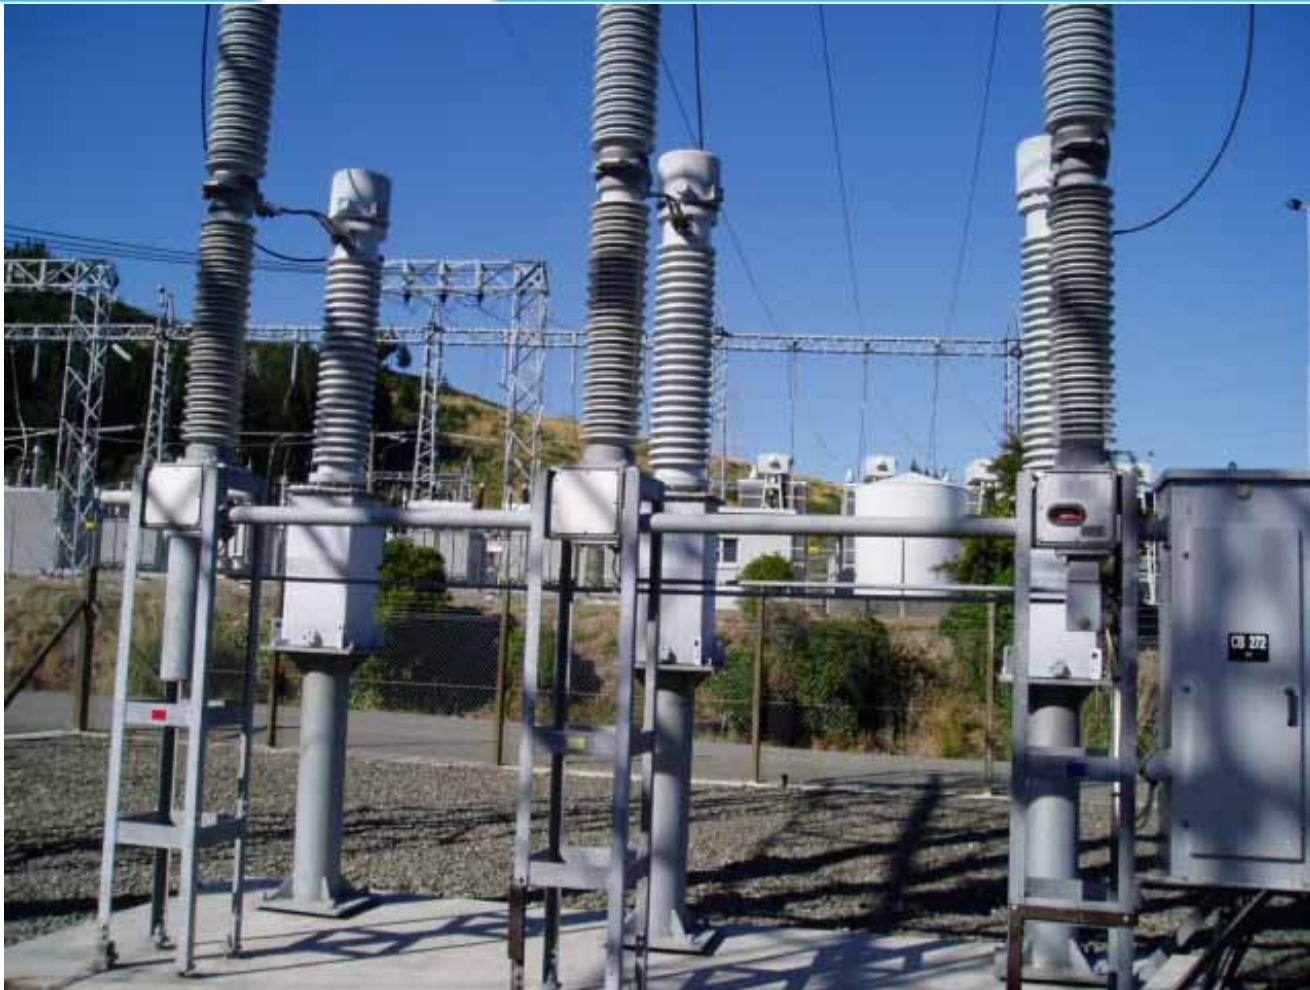
Some older equipment vulnerable to major earthquakes

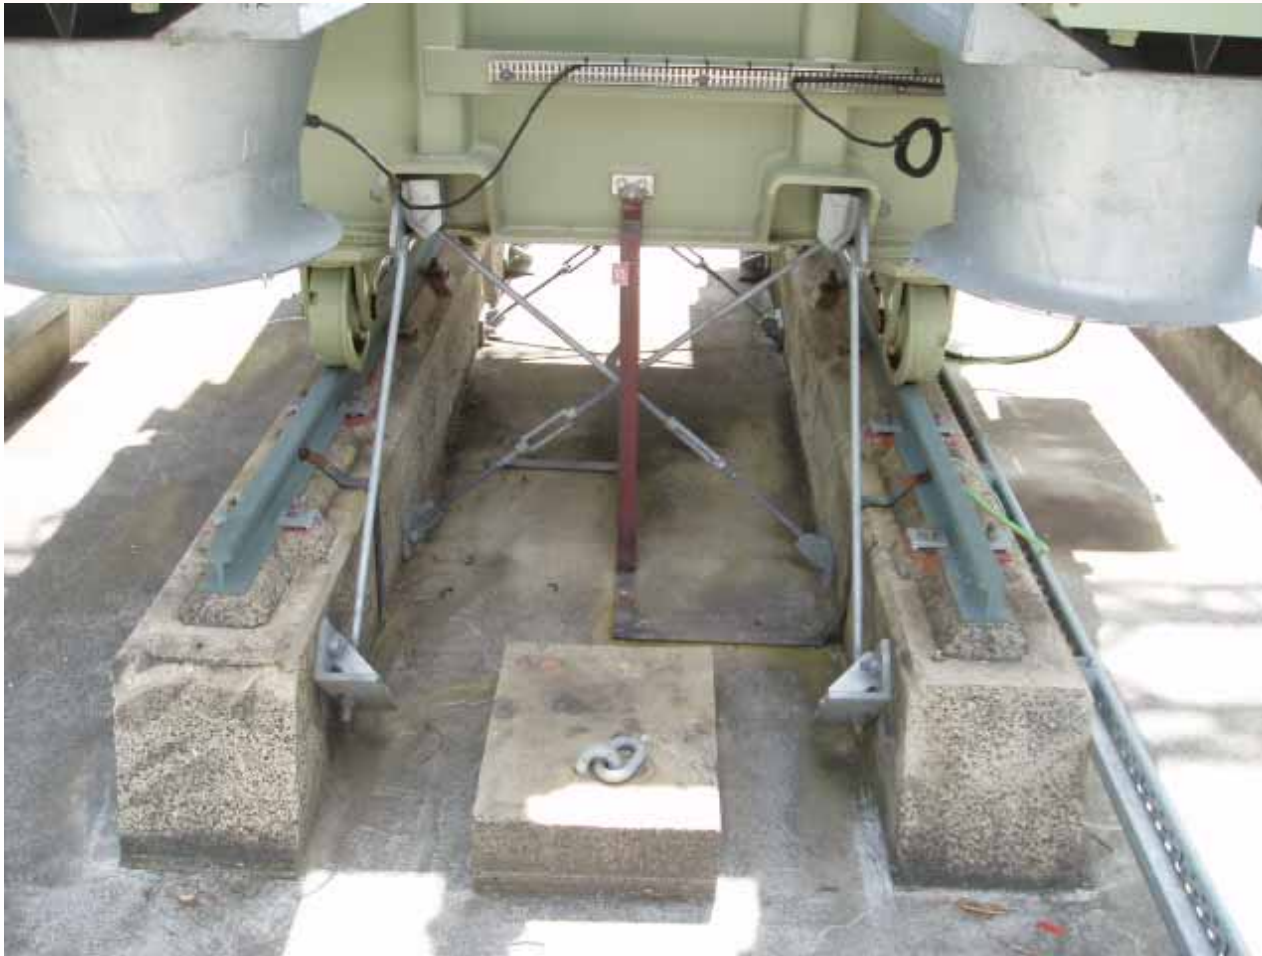
Some transformer hold down not as robust as could be

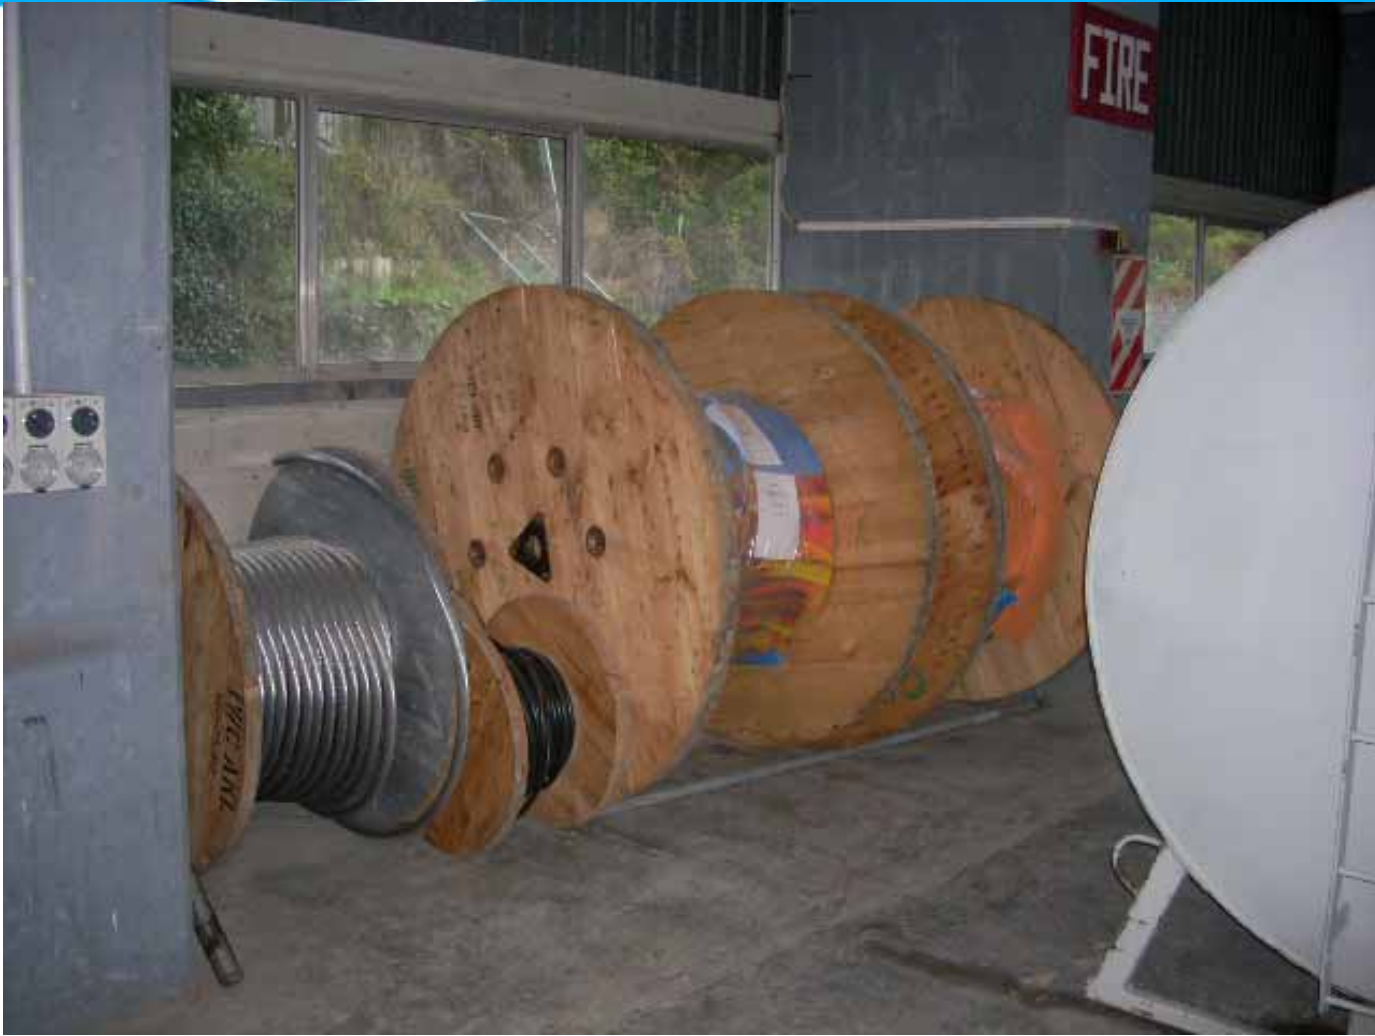
Insecure storage

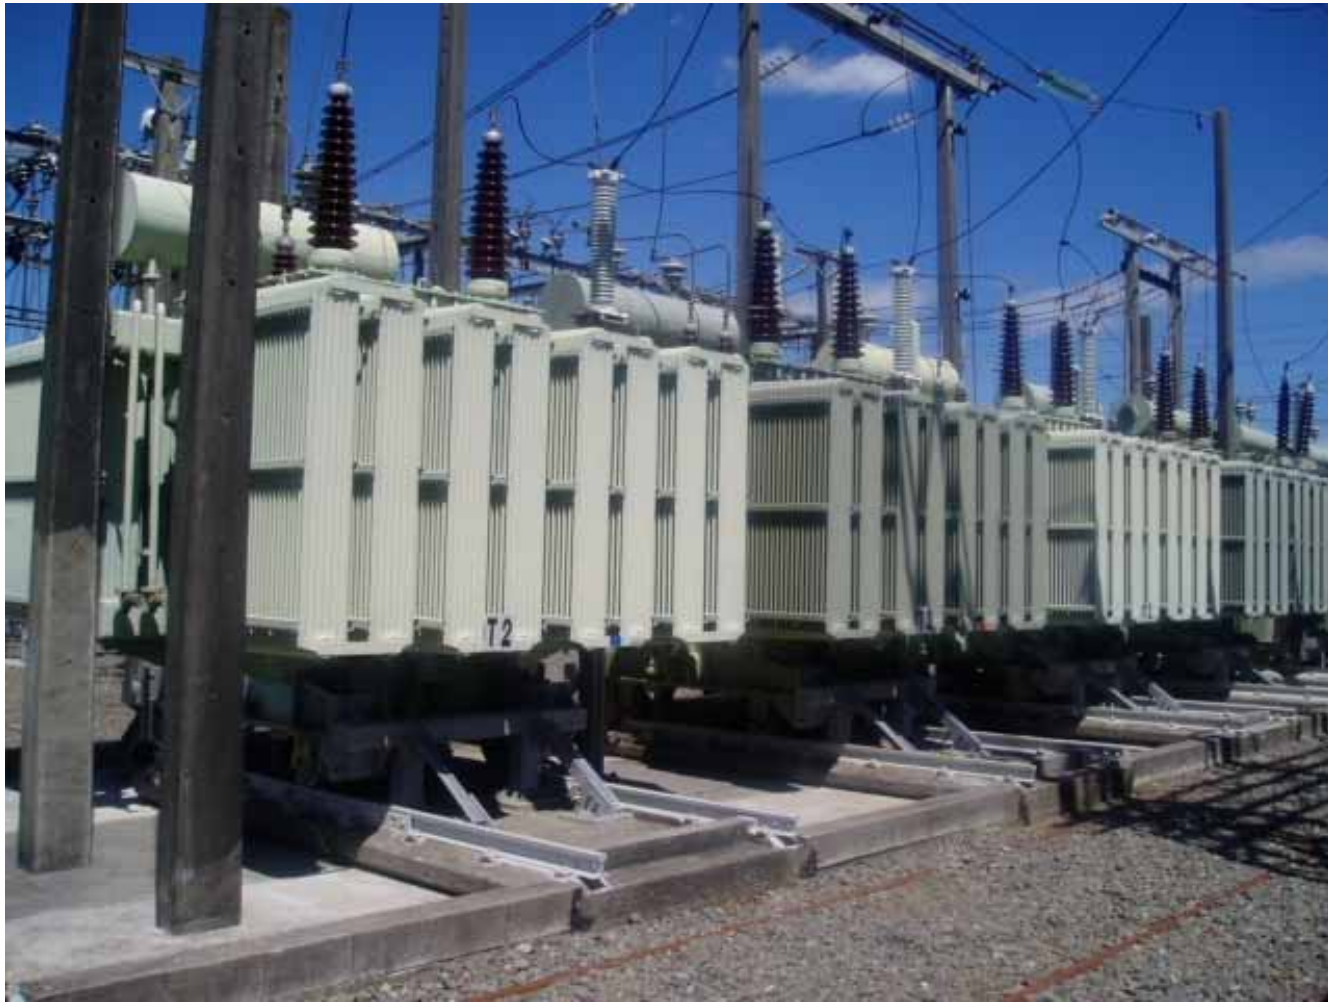
Transformer bank well restrained

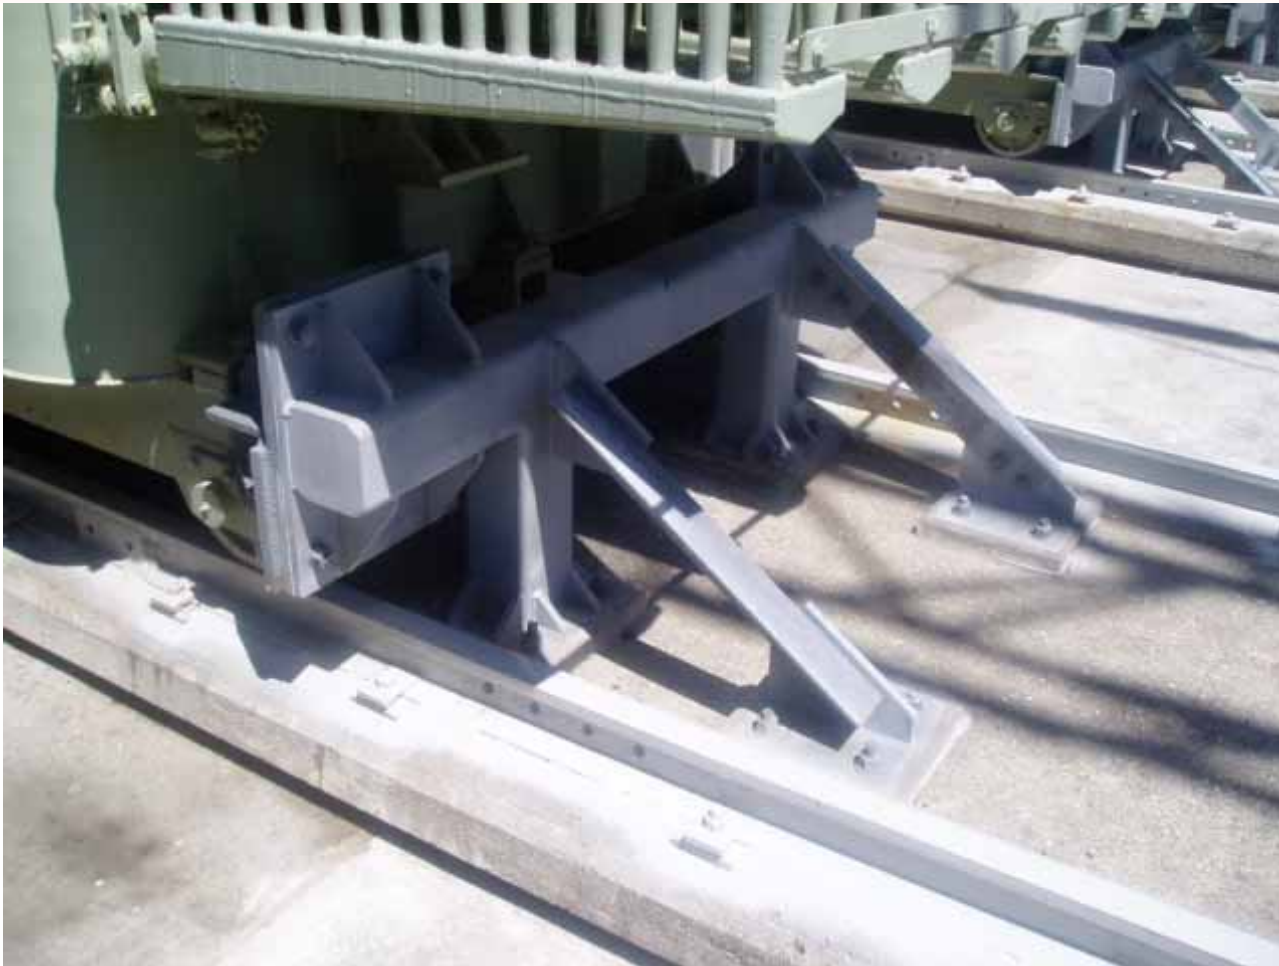
Robust transformer restraint

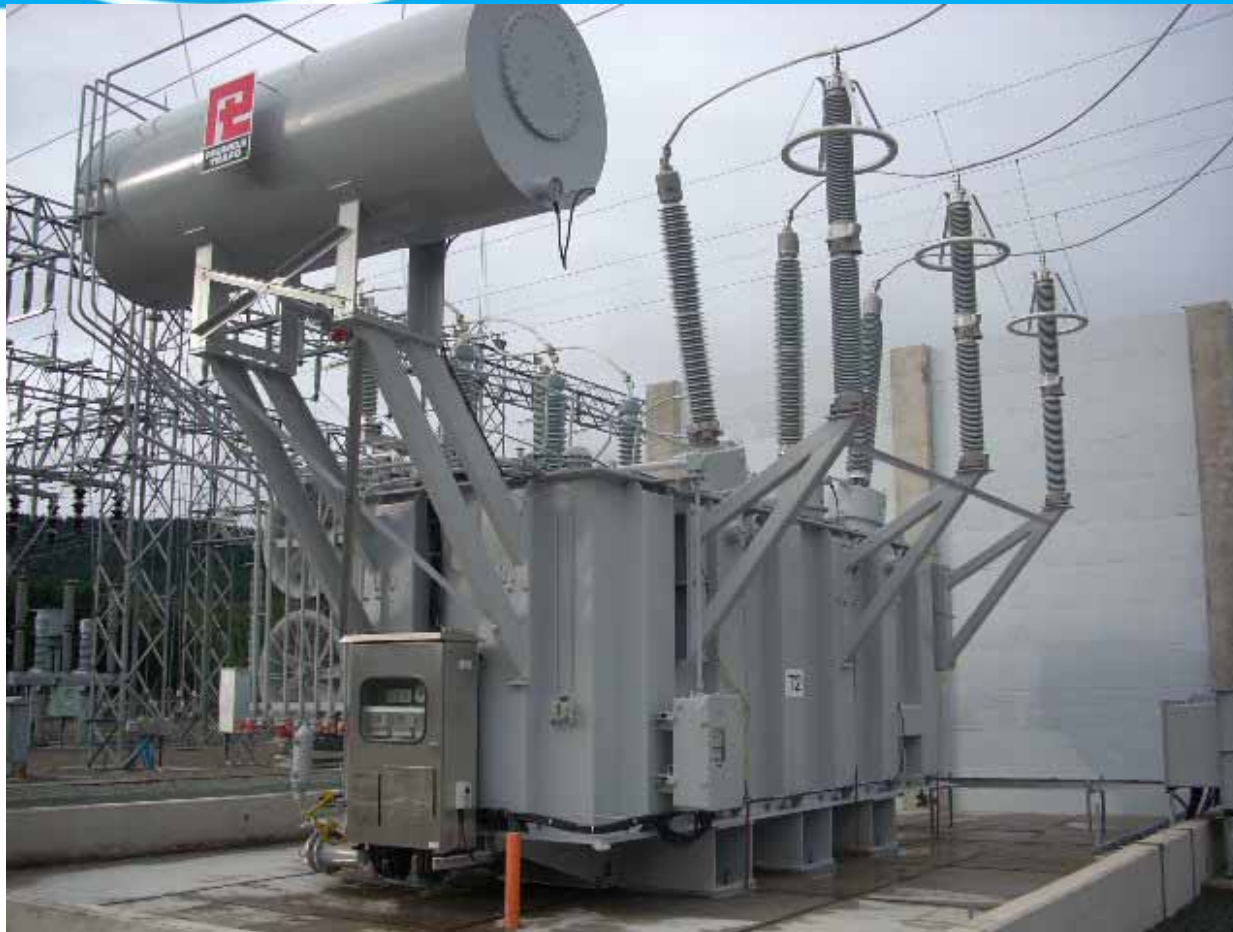
Modern three phase transformer built to current standards

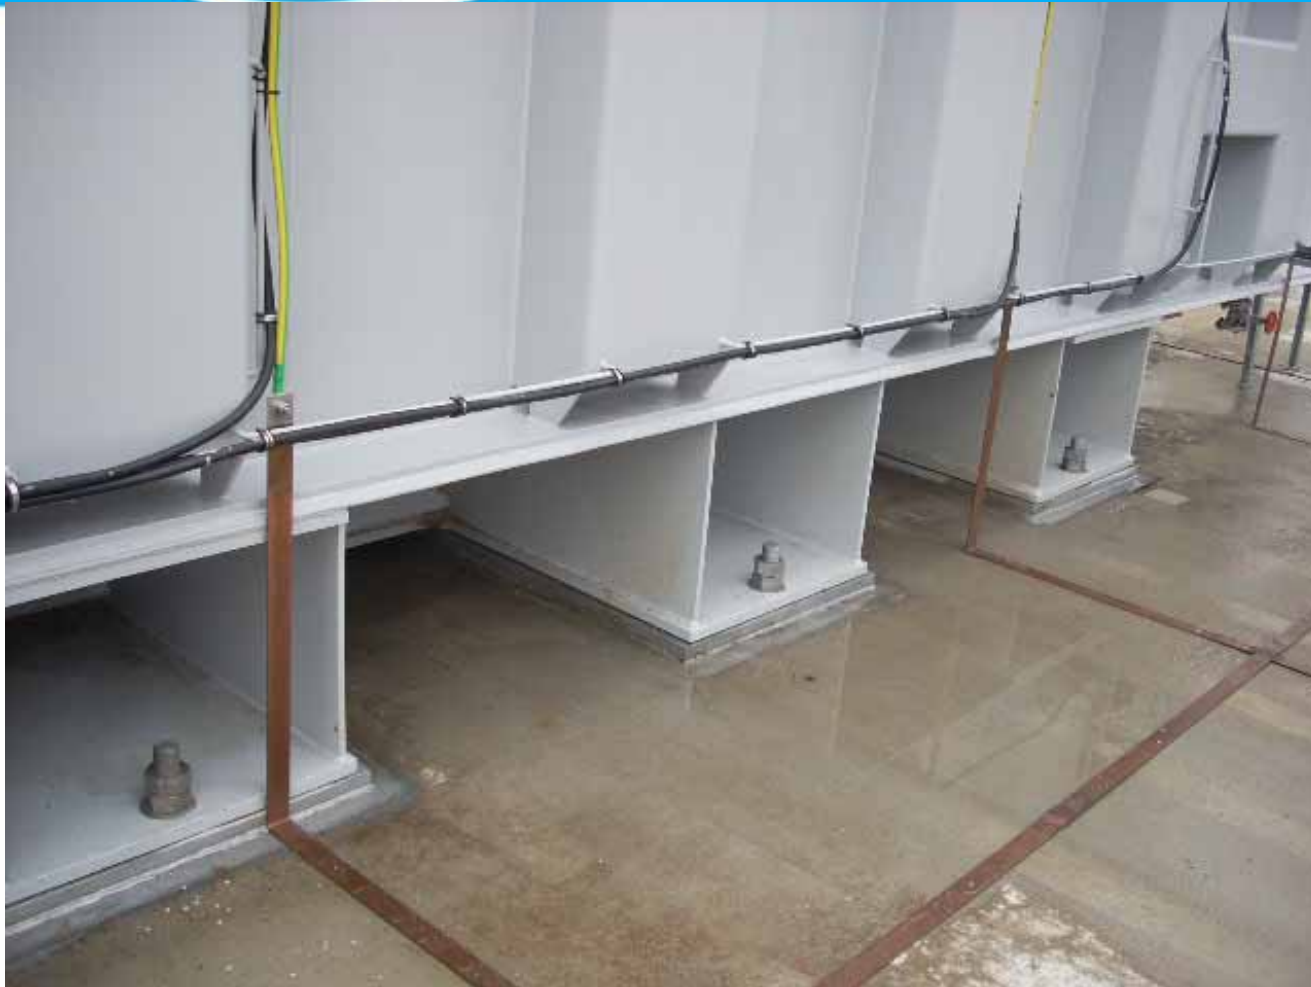
Robust hold down systems

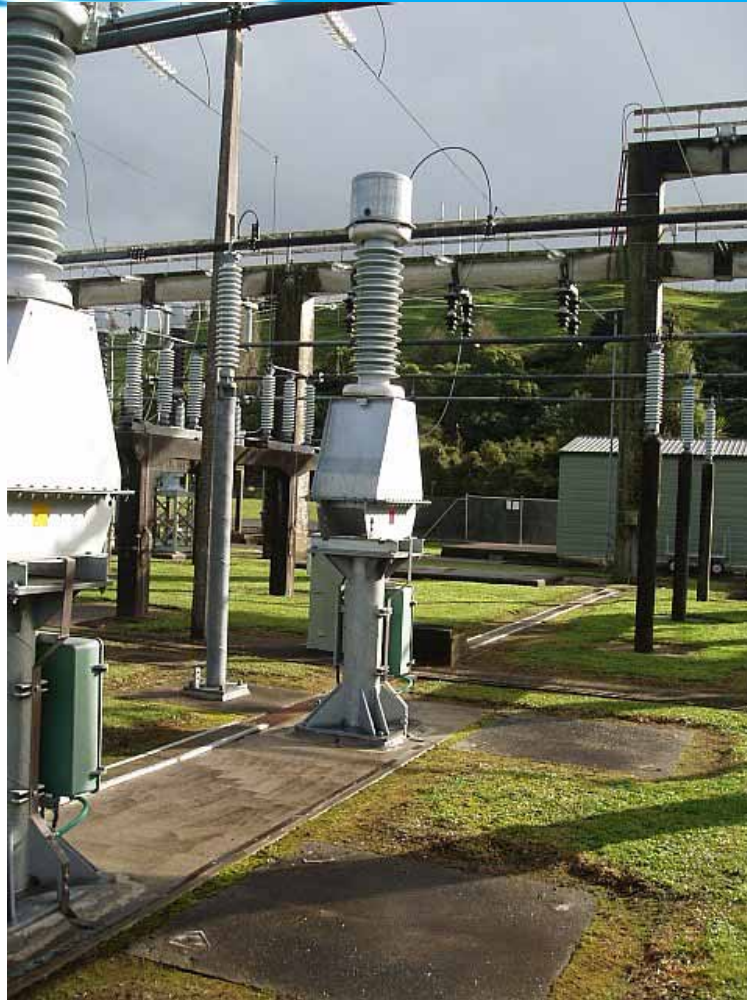
Equipment on robust support stands

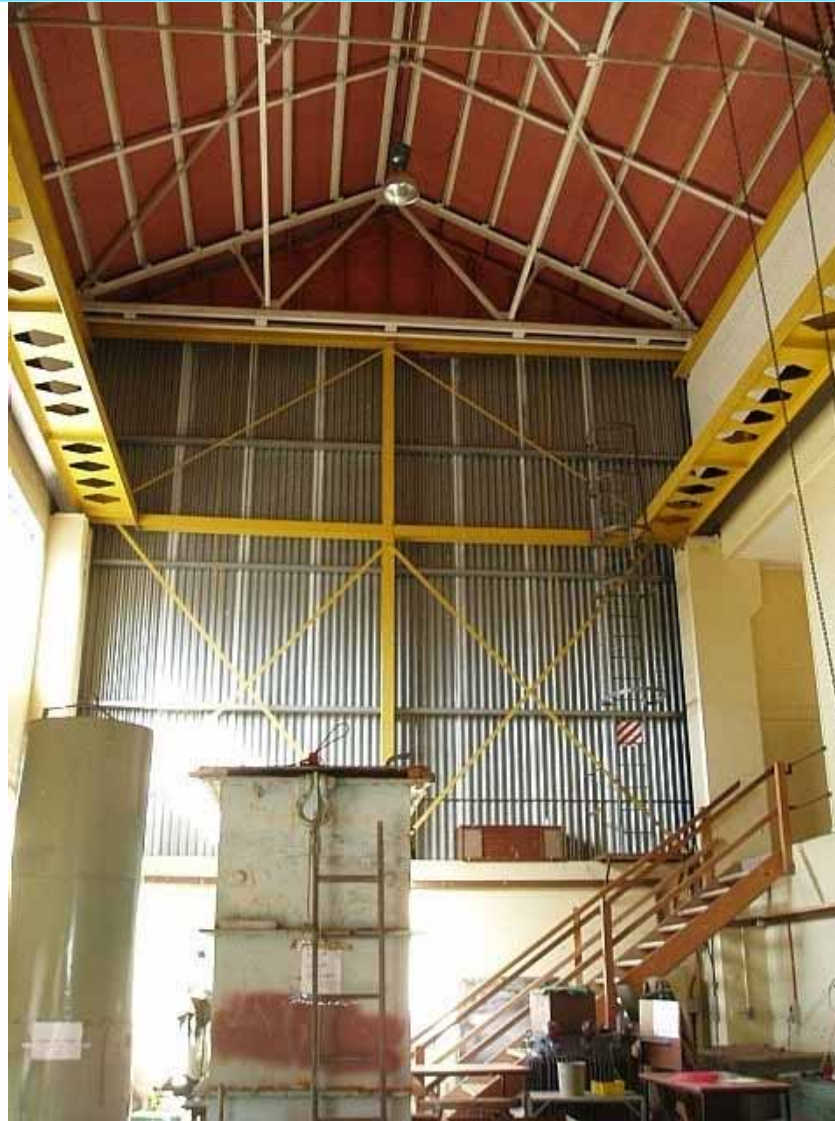
Example of seismic strengthening of an existing building
