Managing Seismic Risk

2008 National Lifelines Forum

Review Programme

Example of photos taken for each site

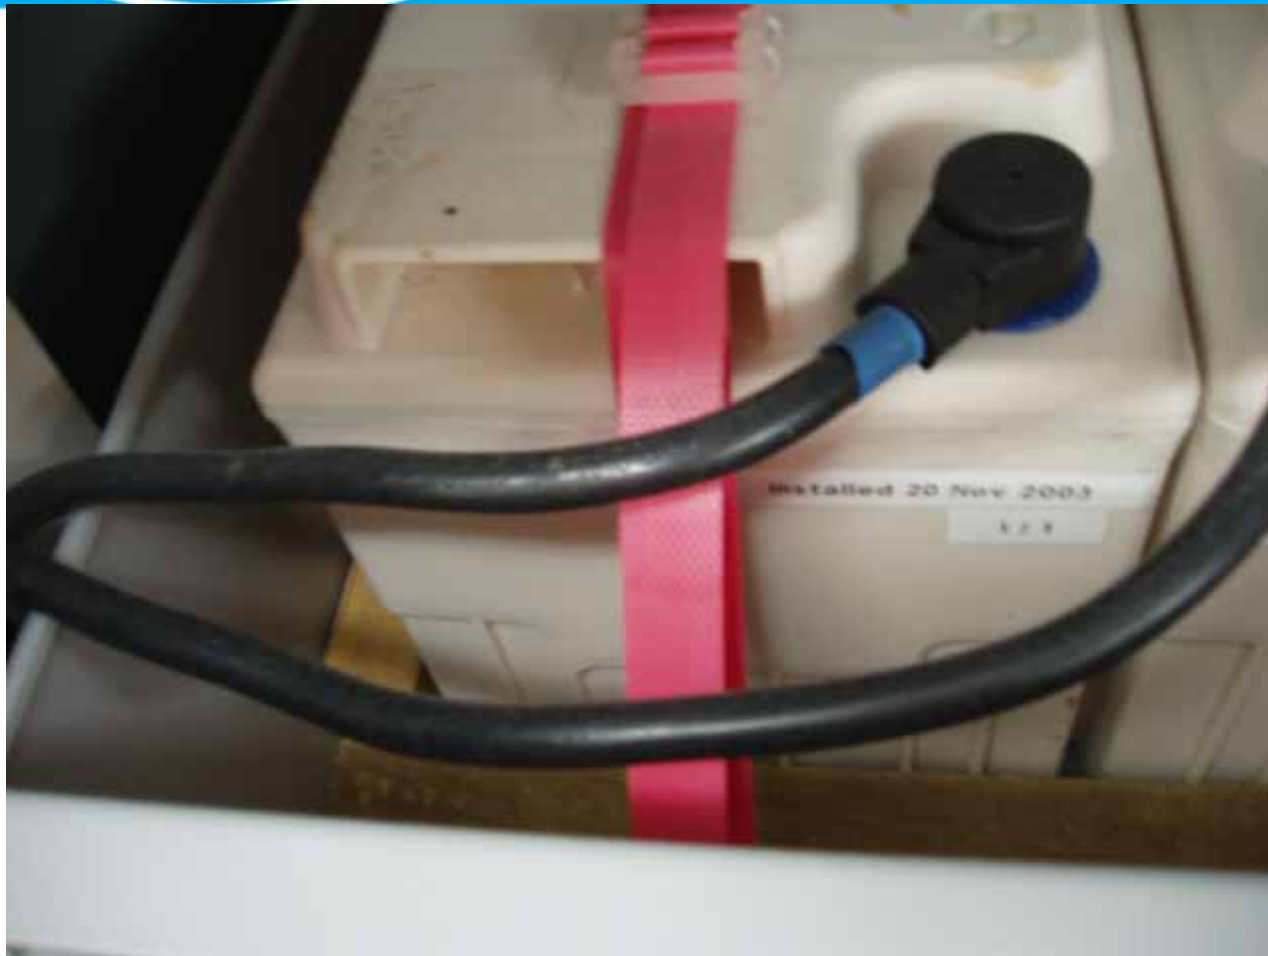
Back up batteries well packed and strapped down

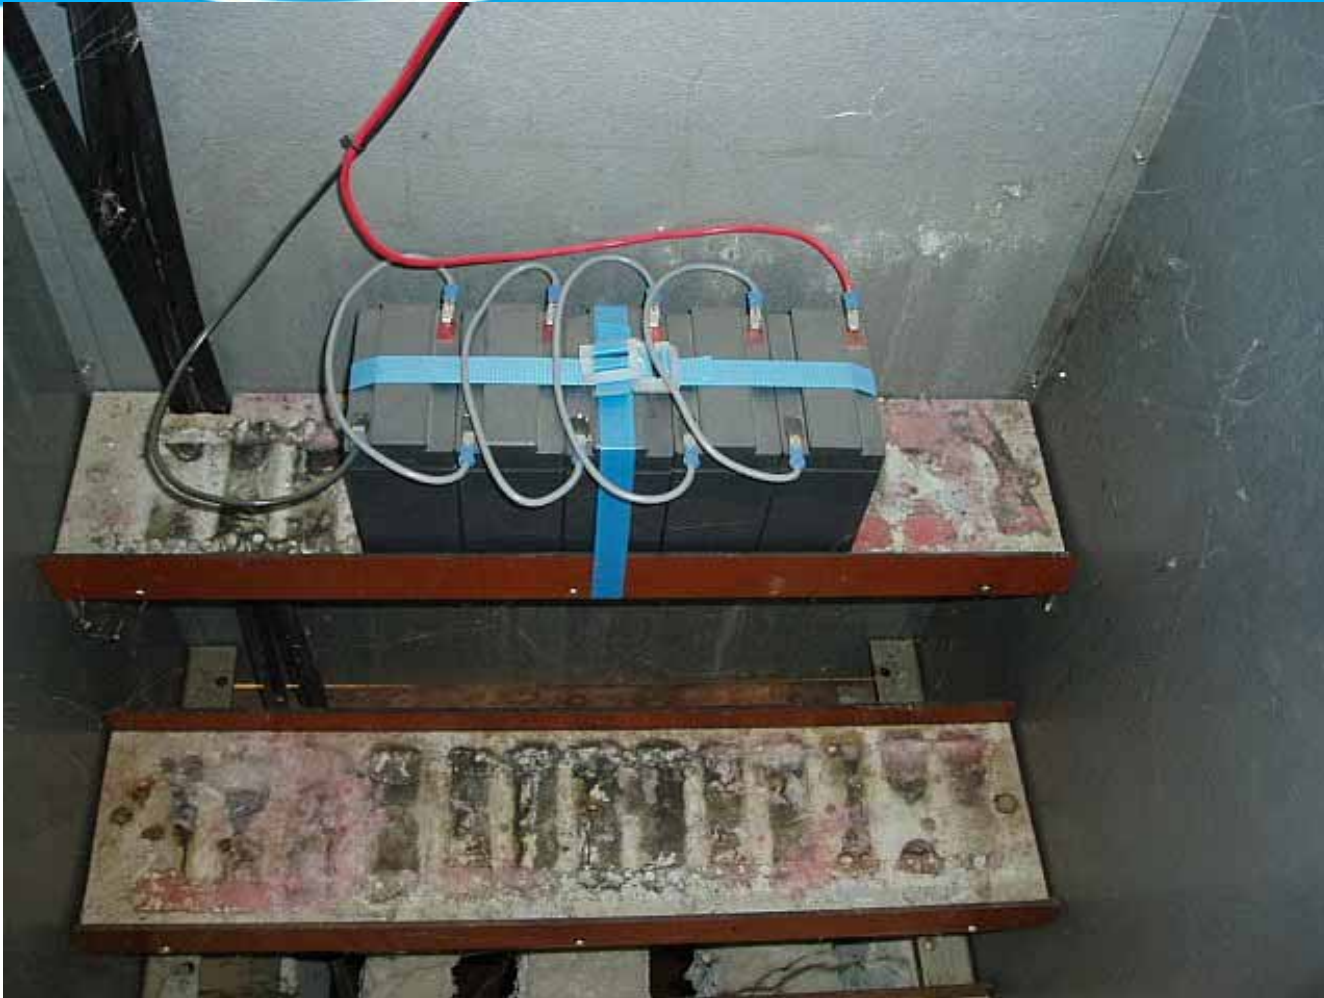
Even small Comms batteries restrained

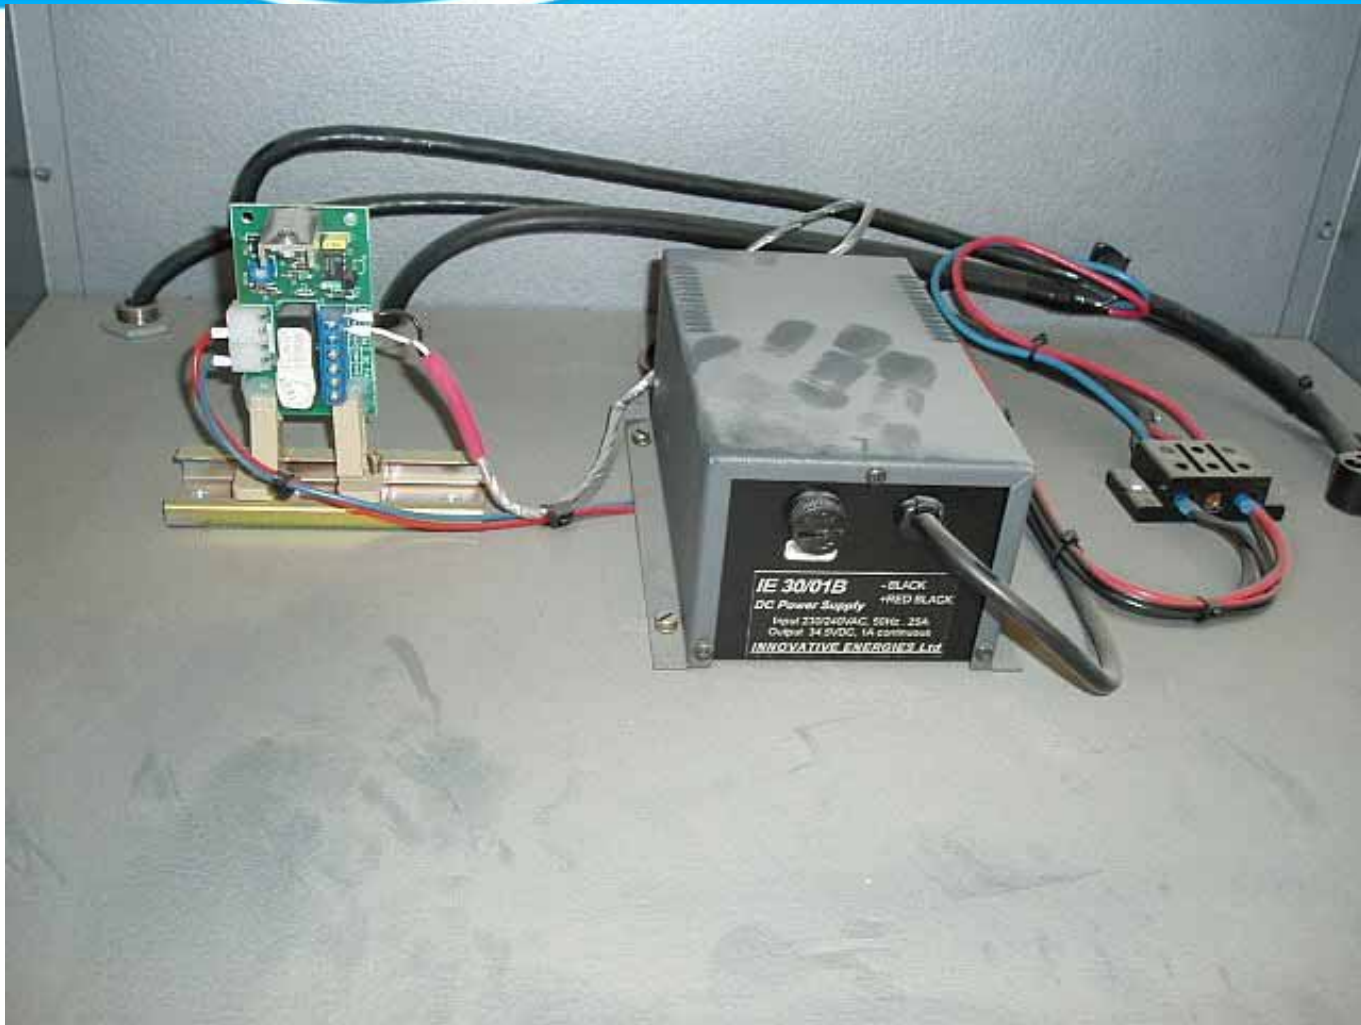
Small equipment within cabinets restrained

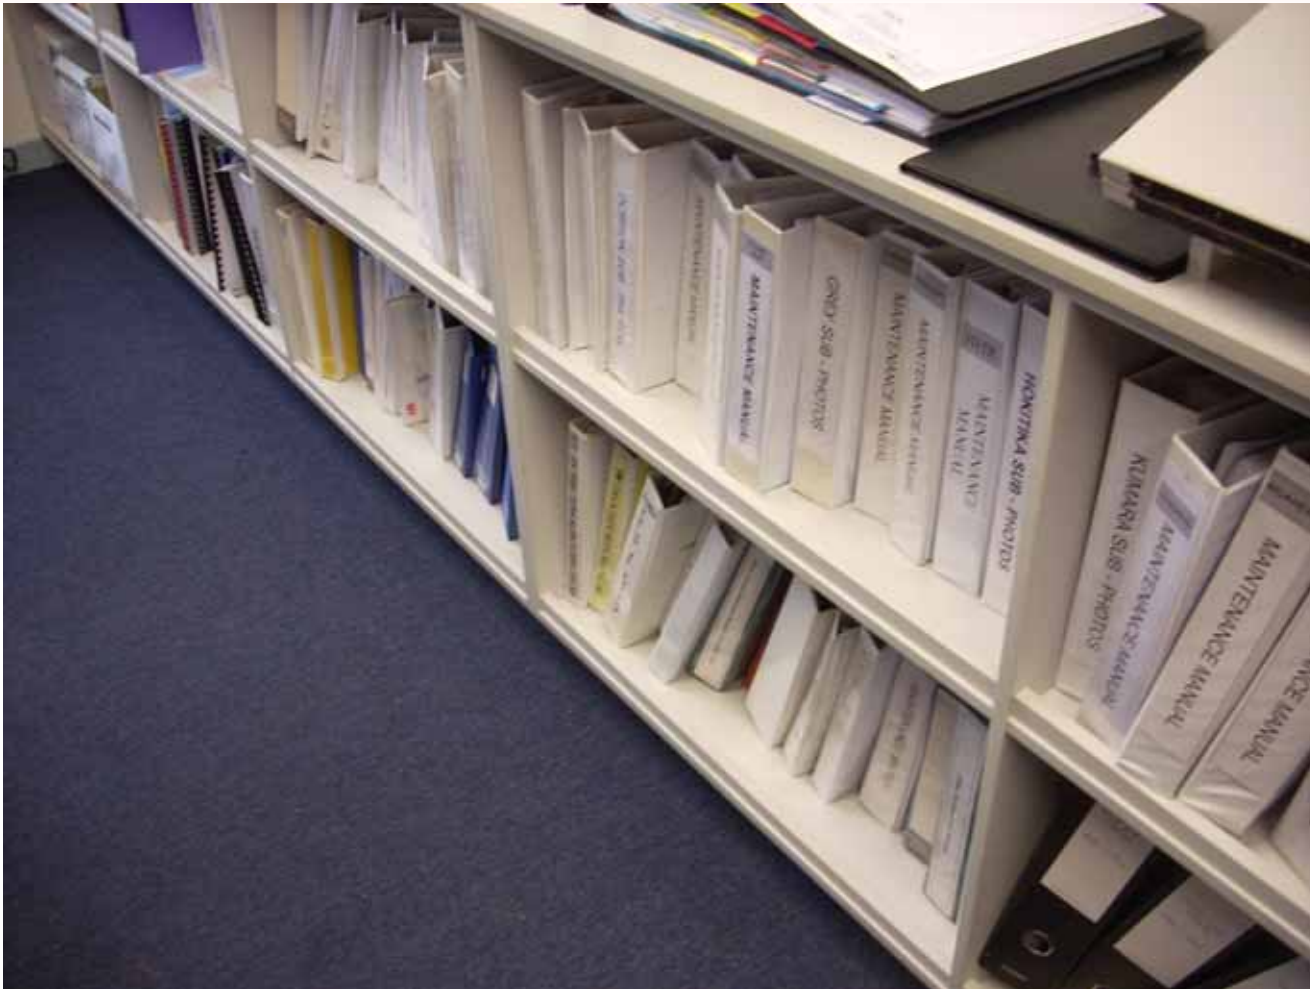
Important manuals restrained within shelving

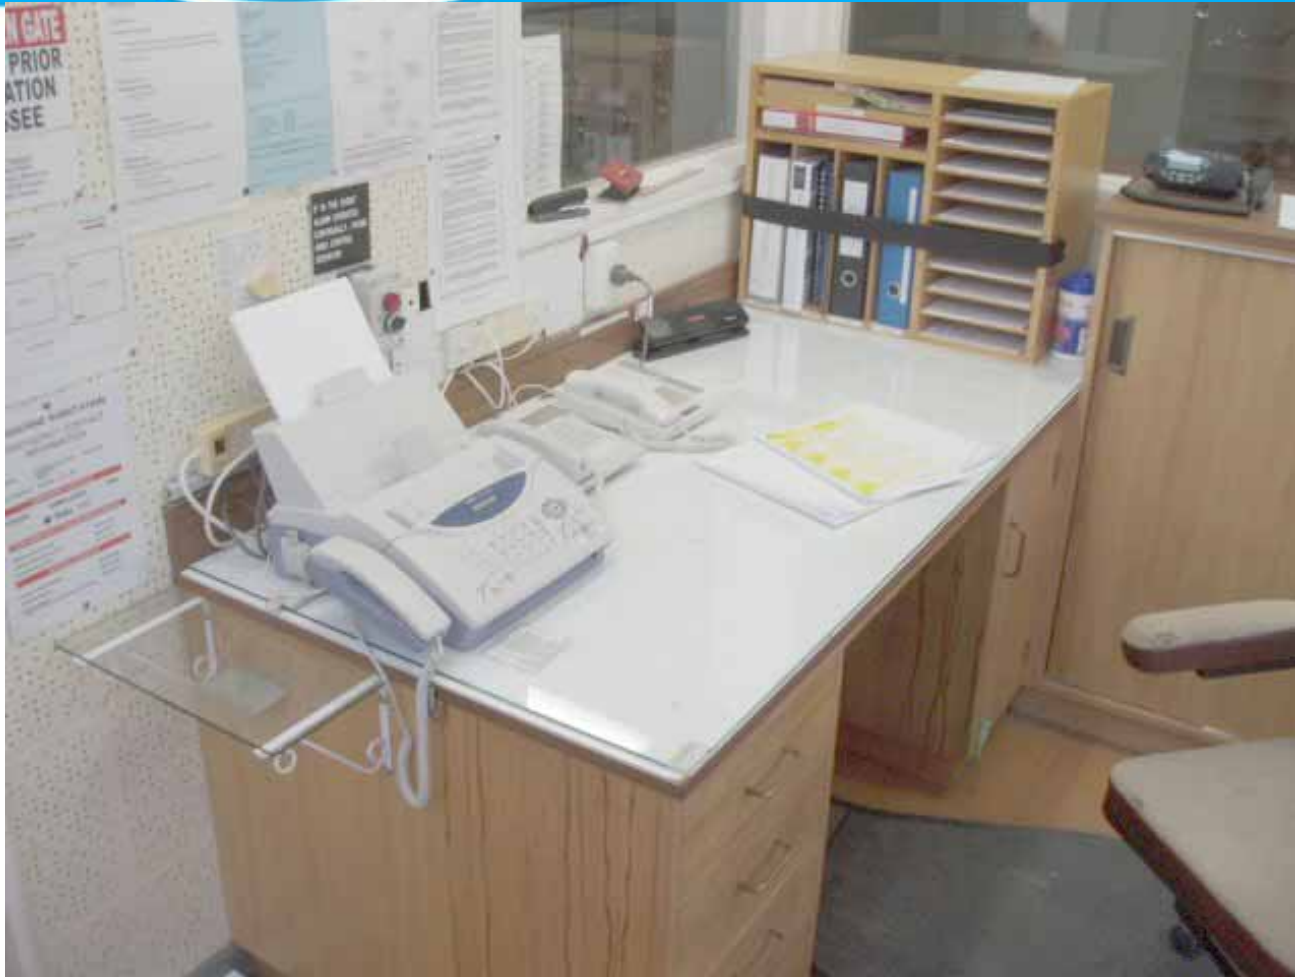
Furniture and equipment restrained (Gisborne prior to earthquake)

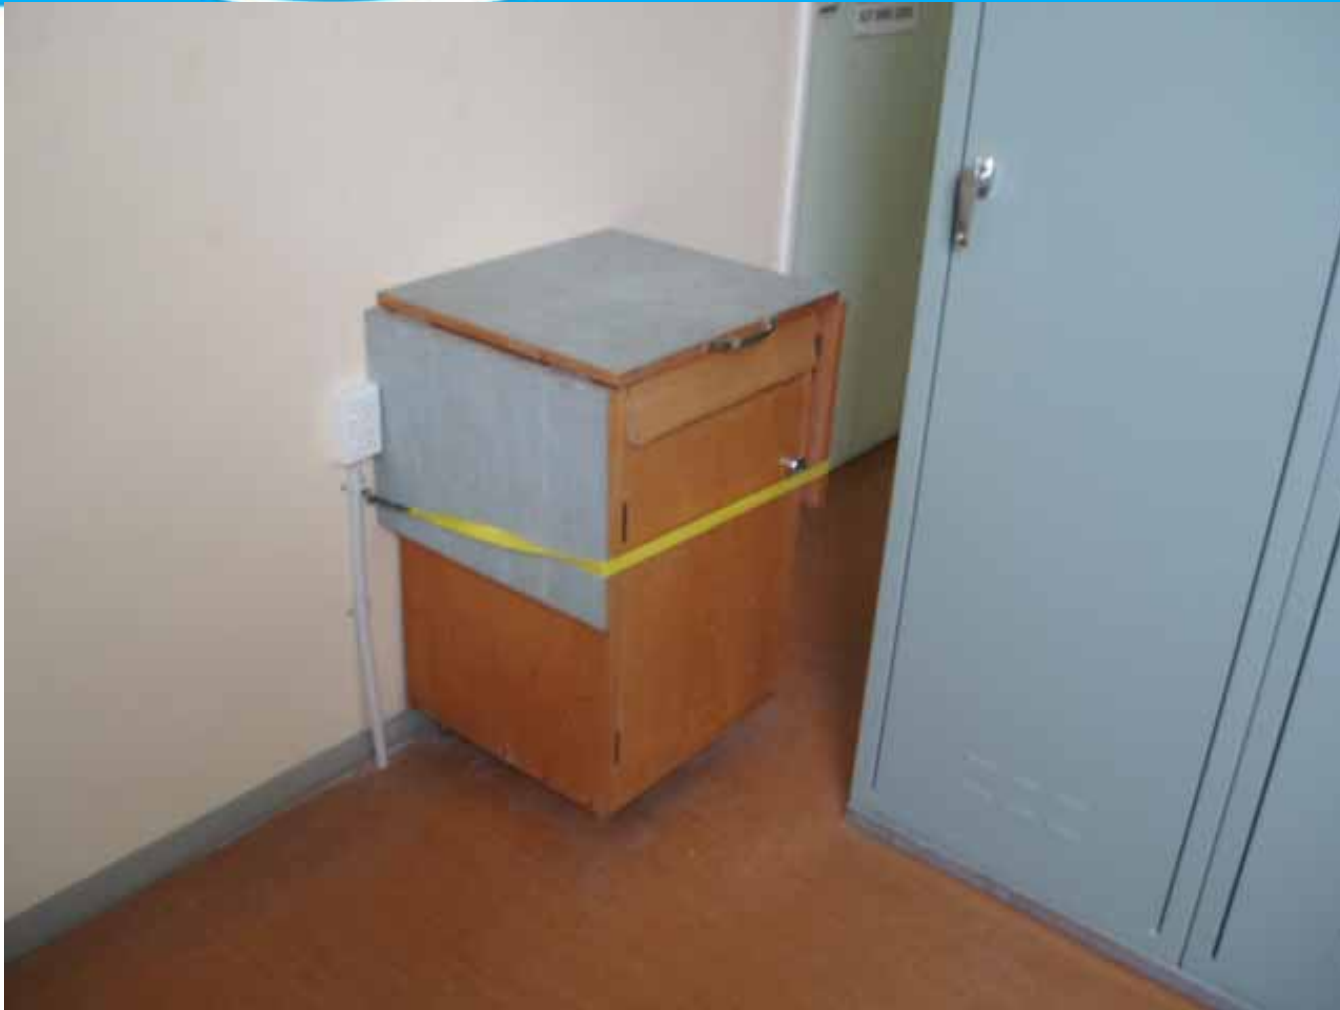
Restrained furniture in relay room (Gisborne prior to earthquake)

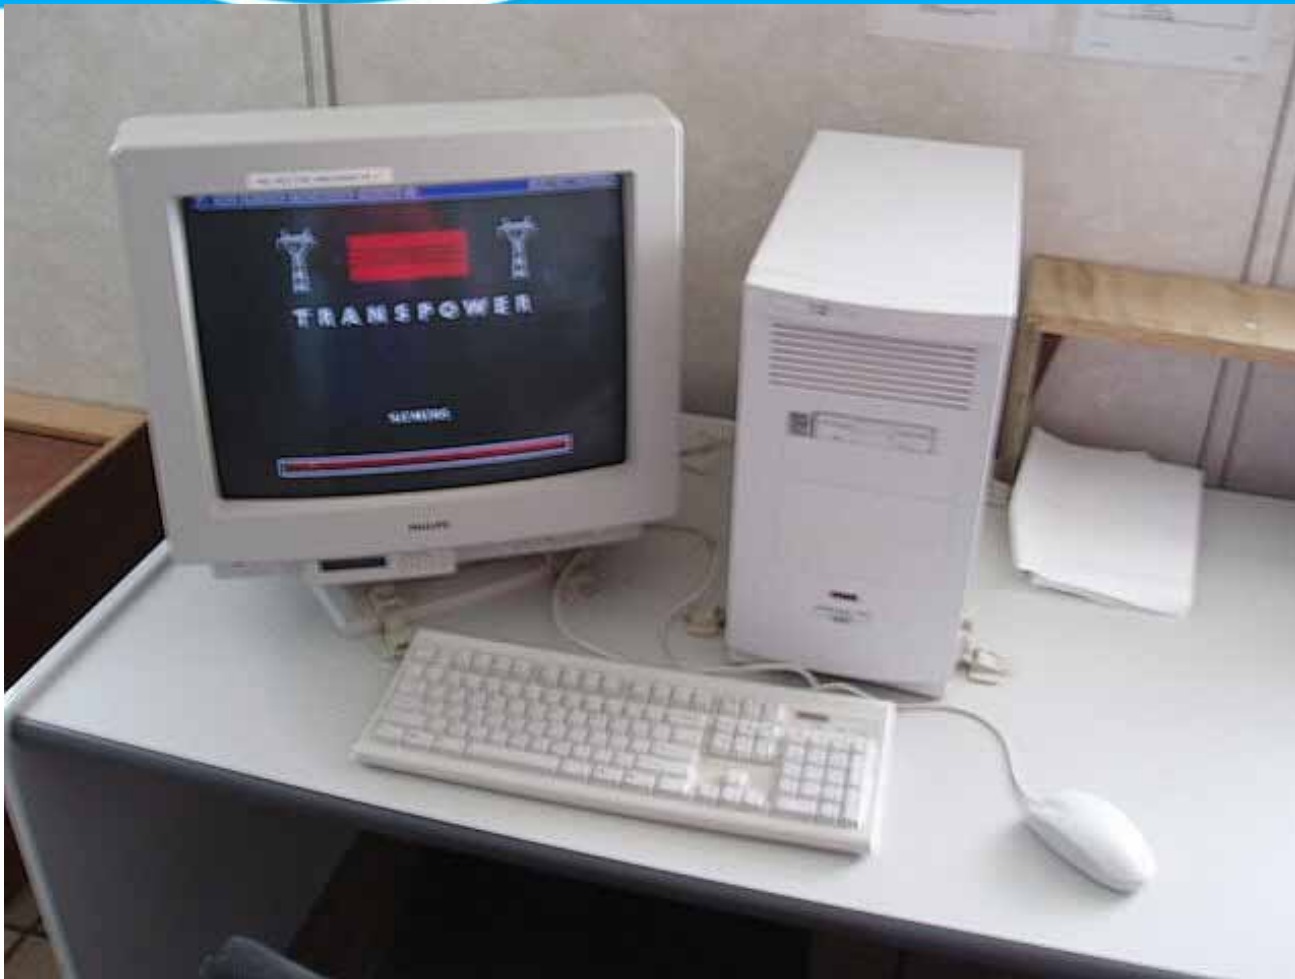
Computer equipment restrained on desk

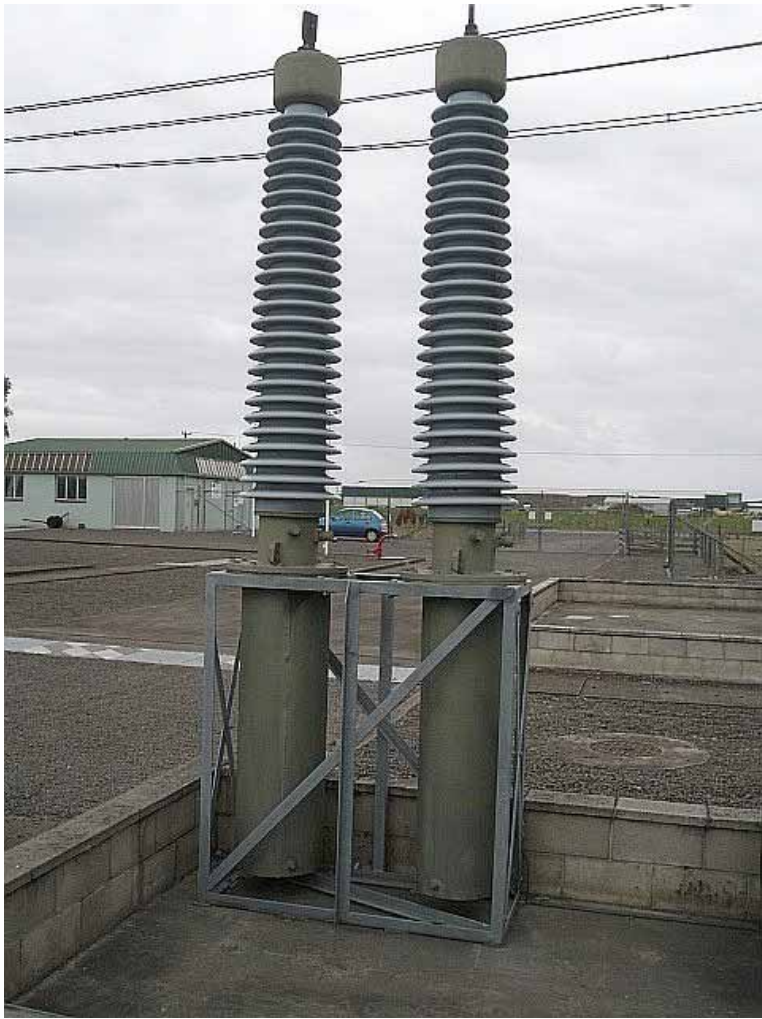
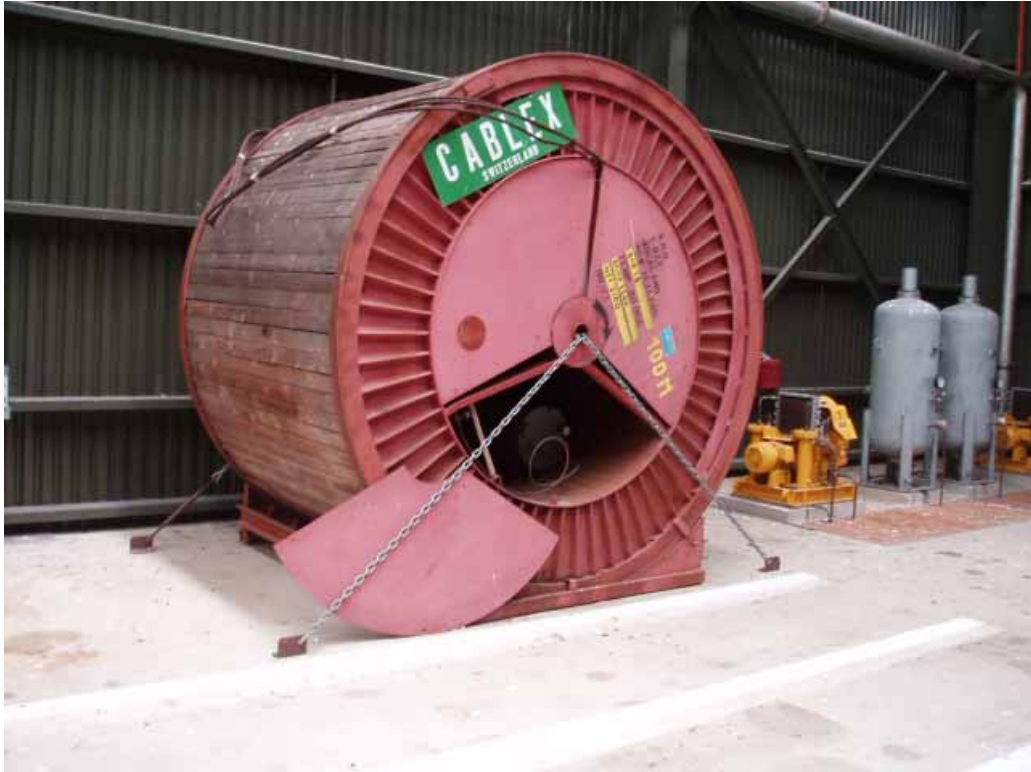
Secure storage

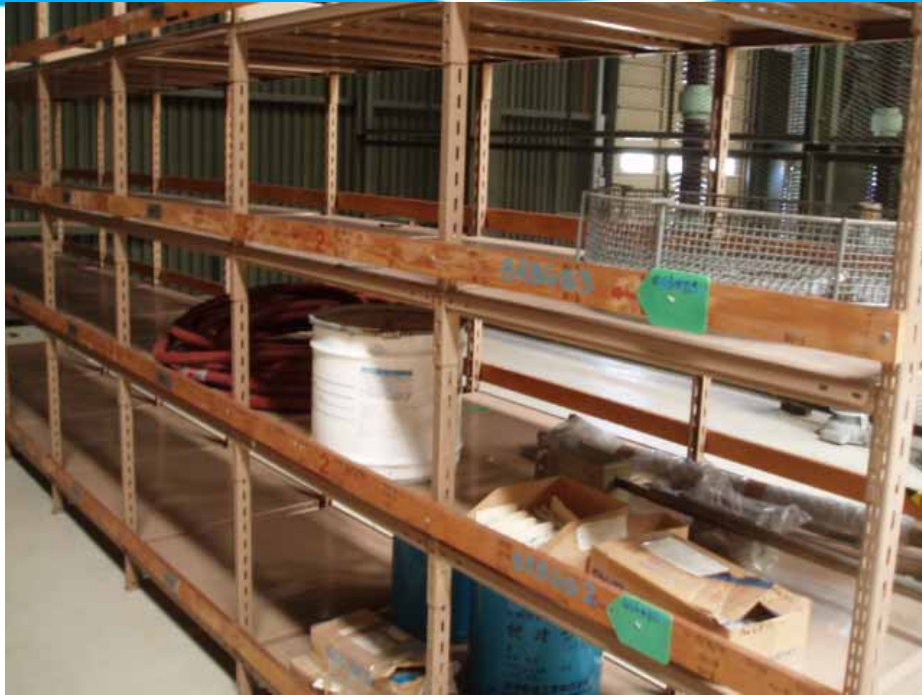
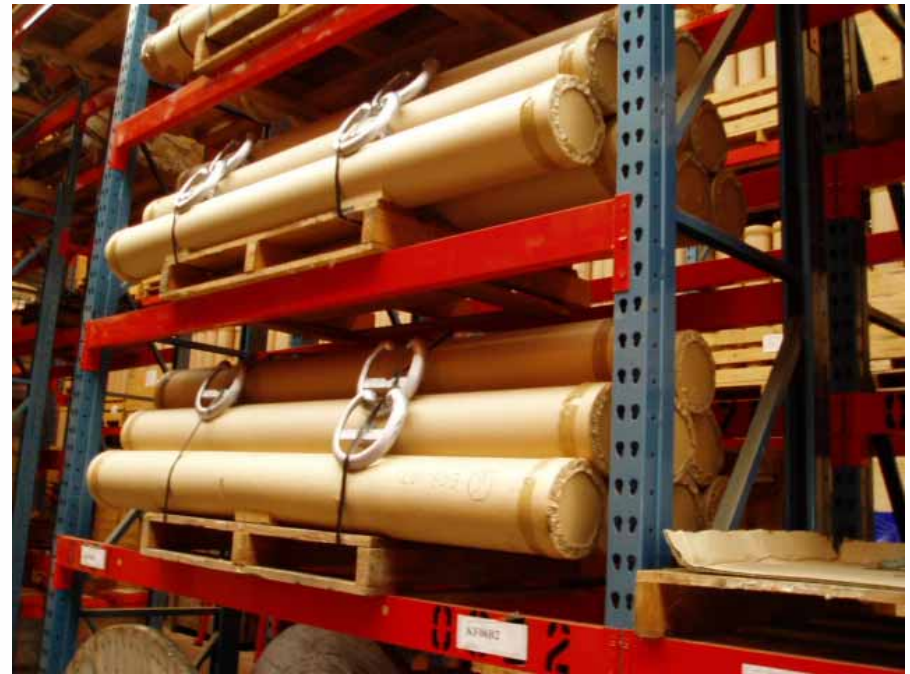
Secure storage
