Promoting Awareness of the Implications of Wellington Lifelines to Earthquake

Project process overview

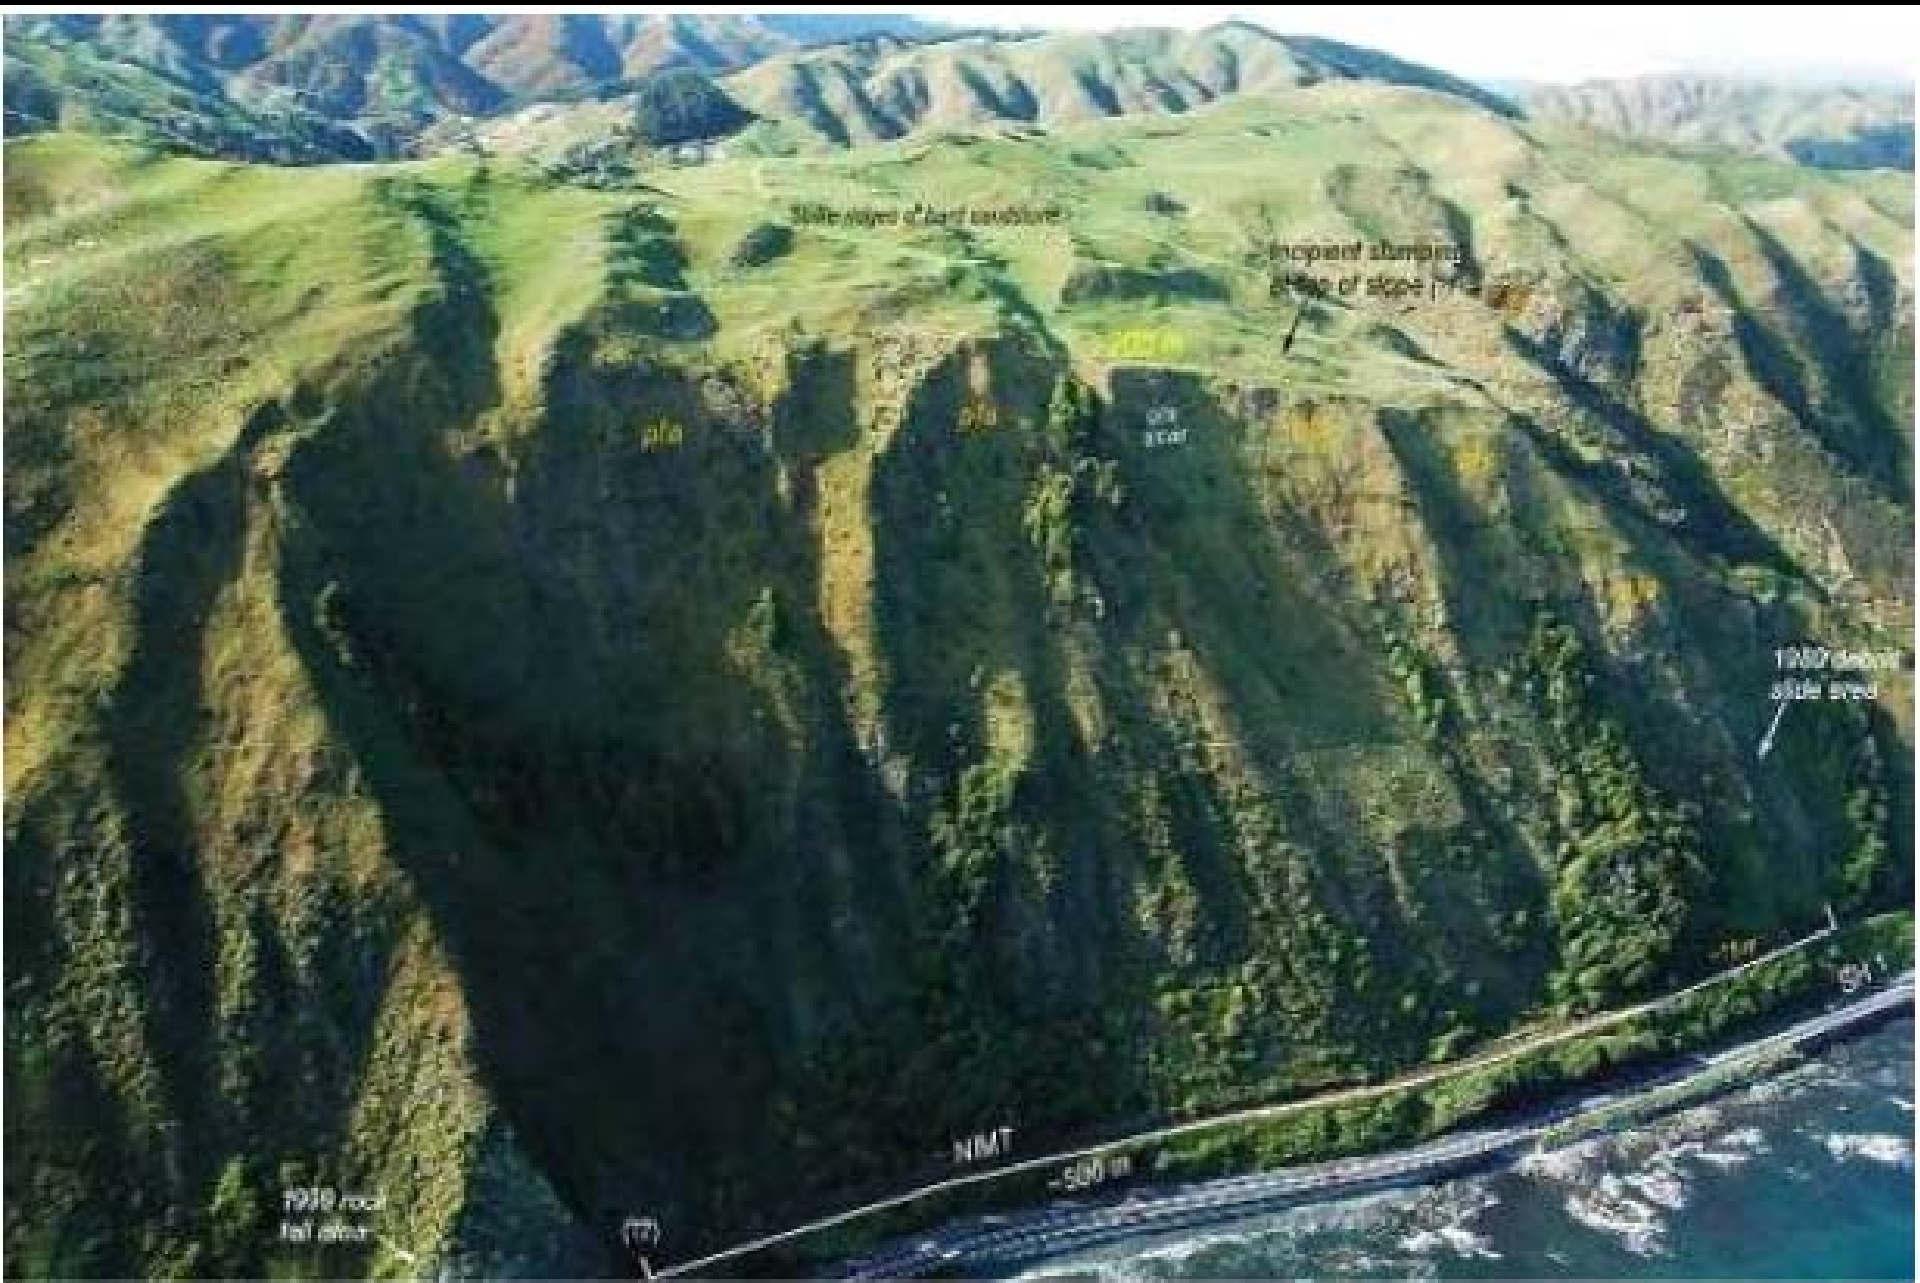
Site layer of hard basaltic

steep of abrupt slope of slope

1990 rock fall area

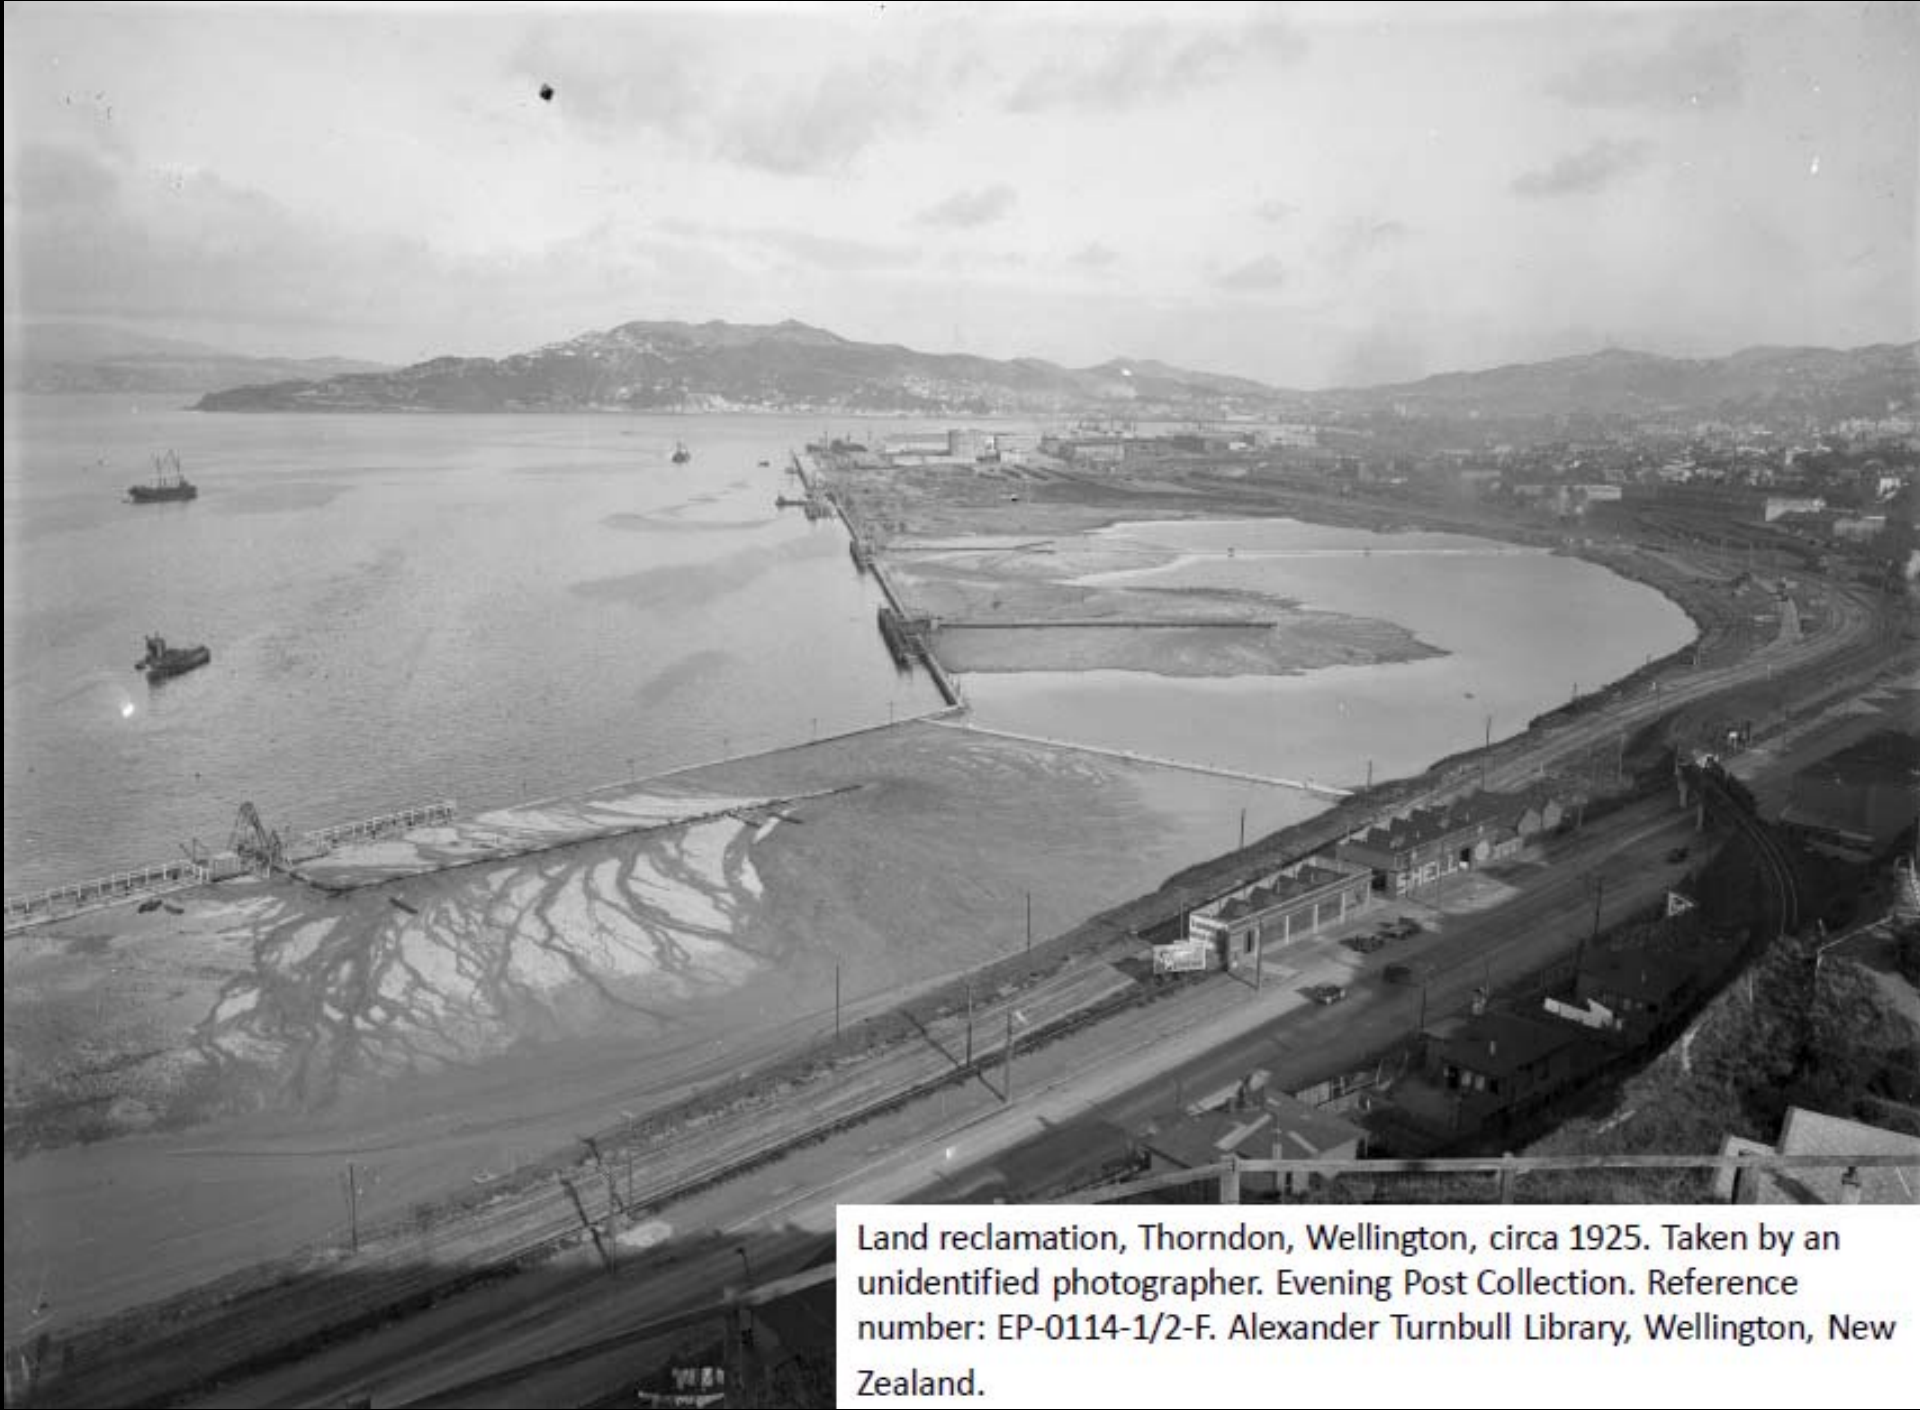
Land reclamation, Thorndon, Wellington, circa 1925. Taken by an unidentified photographer. Evening Post Collection. Reference number: EP-0114-1/2-F. Alexander Turnbull Library, Wellington, New Zealand.
