# Development of Products and Procedures for the Mitigation Tsunami Hazards at Maritime Facilities in Northland

Appendices 1-5

## Report Status

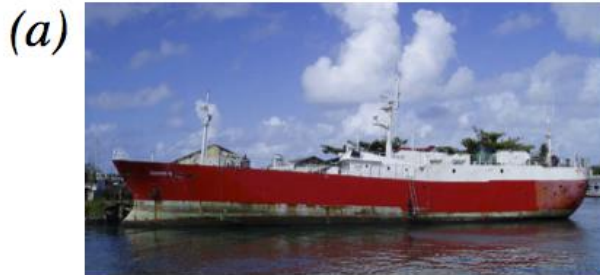
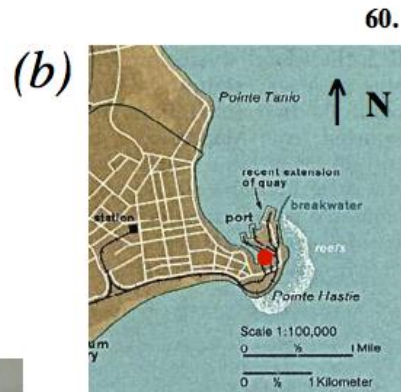
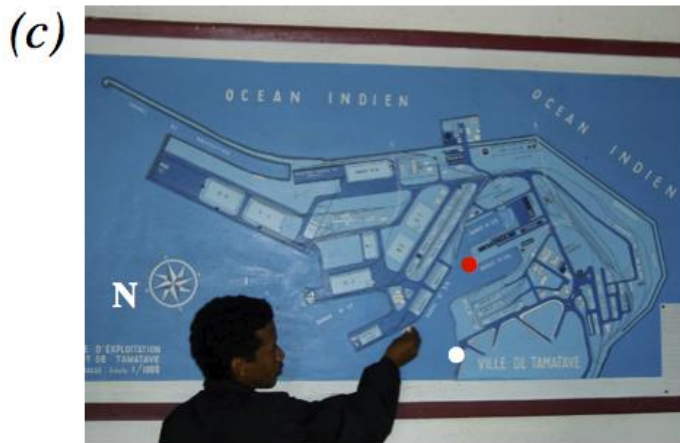
**Figure 5.** (a): The 50-m freighter *Soavina III* photographed on 2 August 2005 in the port of Toamasina. (b): Sketch of the port of Toamasina showing its complex geometry. (c): Captain Injona uses a wall map of the port (ESE at top) to describe the path of *Soavina III* from her berth in Channel 3B (pointed on map), where she broke her moorings around 7 p.m., wandering in the channels up to the location of the red dot (also shown on Frame b), before eventually grounding in front of the Water-Sports Club Beach (white dot; Site 17).

**50-m SHIP BROKE MOORINGS around 19:00 (GMT+3), FOUR HOURS AFTER MAXIMUM WAVES**

**Figure 1.2 Description of the occurrence in Toamasina, Madagascar (reproduced from Okal et al., 2006a).**

In the first case, at the port of Toamasina, Madagascar tsunami waves began affecting the port some 8 hours after the earthquake, consistent with tsunami travel times from Sumatra to Madagascar, with maximum water levels measured to be approximately 0.6 m above mean sea level. The initial tsunami activity was observed for 4 or 5 hours and then abated. Approximately two hours after this, currents in the harbor increased dramatically, eventually causing a 50 m freighter to break her mooring lines and wander through the harbor for the next 3 hours until it was grounded on a sand bar. Luckily the free-floating ship did not collide with any other vessels or wharf structures.

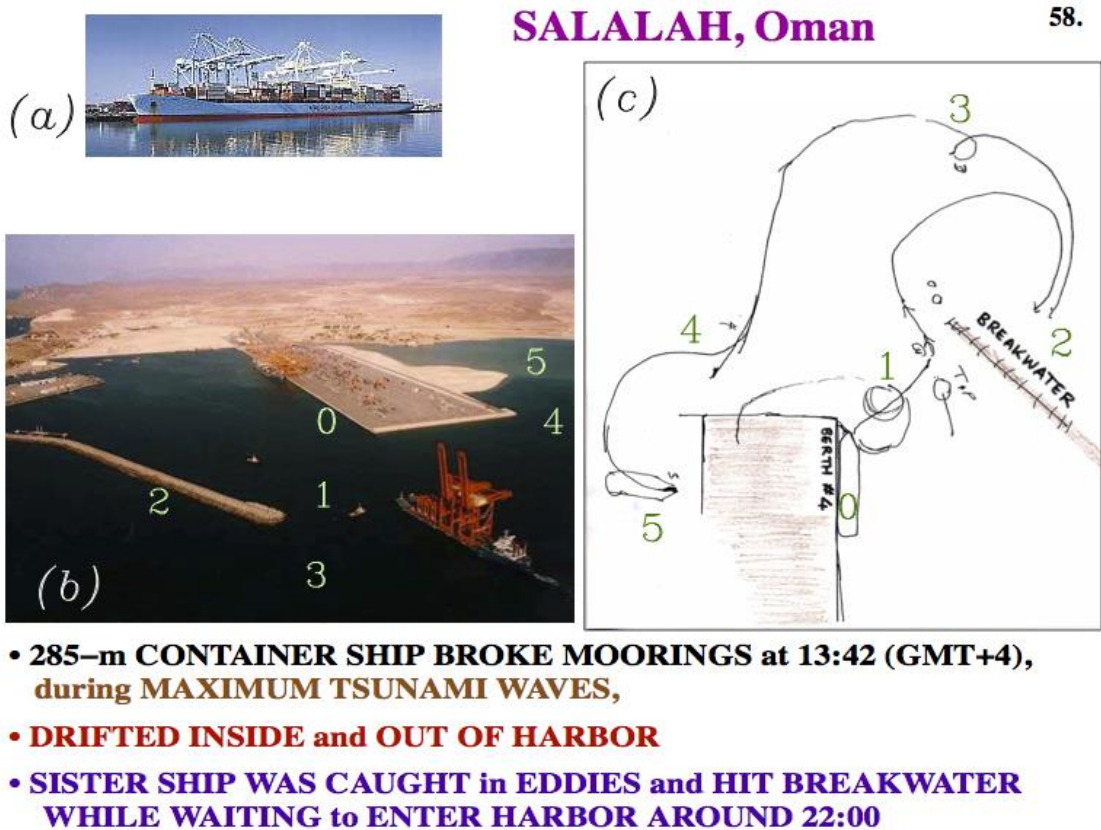
Figure 1.4 Description of the occurrence in Port of Salalah, Oman (reproduced from Okal et al., 2006b).

The third of these events occurred in the Port of Salalah, Oman, an important shipping container terminal servicing the Indian Ocean. At Salalah, approximately 90 min after tsunami first arrival, strong currents near the most offshore unloading berth broke all of the mooring lines of the 285 m freighter *Maersk Mandraki* and pulled it away from the terminal. The ship was reportedly caught in a system of eddies and could not be brought under control even with the use of tugboats. The currents eventually pulled the freighter out of the harbor and beached it on a nearby sandbar. At the same time, the 292 m freighter *Maersk Virginia* was rocked by the tsunami as it entered the harbor. The captain delayed the entry into the harbor and waited outside for several hours during which time strong currents caused the freighter to collide with the breakwater resulting in minor damage to the ship's fuel tank.

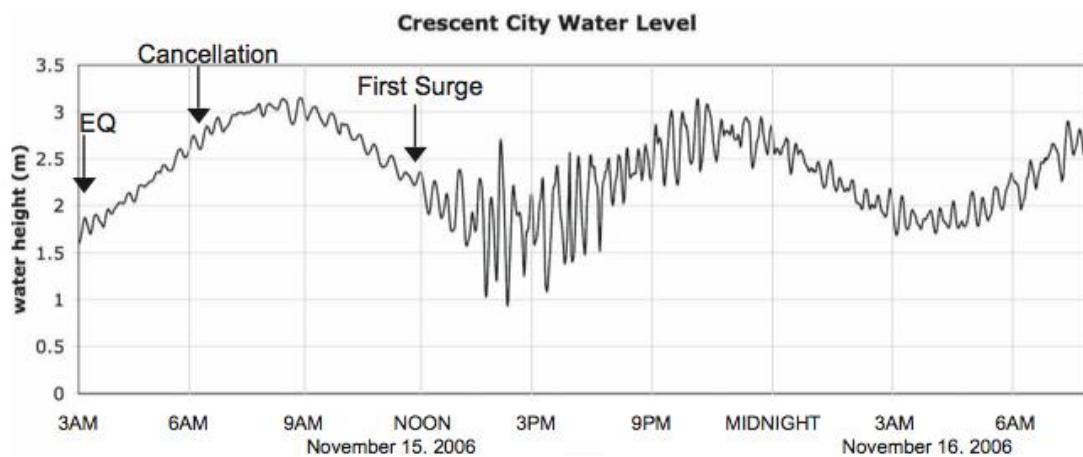
**Figure 1.5** Water level data from the National Ocean Services (NOS) tide gauge in Crescent Harbor. The earthquake occurred at 3:15 am PST (first arrow). Warning and watch were cancelled by WCATWC at 6:42 am PST (second arrow), and the first surge arrives at about 11:40 am PST (third arrow). The gauge is located on Citizens Dock at 41.745 N, 124.185 W. (image reproduced from Dengler et al., 2008).

Dengler et al. (2008) described the effects in Crescent Harbor as a result of the 15 November 2006 tsunami generated by an M 8.3 earthquake located in the Kuril Islands. The size of the earthquake prompted the issuance of tsunami warnings, watches and advisories for different regions of the Pacific Ocean. Crescent City itself was only placed under a tsunami advisory. Due to relatively small wave heights recorded on near-source tide gauges, the watches and warnings were cancelled by the West Coast Alaska Tsunami Warning Centre (WCATWC) approximately three and a half hours after the earthquake. Continued monitoring of oceanic tide gauges however suggested that the tsunami could be larger on the US west coast and prompted the WCATWC to contact emergency managers in northern California to warn them of the possible danger. As a result, the beaches and harbor areas were cleared to remove people from possible danger. The first tsunami waves reached Crescent City just before noon on November 15<sup>th</sup>, and surges steadily increased until mid-afternoon when a maximum surge of 1.76 m (peak to trough) affected the harbor between 2:00 and 2:30 PM PST (Figure 1.5), some three hours after the initial wave.

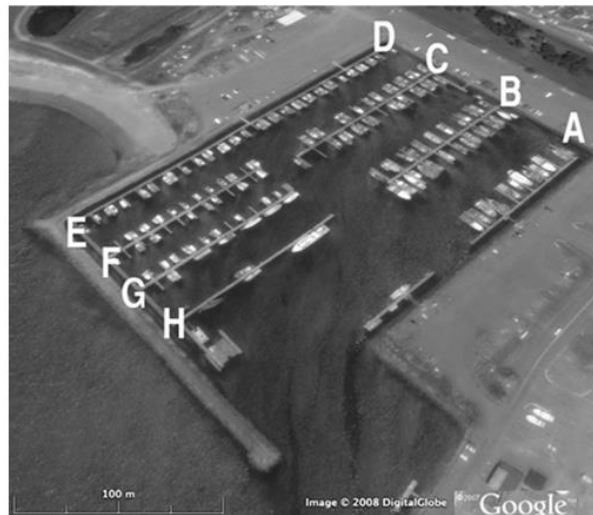
**Figure 1.6 Small-boat basin. Docks F, G, and H were either completely or severely damaged during the 2006 tsunami (from Dengler et al., 2008).**

It should be noted that these peak surges occurred around low tide and this may have mitigated the overall effects. Nevertheless, very strong and damaging currents were reported beginning with the initial waves and intensifying as the larger surges came through. The design of the docks in use in Crescent City connects the floating platforms to the metal pilings by a metal pile ring. Since the strong currents pushed the docks laterally pinning the pile ring against the pilings, the docks were unable to adjust to the changing water level allowing water to flow over the top. The increased hydrodynamic forces resulted in severe damage to several docks, particularly those located nearest to the entrance of the inner harbor (Figure 1.6).

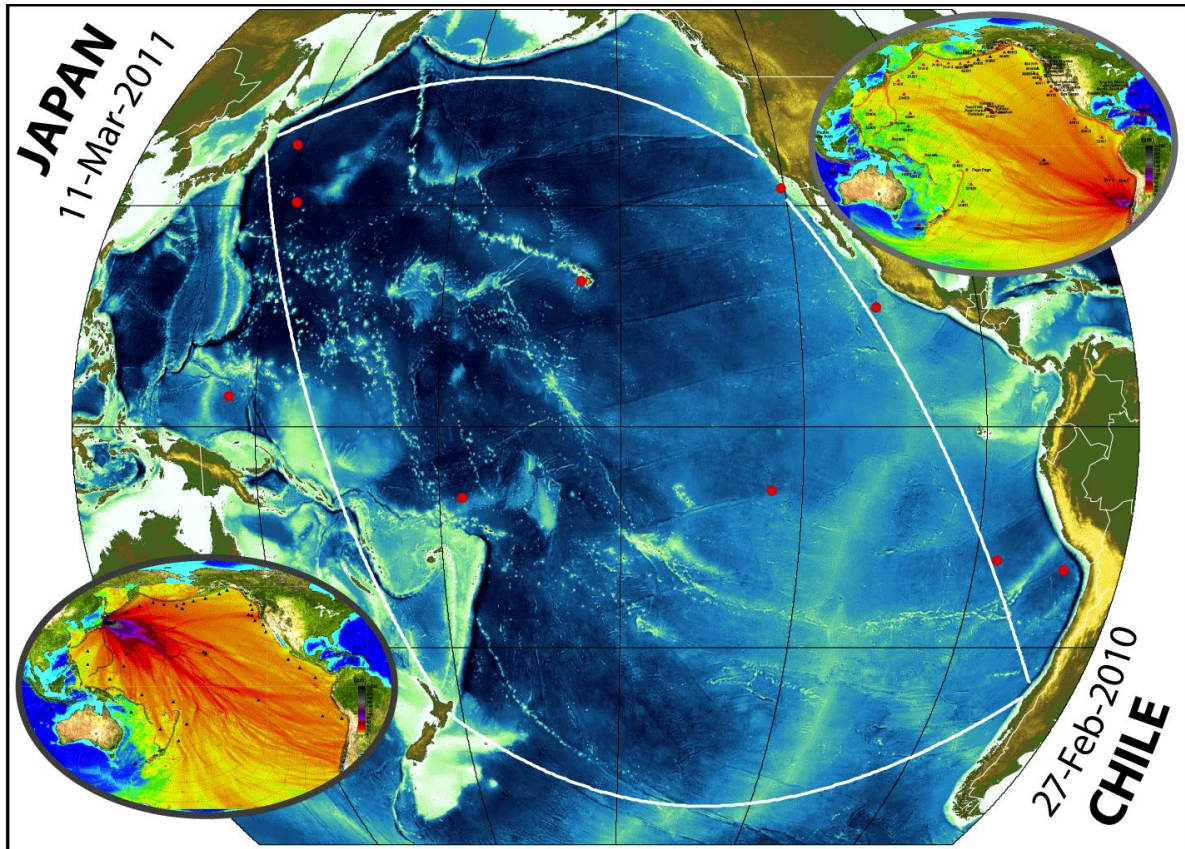
**Figure 1.8** The tsunamis of 2010 and 2011 across the Pacific and relative to New Zealand and California.

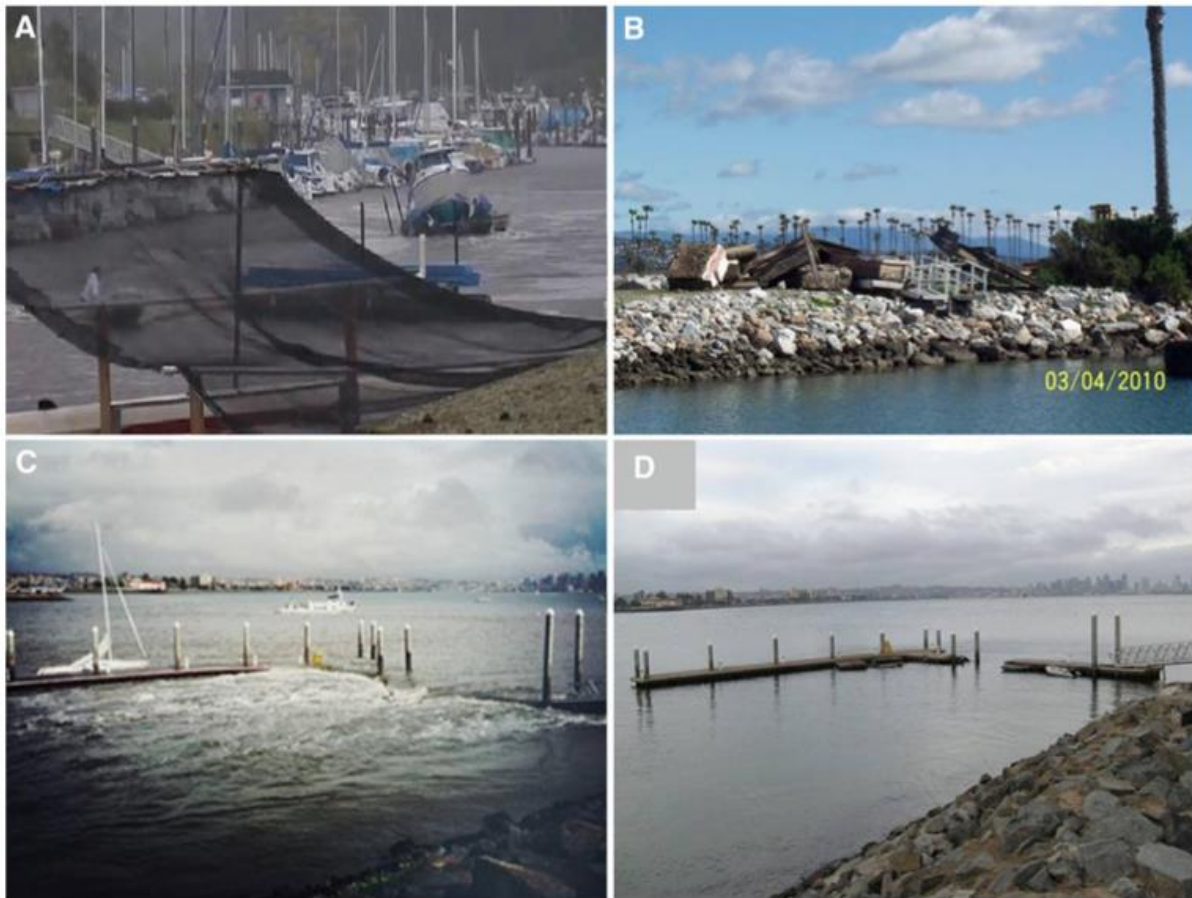
**Figure 1.9** Photos from the February 27, 2010 tsunami in California. (A) is a still image of a boat that floats loose during the tsunami in Santa Cruz Harbor (source: YouTube video). (B) A photo of docks damaged during the 2010 tsunami in Ventura Harbor (source: Dale Carnathan). (C) and (D) Pictures showing flooding and damage to dock taken during and after the 2010 tsunami, northern Shelter Island, San Diego Bay (sources: (C) is still image from YouTube video; (D) is by Rick Wilson). (Reproduced from Wilson et al., 2012).

In California, the Chile tsunami began affecting San Diego, CA around mid-day on February 27 and steadily moved northward over the next several hours. The surges caused currents of up to 8 m/s (~16 knots) according to eyewitness accounts, although these values may be overestimated. Nevertheless, strong and damaging currents were observed, particularly in San Diego, Ventura and Santa Cruz Harbours (Figure 1.9).

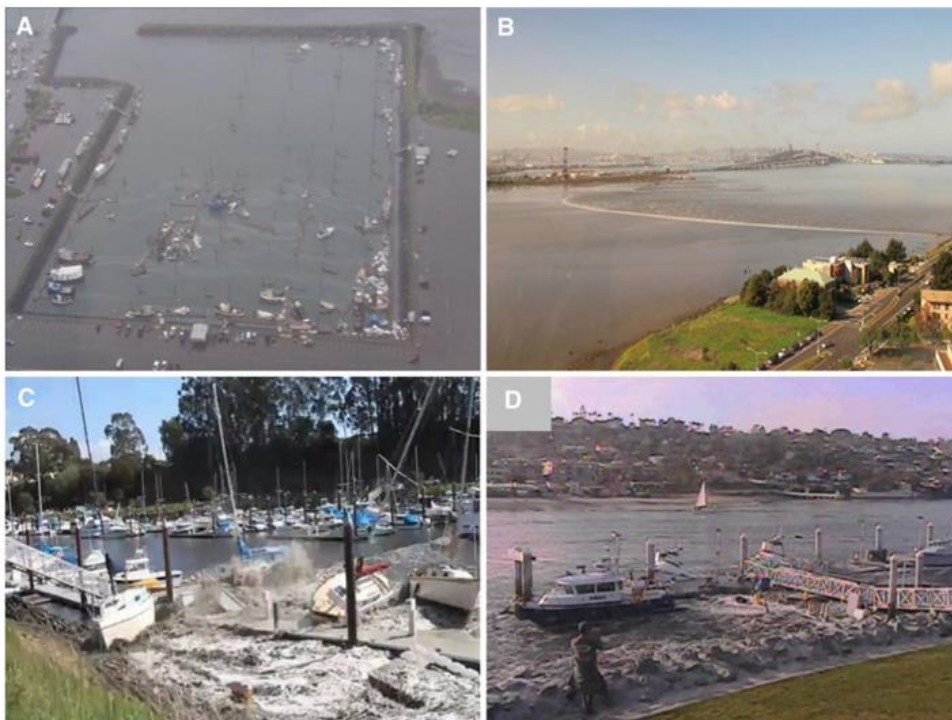
**Figure 1.10 Photos from the March 11, 2011 tsunami in California. (A) Aerial view of heavy damage within Crescent City small boat basin. (B) A tsunami bore in east San Francisco Bay. (C) A tsunami bore damaging boats in Santa Cruz Harbor. (D) A boat sinking and damage to docks in southern Shelter Island, San Diego Bay (Reproduced from Wilson et al., 2012).**

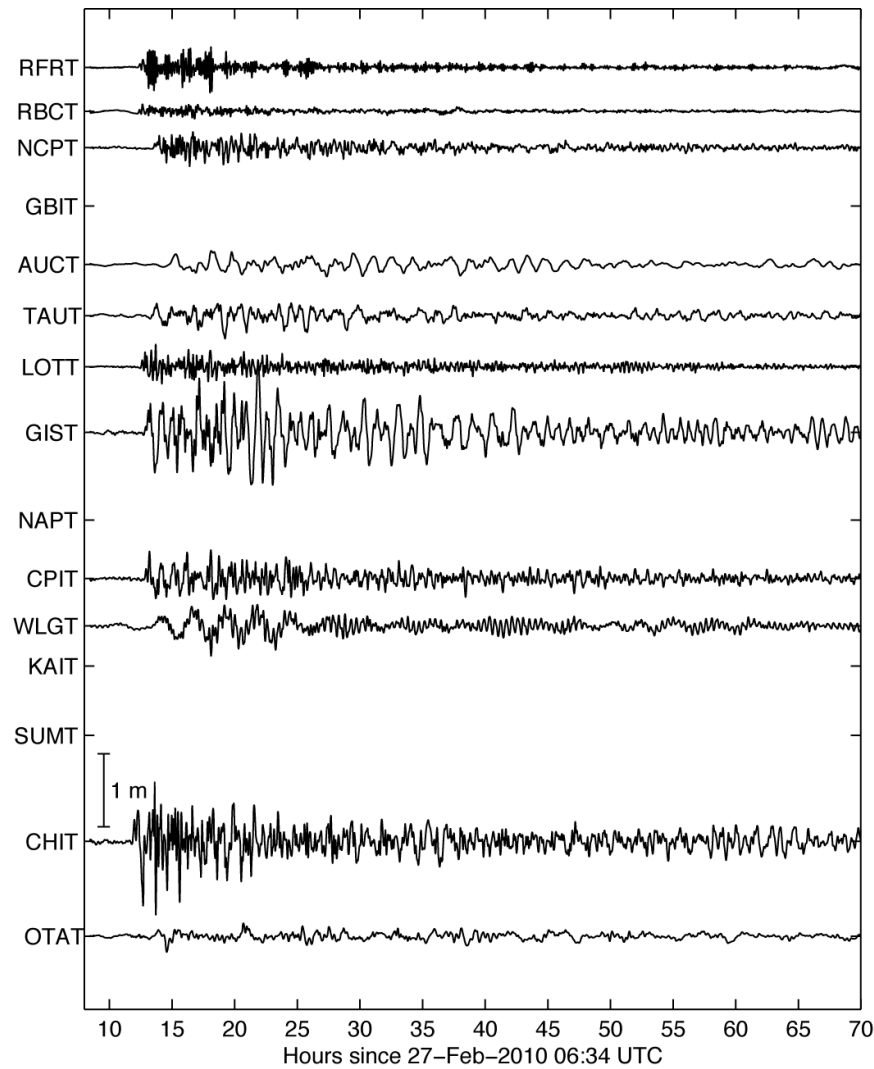
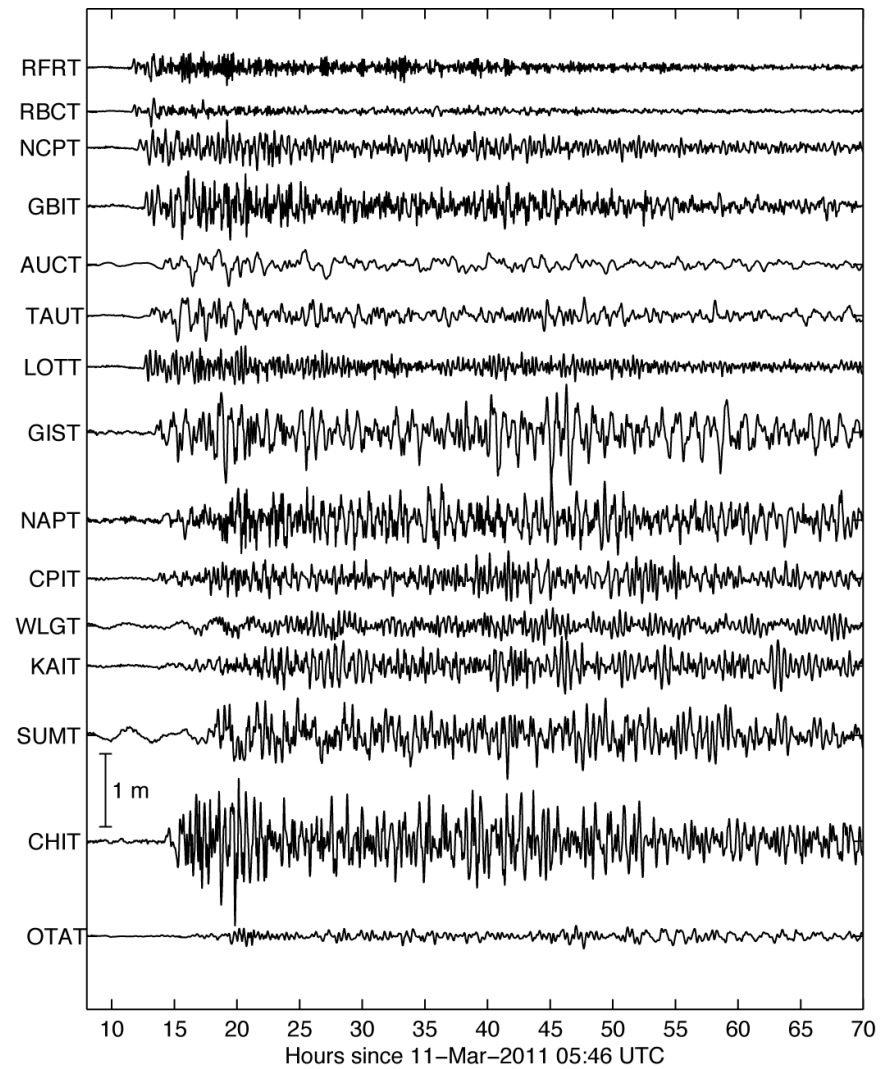
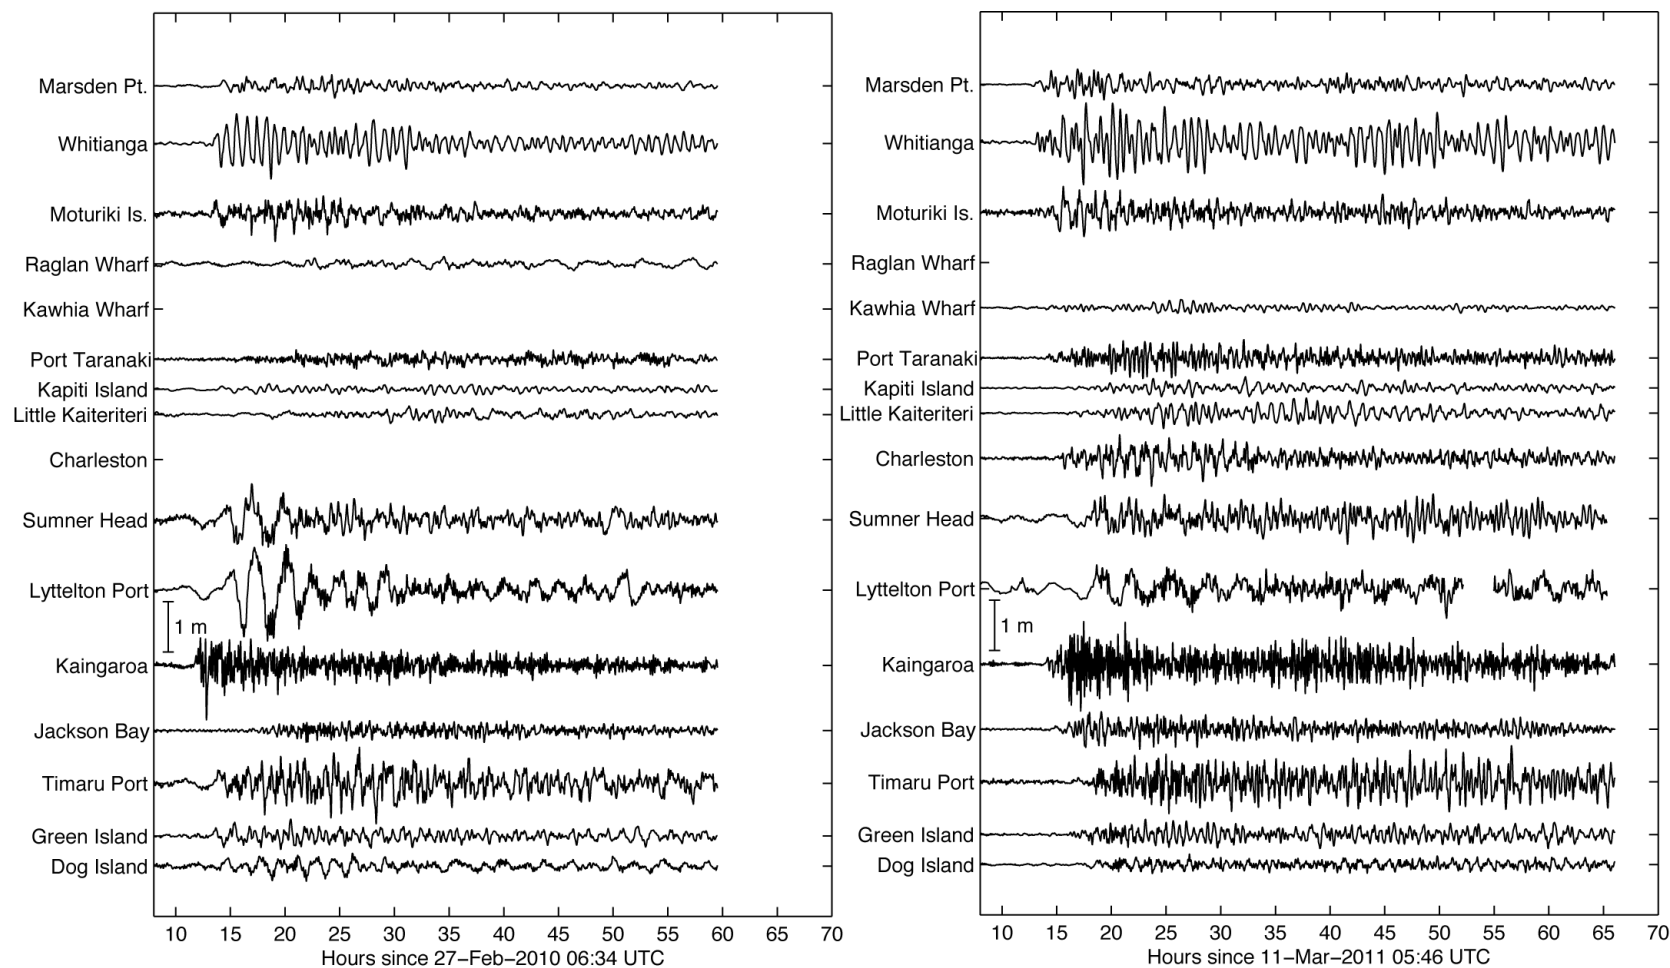
**Figure 1.11 Residual water levels at New Zealand tide gauges from the 2010 Chile (previous page) and 2011 Japan (this page) tsunamis. The extended duration of the tsunami signal (more than 2 days) is clearly evident. Location and station names are referenced in Error! Reference source not found..**

In New Zealand, the effects were limited mostly to strong currents and surges with no reports of significant damage. Borrero and Greer (2013) reported extensively on the tsunami signature on New Zealand tide gauges and noted the extended duration of the tsunami effects in New Zealand waters. This is clearly evident on the residual tide gauge data shown in Figure 1.11 (reproduced from Borrero and Greer, 2012).

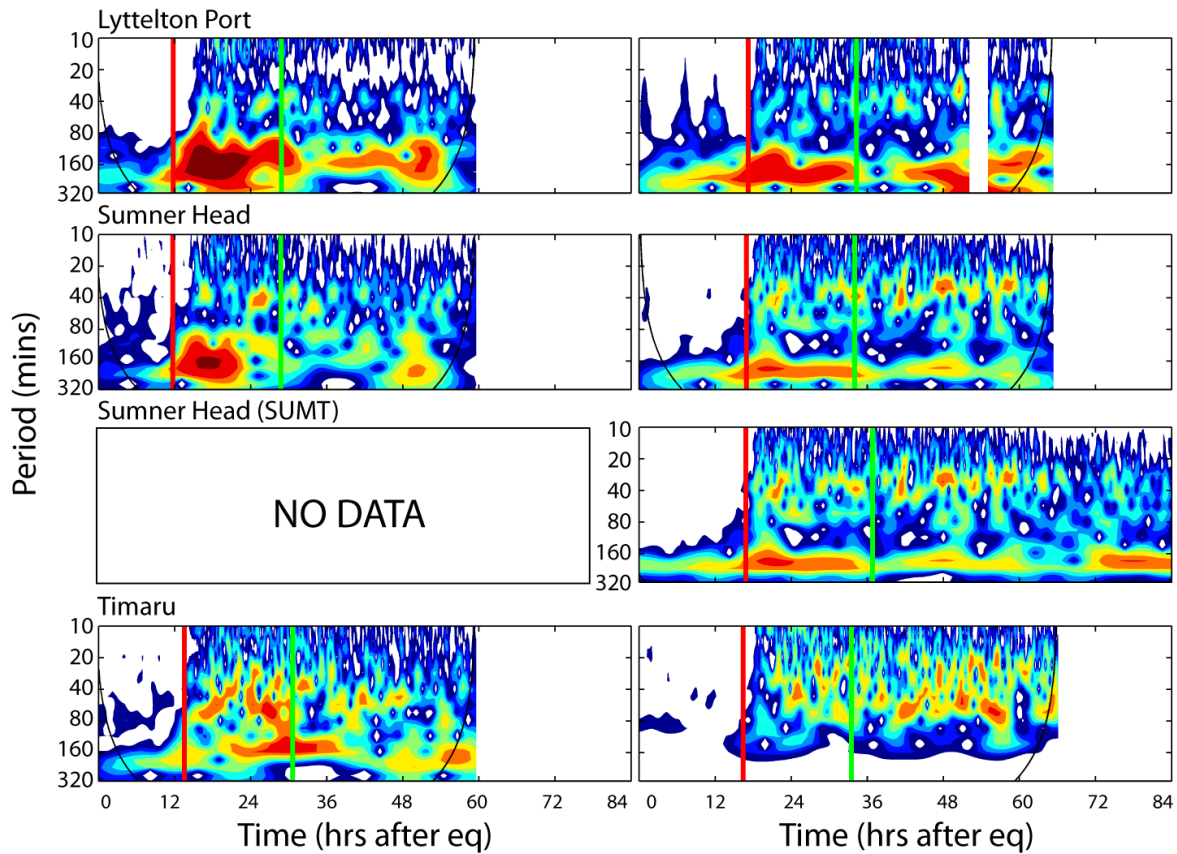
**Figure 1.13** Wavelet spectrograms at select ports and tide gauges in New Zealand for the 2010 and 2011 tsunamis. Vertical axis is wave period in minutes, horizontal axis time after earthquake in hours. Vertical red bar indicates tsunami arrival time. Hot colours indicate higher energy levels at that particular time/frequency combination. Location and station names are referenced in Error! Reference source not found. ( reproduced from Borrero and Greer, 2012).

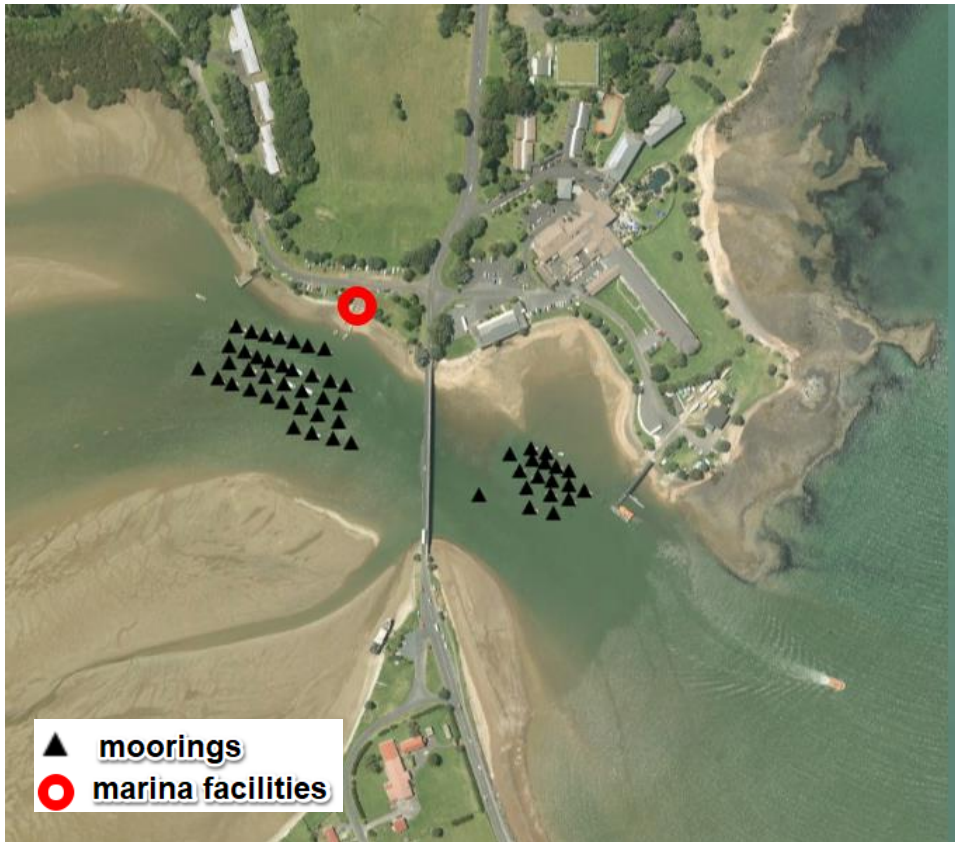
Figure 2.3 Locations of moorings at Waitangi.

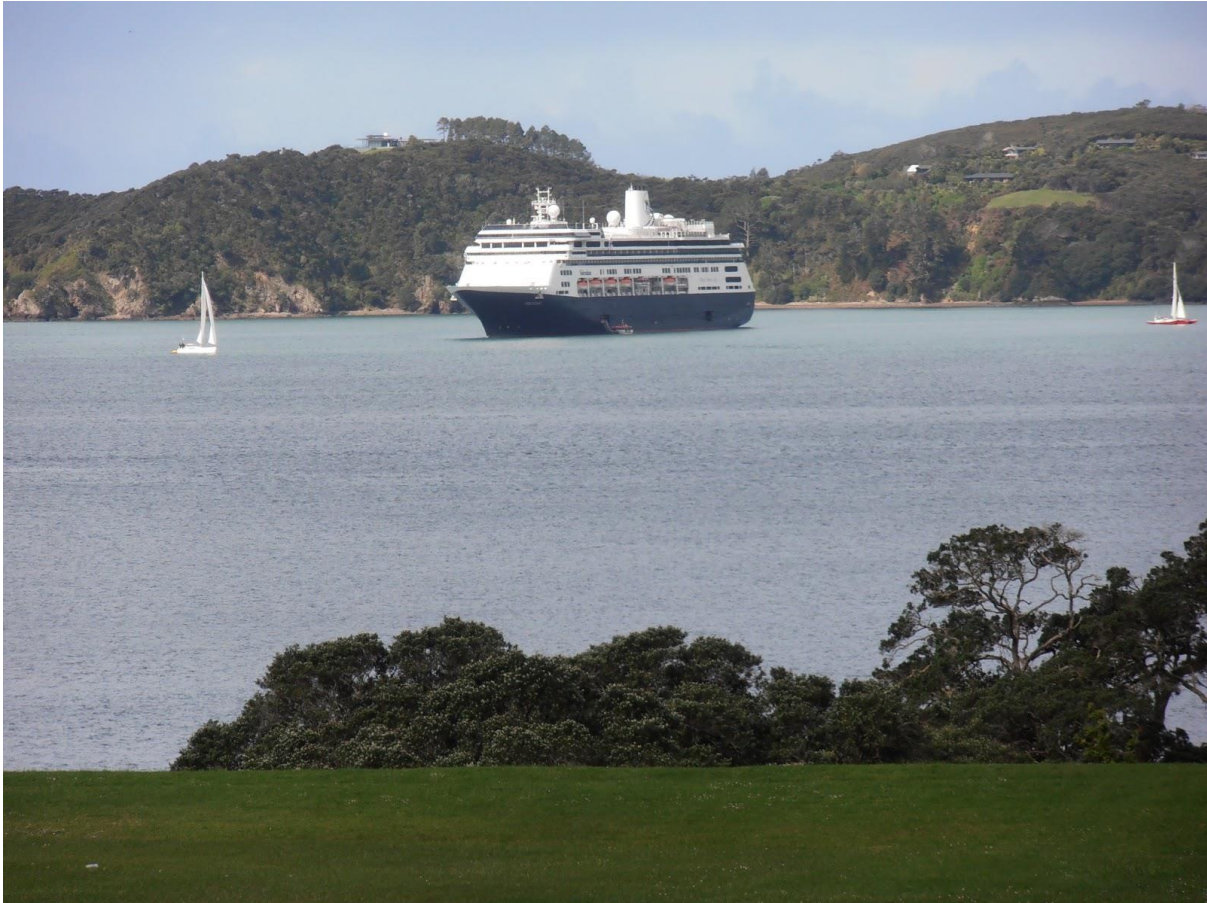
Figure 2.4 (top) A cruise ship moored offshore of Waitangi. (bottom) the cruise ship mooring locations.

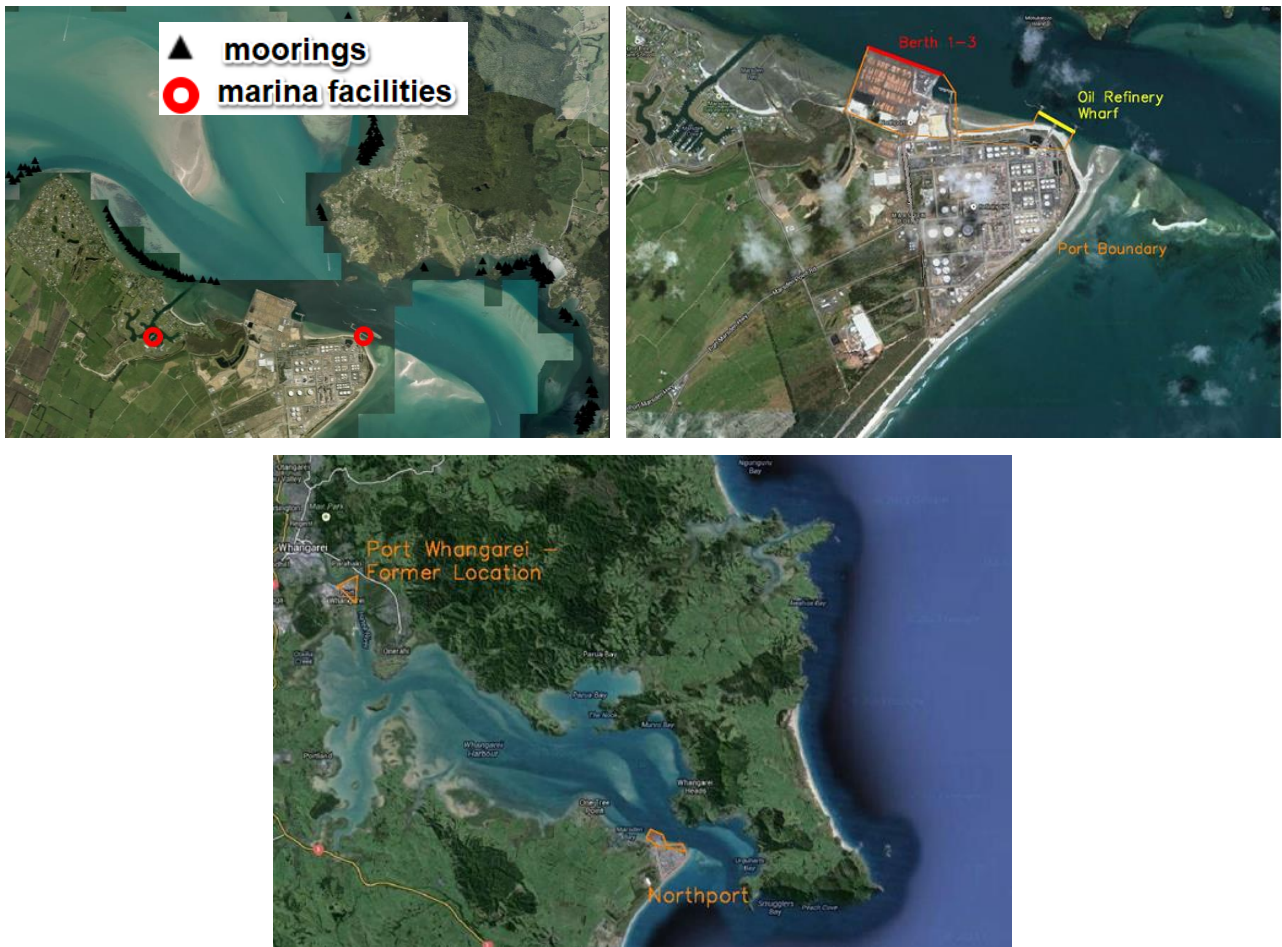
Figure 2.8 Locations and layout of facilities at Marsden Point (figures reproduced from Popovich, 2015).
