# Tsunami Impacts to Lifelines:

*Review of Current Knowledge and Post-Event Survey of the 16 September 2015*

*M8.3 Illapel, Chile Tsunami*

Nick Horspool, Stuart Fraser (GNS Science)  
Richard Mowll (Wellington Lifelines Group)

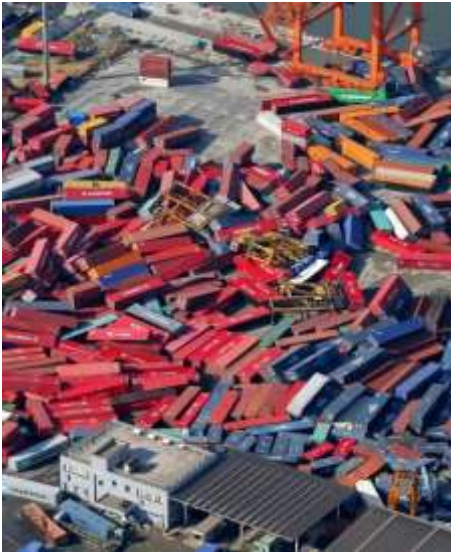
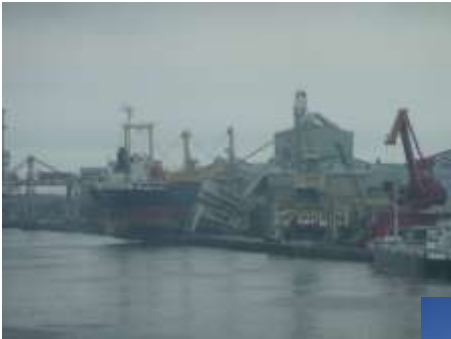
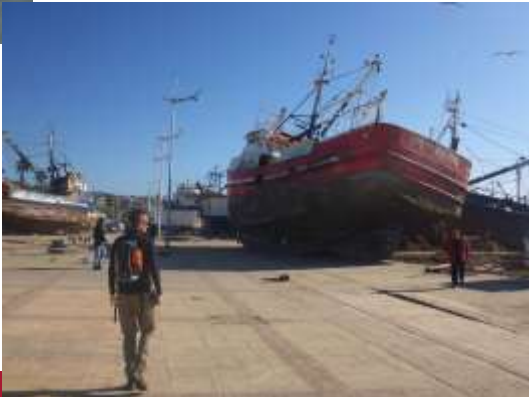
- Wharves relatively unaffected by tsunami (higher levels of earthquake damage likely)
- Operations heavily affected by floating debris

- Strengthen ties between piers and decks to resist buoyancy forces
- Develop response plan for large vessels to exit to deep water (~150m depth)
- Some evidence 'bumpers' can reduce impact forces from debris/vessel strikes
- Evacuation plan for port/wharf personnel

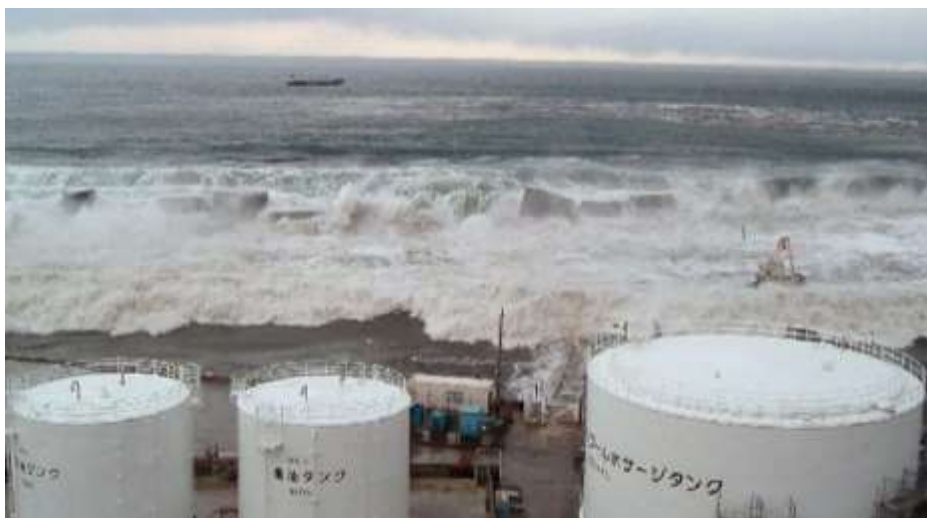
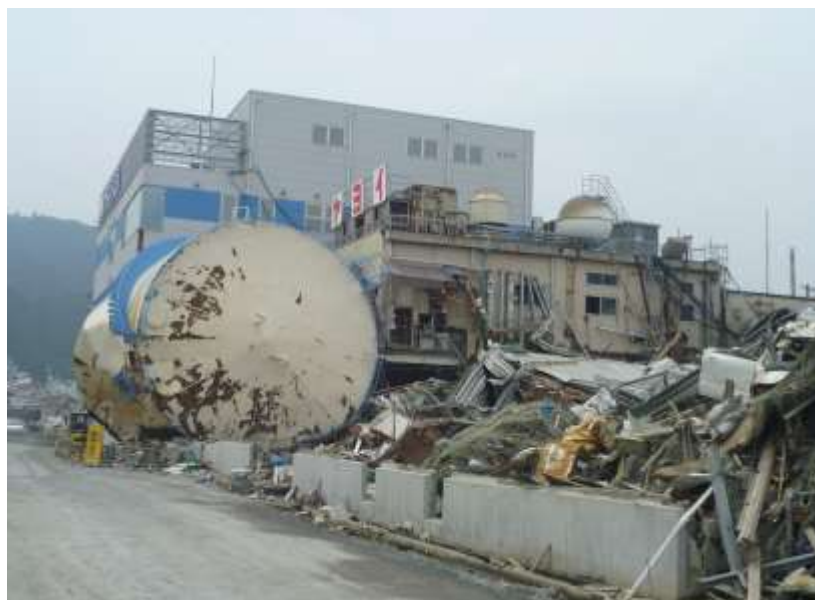
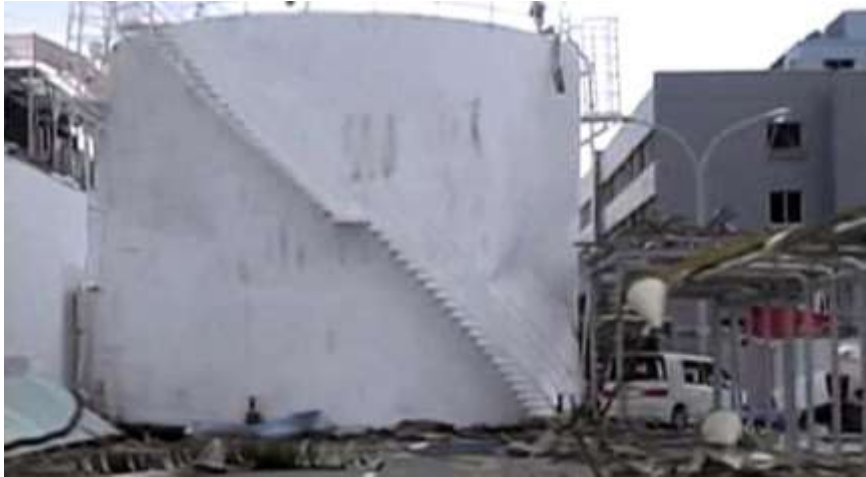
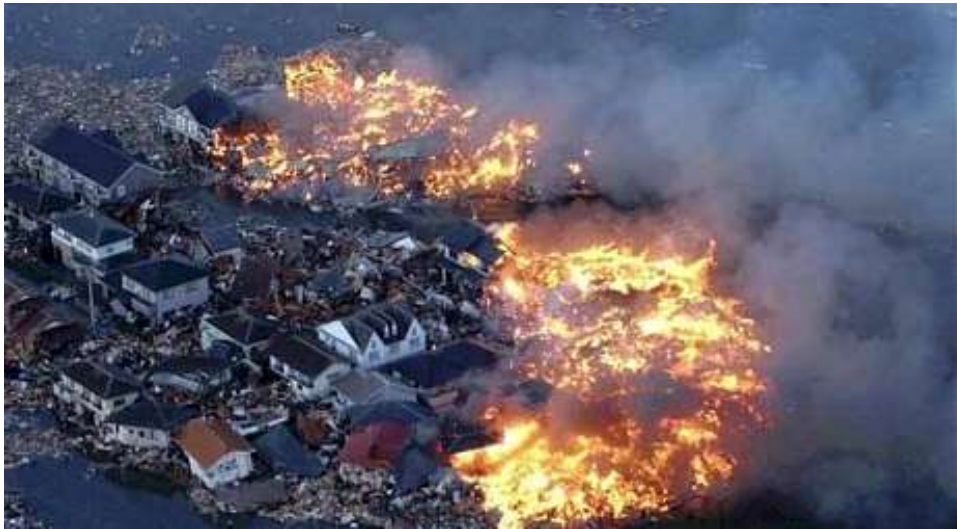
- Damage to pipe connections ( > 2 m)
- Scour of tank foundation
- Buckling of base of tank
- Floatation and entrainment ( > 2m) dependent on capacity and fullness
- Fire following

- Large capacity tanks are less likely to slide and float
- Relocate tanks outside of tsunami inundation zone
- Construct scour resistant foundations
- Construct tanks to seismic design standards to resist lateral loads
- Locate tanks away from sources of debris
- Minimize low levels of fuel in tank

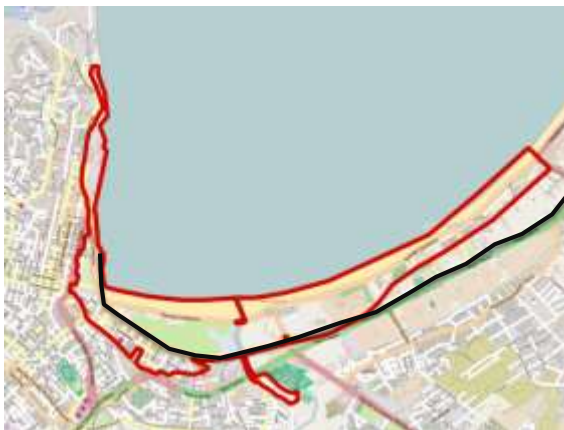
## Rail – Coquimbo Survey

- Single track in inundation area
- On wooden sleepers
- Shifted laterally in <1 m flow depths
  - 200 m length
- Washed away in > 2 m flow depths
  - 800 m length
- Minor scouring of ballast

- Develop contingency plan to clear debris from line, repair overhead lines, repair scour or washouts
- Stock pile of spares of electrical equipment
- Develop tsunami evacuation response plan for passengers on coastal lines
- Strengthen steel rail bridges in tsunami inundation zones

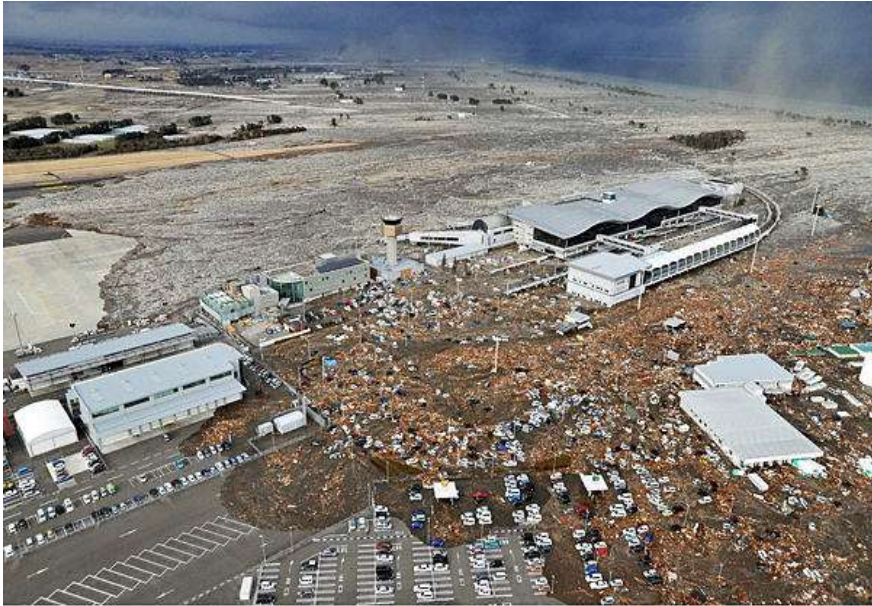
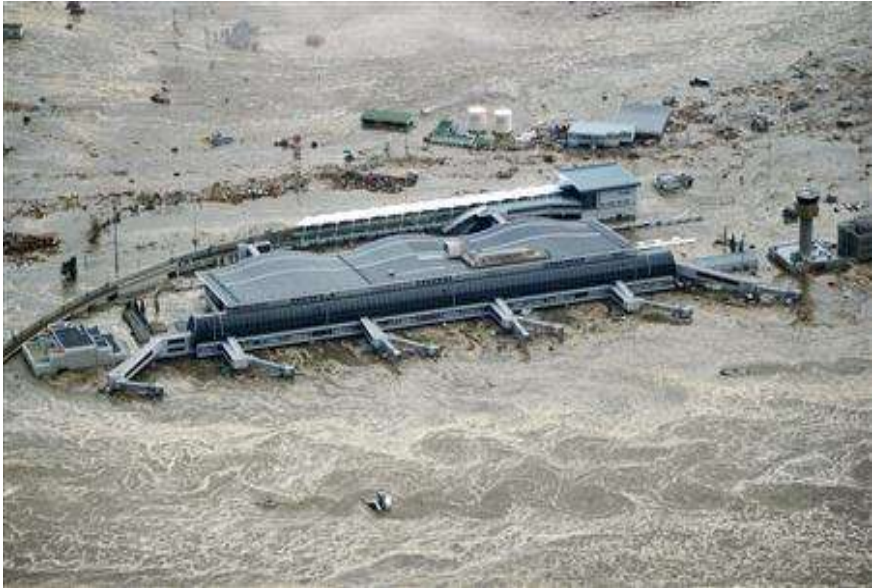
- Damage and flooding of terminal buildings
- Damage to low lying electrical equipment
- Floatation of vehicles and machinery
- Floatation of aircraft (no planes in Sendai airport)
- Scour of embankments (not runway tarmac)
- Debris deposition on runway
- Ponding of water on runway

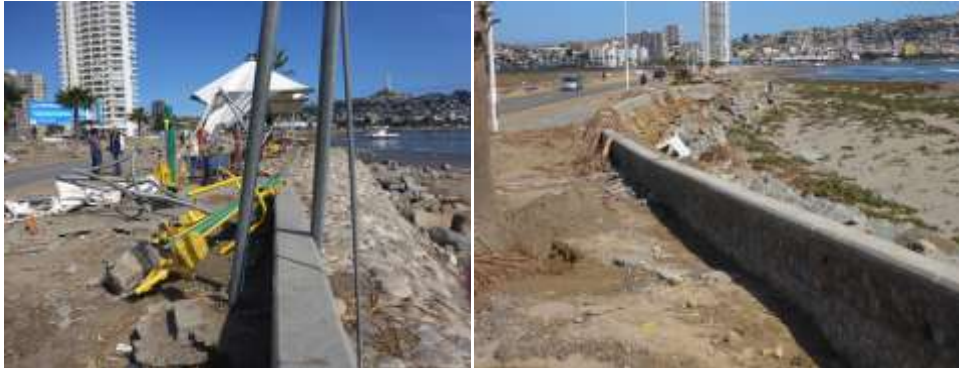
## SeaWall Construction

- Large stone riprap
- Concrete conglomerate sloping and vertical wall
- Loose sand fill beneath

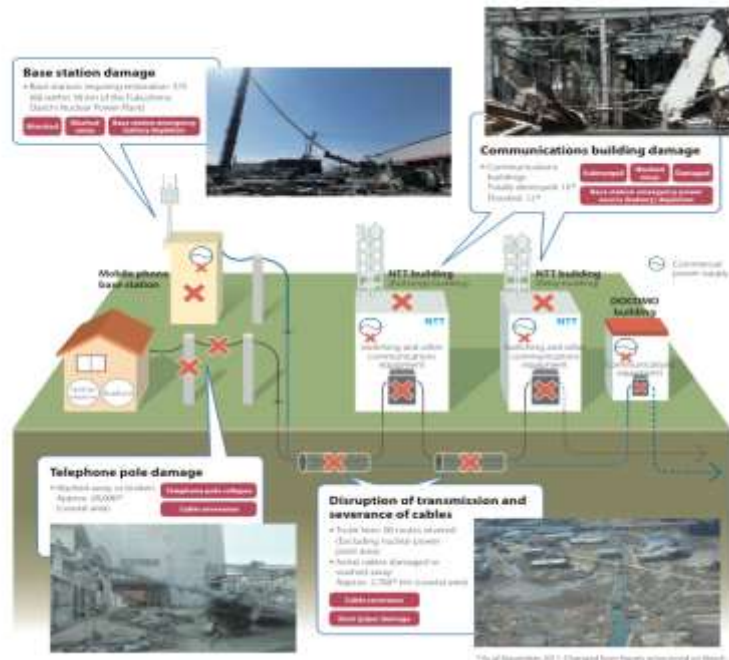
- Cellular sites from debris strike or hydrodynamic forces on towers or collapse of buildings
- Exchanges from flooding or washout of building
- Buried cables entering buildings (scour around foundation)
- Buried cables from scour
- Power outages to cell sites/exchanges and depletion of backup batteries (2 hrs) and flooding of backup generators
- Washout and flooding of submarine cable landing sites

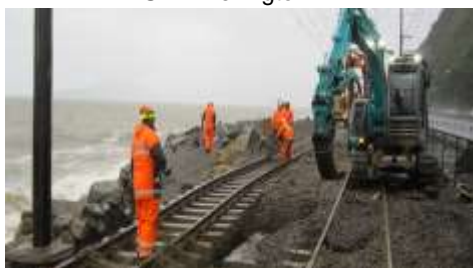
SH2 Wellington

- Multiple lifelines services run along route
- Potentially vulnerable to scour and washout

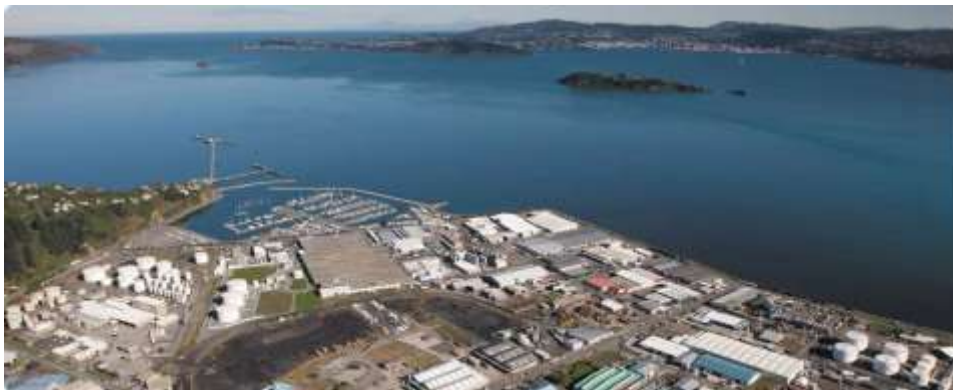
## Seaview Fuel Terminal

- Significant source of debris from vessels
- Wellingtons main road fuel supply
